# POWER REACTOR EVENTS

United States Nuclear Regulatory Commission

March-April 1982/Vol. 4, No. 3

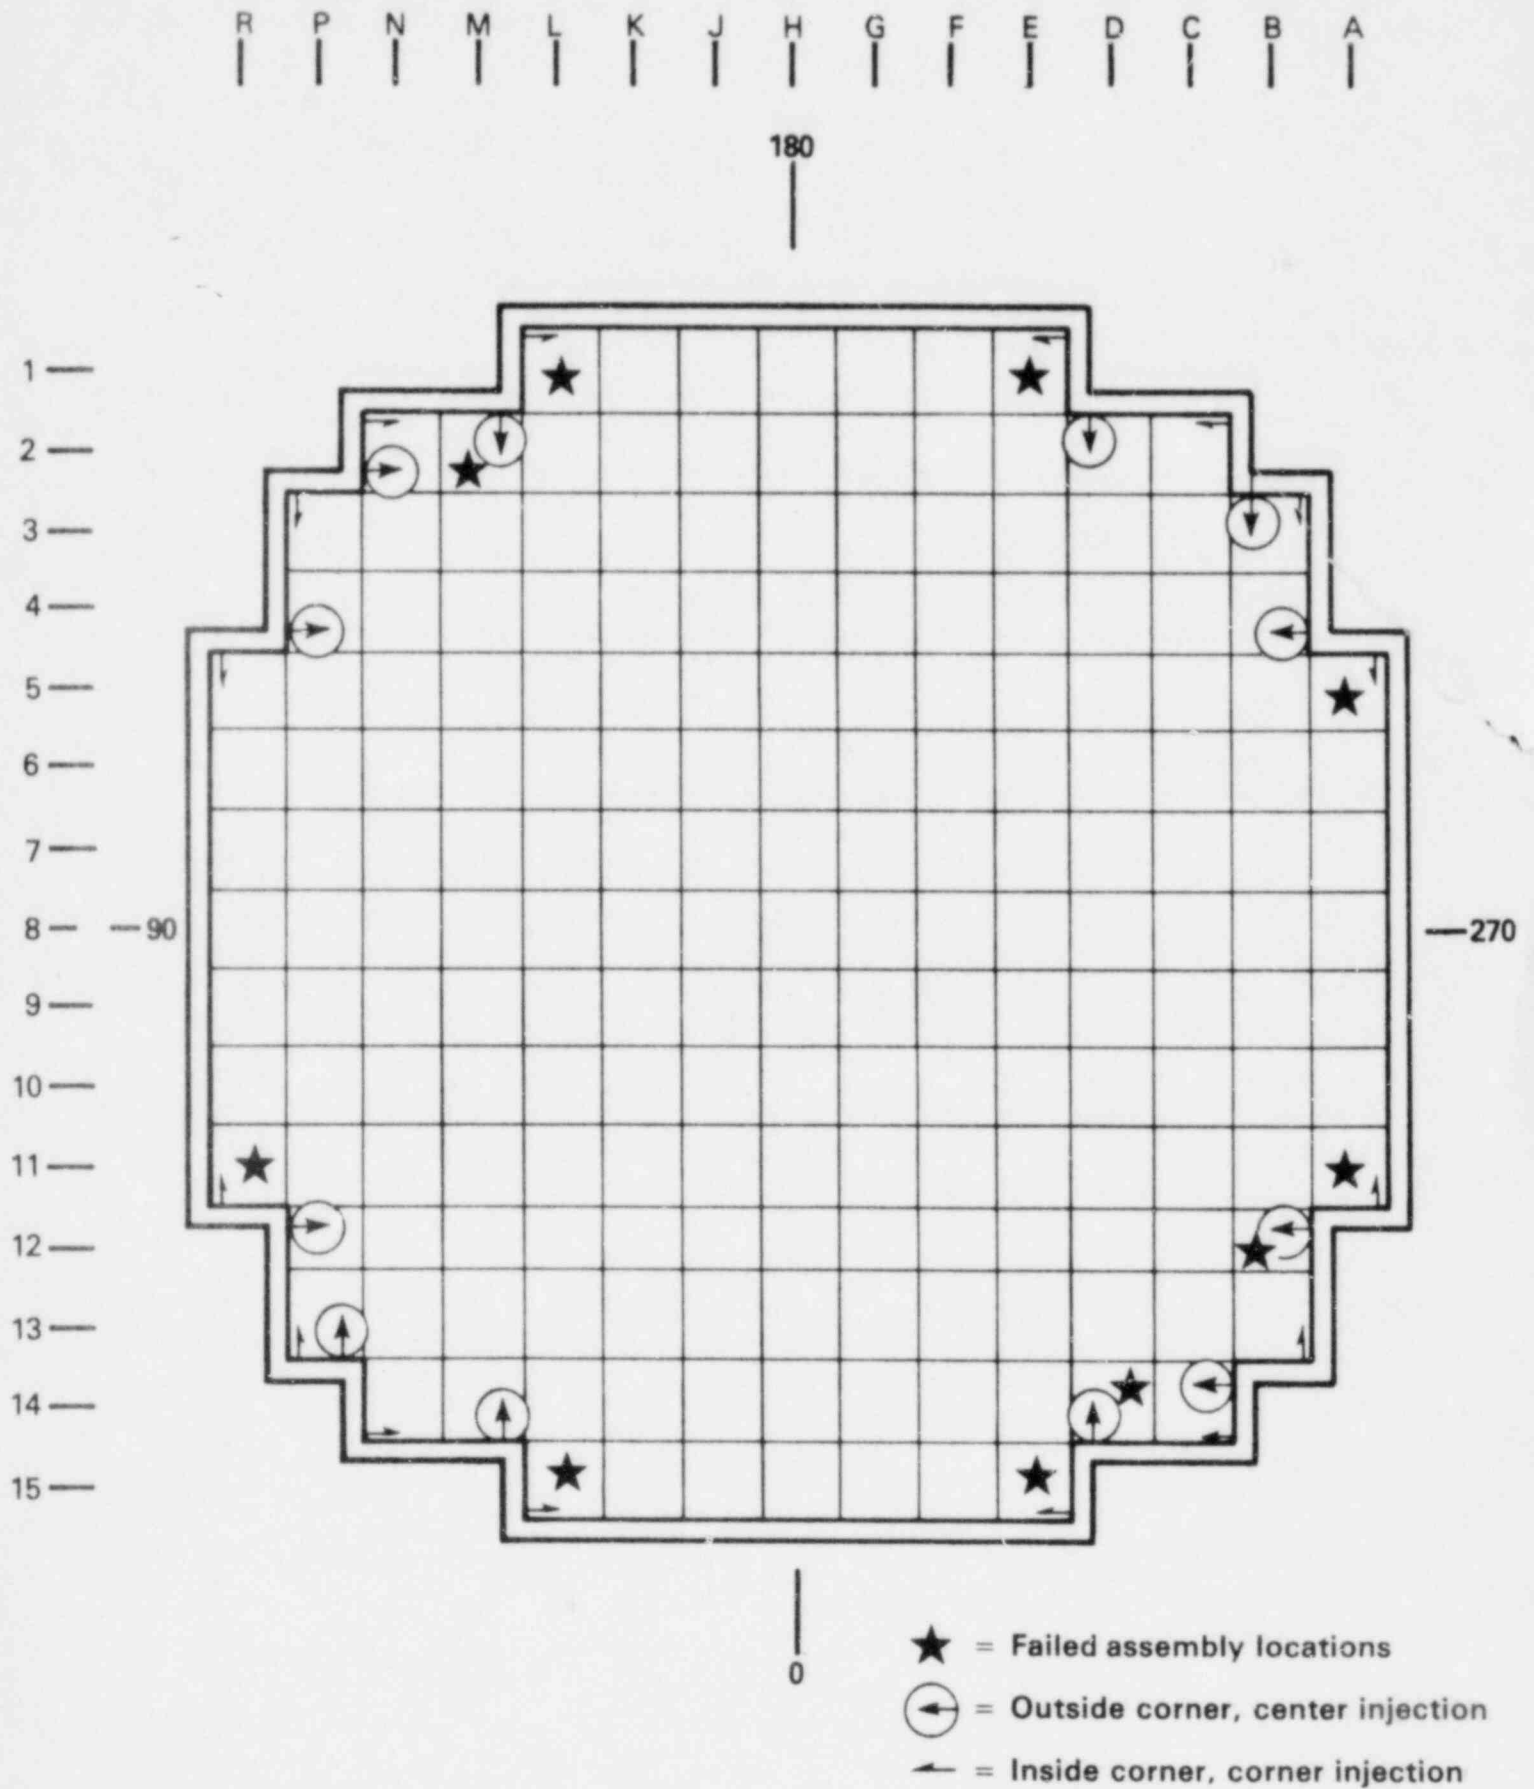
Figure 1. Grid of Trojan Core

The apparent cause of the fuel damage was water-jet induced vibration of fuel pins in fuel assemblies that are adjacent to baffle plate joint locations with enlarged gaps (see Figure 1). The degradation of the balance of the assemblies was due to minor clad defects, which were detected by the sipping technique. Two types of baffle gap related failures were present. Type 1 is the outside corner or center injection jetting failure. In this case, the water jet impinges directly on the third rod from the corner and causes it to fail in the upper axial regions from direct water impingement combined with induced rod whirling/vibration. Type 2 of baffle gap related failure is the inside corner or corner injection jetting failure, whereby a jet of water flows parallel to the fuel bundle perimeter face between the fuel and the baffle plate. The flow causes fuel rod whirling to occur at the first few rod locations and leads to severe rod failure in the upper axial regions.

Previously (April 25, 1980) abnormal degradation had been discovered in two fuel pins at Trojan. The apparent cause of this fuel damage was also water-jet impingement on the fuel pin via an enlarged baffle plate joint gap. Corrective peening action was taken in 1981 to close these gaps. In 1982, it appears that the jetting problem in the Type 2 failures was caused by the peening done in 1981 on the outside corner joints of the baffle plate. The assemblies that failed during the recent cycle by the Type 1 mechanism, however, appeared to have less damage than those failing before the peening.

The licensee conducted an augmented fuel inspection program in which all fuel assemblies to be used in the subsequent cycle were leak checked by fuel sipping and visually inspected to be damage free. Accessible loose pellets and debris will be retrieved from the reactor vessel internals and refueling cavity. Damaged assemblies adjacent to the baffle will be replaced with new modified fuel assemblies using stainless steel pins in place of fuel rods to ensure fuel integrity until permanent repairs can be made.<sup>1-3</sup>

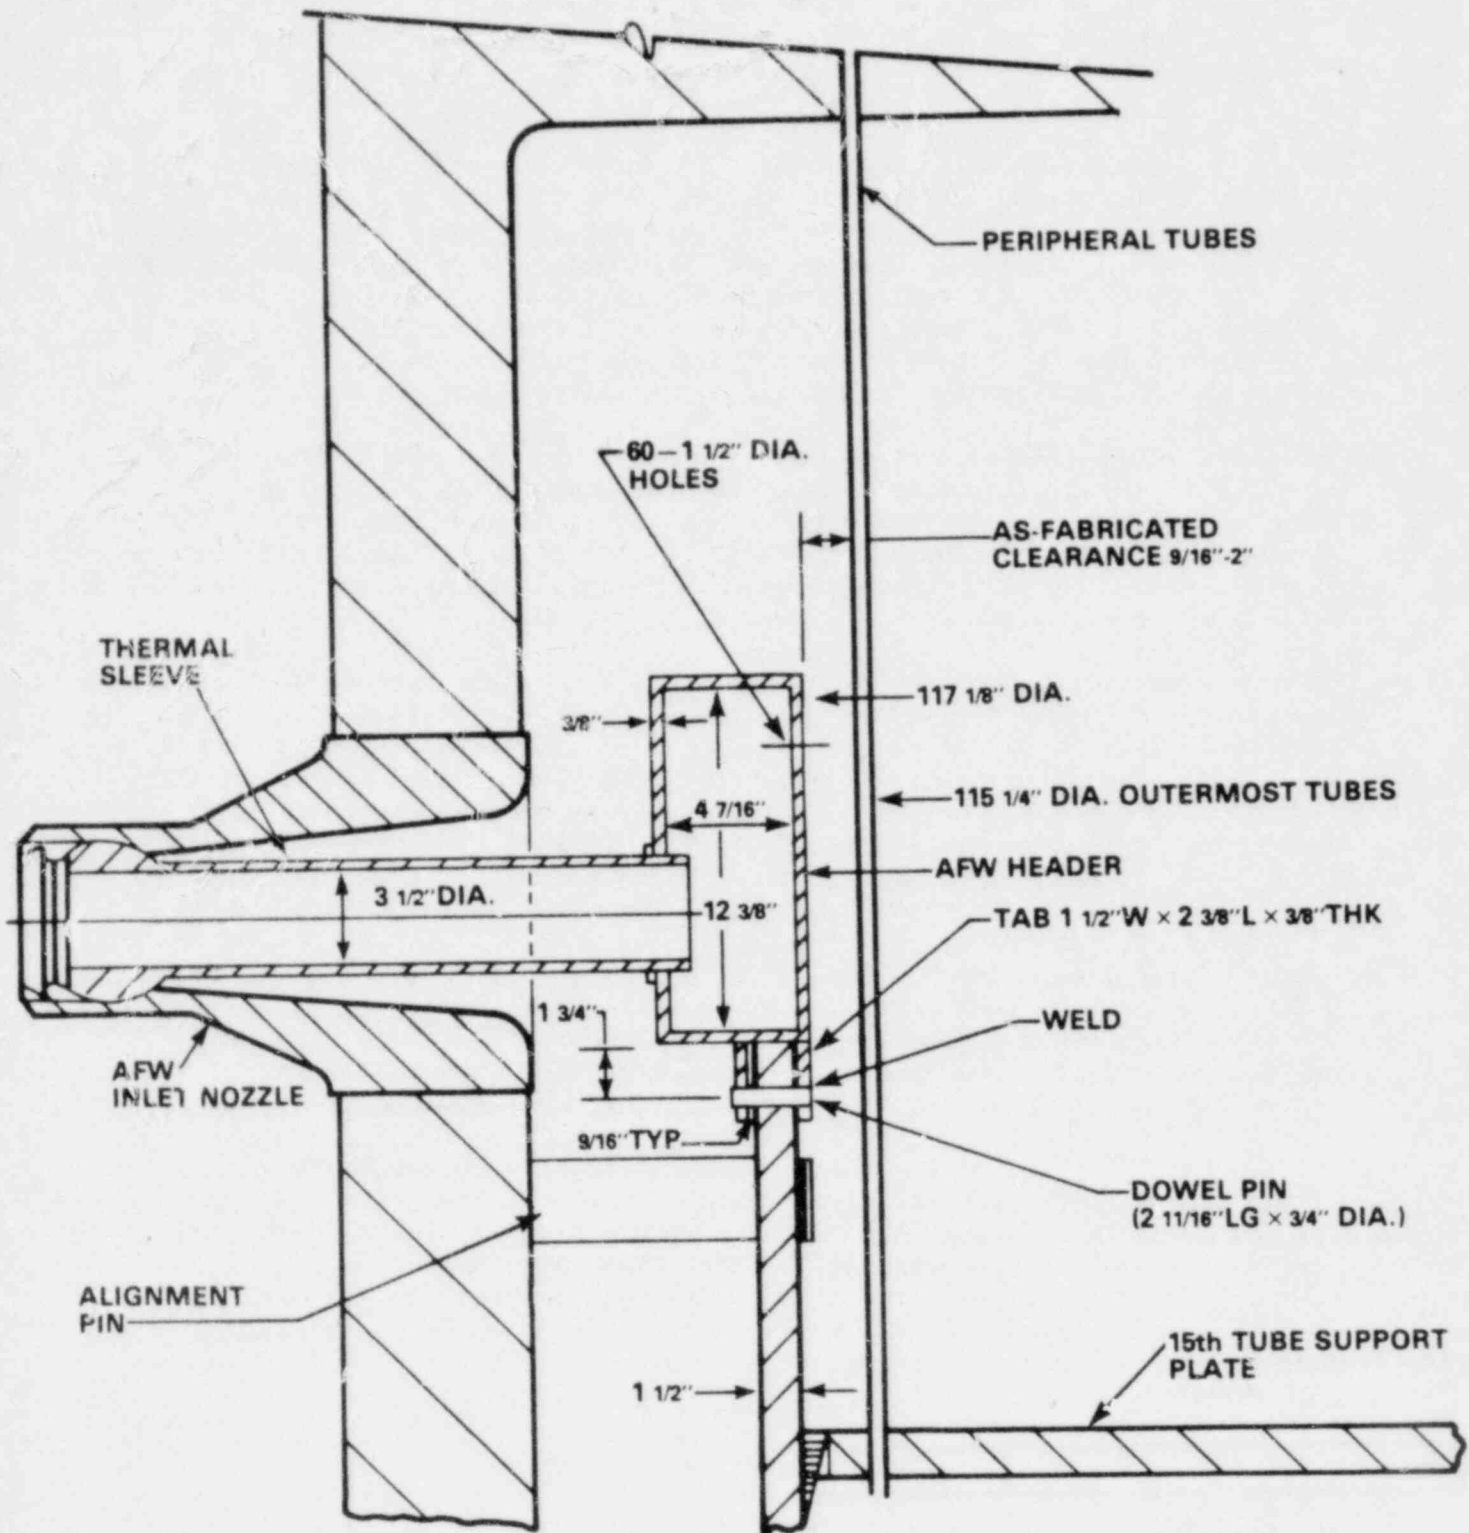
Figure 2. Internal AFW Header Design (Longitudinal Section) for Davis - Besse Unit 1

The toroidal AFW header is located near the top of the shell on B&W OTSGs (see Figure 2). At these three units only, the header is located inside the OTSG. It is rectangular in cross section and encircles the steam generator tube bundle. It is totally supported by the steam shroud attached at eight locations by brackets and pins. A thermal sleeve connects the header to the AFW inlet nozzle. This thermal sleeve is slip fitted into a hole in the outboard face of the header. The as-fabricated clearance between the header and the tubes varies from 9/16 to 2 inches. The header size and shape was selected to minimize the interference with steam flow.

The damage was first discovered at Davis-Besse Unit 1 on April 13. Personnel found indications of tube denting in the vicinity of the AFW ring header inside steam generator No. 1 during eddy current inspection of the peripheral tubes. Further investigation determined that one of the supports for the ring header was damaged, and a holding pin was missing from a second support. A 16-inch access port in the shell of each steam generator was removed to allow further inspection. The ring header was found separated from the thermal sleeve and had a concave deformation in the outer wall. The thermal sleeve was out of the header, misaligned, and butted against the header penetration. In this configuration, AFW flow through the header was reduced and forced into the space between the shell and the shroud. Of the eight brackets holding the ring header, the four which were closest to the access ports were bent, with the holding pins missing from two brackets and damaged in two others. Steam generator No. 2 was subsequently examined. The four pins closest to the access port were missing and two bracket pieces were broken off. Three of the pins were located and recovered.

The Davis-Besse licensee has evaluated several possible failure mechanisms and has concluded that the most likely cause is condensation-induced high pressure differentials. These can be generated when cold auxiliary feedwater is injected into the header. During normal operation, the header would be filled with super-heated steam since it sits in the upper super-heat region of the steam generator. When cold auxiliary feedwater (<100°F) is injected into the rectangular header, very large local pressure differences can occur with large steam-water contact areas which cannot be compensated for quickly enough locally through the 60 1-1/2-inch diameter flow holes. Except for the extra strength weld areas, the 3/8-inch plate walls are not reinforced and are inadequate for the loads generated under these conditions. In addition to the possibly large reduced pressure areas, the header experiences high thermal differences when the cold auxiliary feedwater enters the header and begins to fill from the bottom up and flows around the header from the single nozzle.

B&W and the licensees of the three plants involved have developed a design change for permanent repair. These repairs are underway and nearly completed at Davis-Besse and Rancho Seco. The three plants will use the same conceptual design. The repair procedure will satisfy two major objectives: (1) the existing internal AFW header must be stabilized to preclude damage to the steam generator tubes, and (2) a different means of injecting auxiliary feedwater to the steam generators must be provided. To satisfy these objectives the internal AFW header will be further restrained to the shroud on which it currently rests, and an external AFW header will be installed with six injection nozzles (eight at Davis-Besse) to provide AFW flow. (This external AFW ring design already exist at five other B&W plants.) The AFW penetration will be blank flanged, and the internal header will not be used for flow distribution.<sup>7-15</sup>

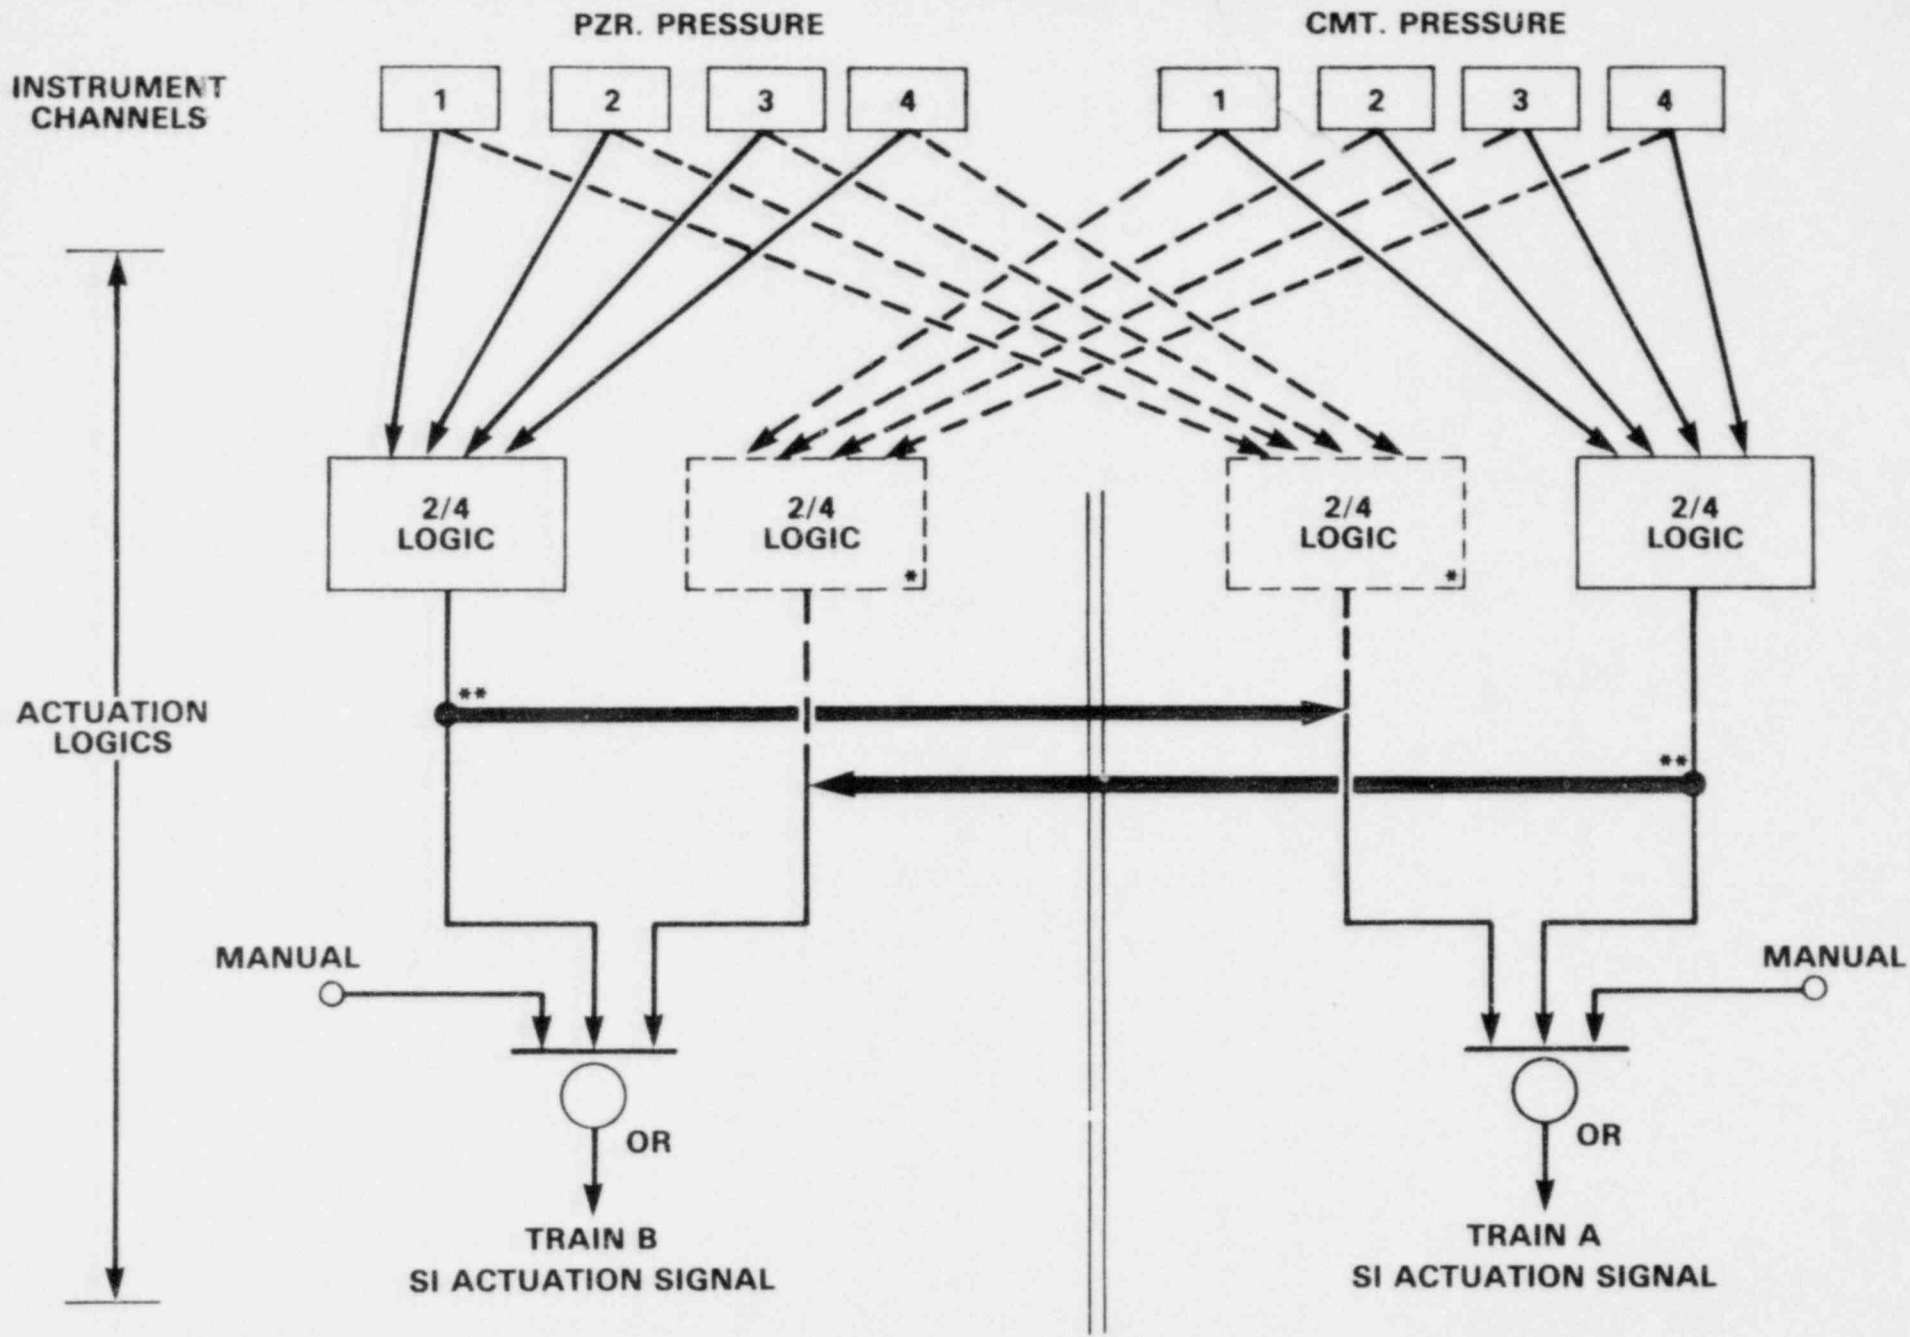
Figure 3. SI ACTUATION SIGNAL LOGIC FOR MAINE YANKEE

parameter. Redundant trains (A and B) of SI equipment are provided to perform the required safety function. At the time the error was discovered, the logic matrix which combines the signals from the sensing channels to produce SI initiation, based on a trip of any two of the four sensing channels, was implemented by only a single logic element for each parameter (see Figure 3). High containment pressure was a two-out-of-four train A logic and low pressurizer pressure was a two-out-of-four train B logic. Therefore, the design satisfied the single failure criterion only for events which result in coincident low pressurizer pressure and high containment pressure, such as a design basis loss-of-coolant accident.

On February 22, the licensee provided a proposed modification of SI logic, and revised this proposal on March 8. The modification added two-out-of-four logic matrices to both the A and B train logic such that each train of SI is independently initiated based on either low pressurizer pressure or high containment pressure. This change includes a provision for separation of electrical wiring for redundant circuits in order to improve the independence between trains. The modification was judged acceptable by the NRC in a safety evaluation issued to the licensee on April 27, and has subsequently been installed at the plant.
