Report to Congress on Abnormal Occurrences

January - March 1982

**U.S. Nuclear Regulatory
Commission**

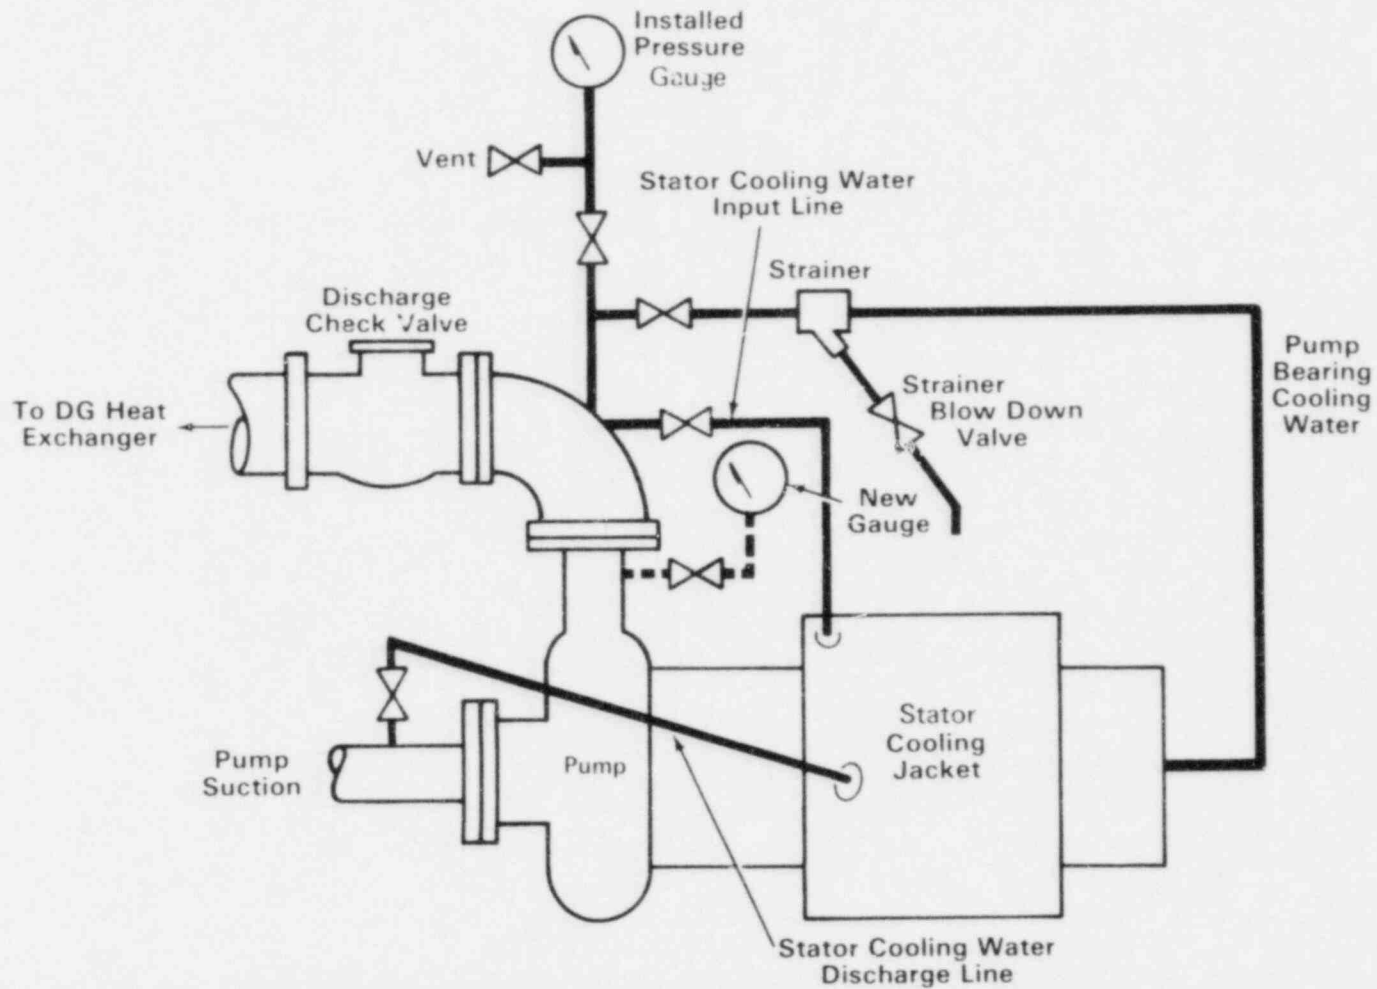
Figure 1. Diesel Generator Cooling Water Pump (DGCWP) and Discharge Check Valve

A broken check valve on the discharge of the Unit 3 pump was found and replaced. The valve disk had broken free of the pivot arm and was lodged in the discharge side of the valve, restricting nearly all flow.

The Unit 2/3 pump was replaced. During the pump replacement, the licensee inspected the pump's check valve and found it to be broken. As was the case with the Unit 3 pump discharge check valve, the disk had broken free of the pivot arm. In the case of the Unit 2/3 pump, however, the disk had not lodged into the body of the valve, but was free to move in any direction within the valve body. The valve was replaced.

During the October 23 through December 1, 1981 events, the Unit 2 D/G had functioned properly. However, as part of the investigation, the Unit 2 pump discharge check valve was inspected. It was found that this valve was also broken, but at a different point. The valve hinge broke and the pivot hinge remained rigidly attached to the valve disc. This valve was also replaced.

Cause or Causes - The D/Gs were made inoperable due to insufficient cooling water flow to the D/G heat exchangers. In most of the events, the degraded flow was caused by broken check valves in the cooling water pump discharge. In one event, even though the check valve was broken, it was not restricting flow; a decrease in discharge pressure was caused by worn bearings on the D/G cooling water pump. For the check valves for Unit 3 and Unit 2/3 D/Gs, the valve disk had broken free of the pivot arm. For Unit 2 D/G, the pivot arm remained attached to the valve disk, but was broken at the hinge to the valve body. The disks for the Unit 3 and Unit 2/3 check valves were at times in such a position that flow was restricted to the cooling water heat exchanger which caused the D/Gs to overheat. The disk for the Unit 2 check valve had apparently not located itself in a critical position to affect flow.

1. All three discharge check valves have been replaced.
2. Instrumentation changes for the cooling water systems for all three diesels will be made. An additional pressure gauge on the discharge volute of each DGCWP has been installed (see "New Gauge" in Figure 1). When an engineering study is completed, the licensee will also provide a more accurate indication of system flow than presently exists (i.e., 0-200 psig gauges on the inlet and outlet of the heat exchangers are unreliable to indicate a small differential pressure).

5. Because each diesel experienced a defective check valve, the licensee plans to examine and test each valve annually.

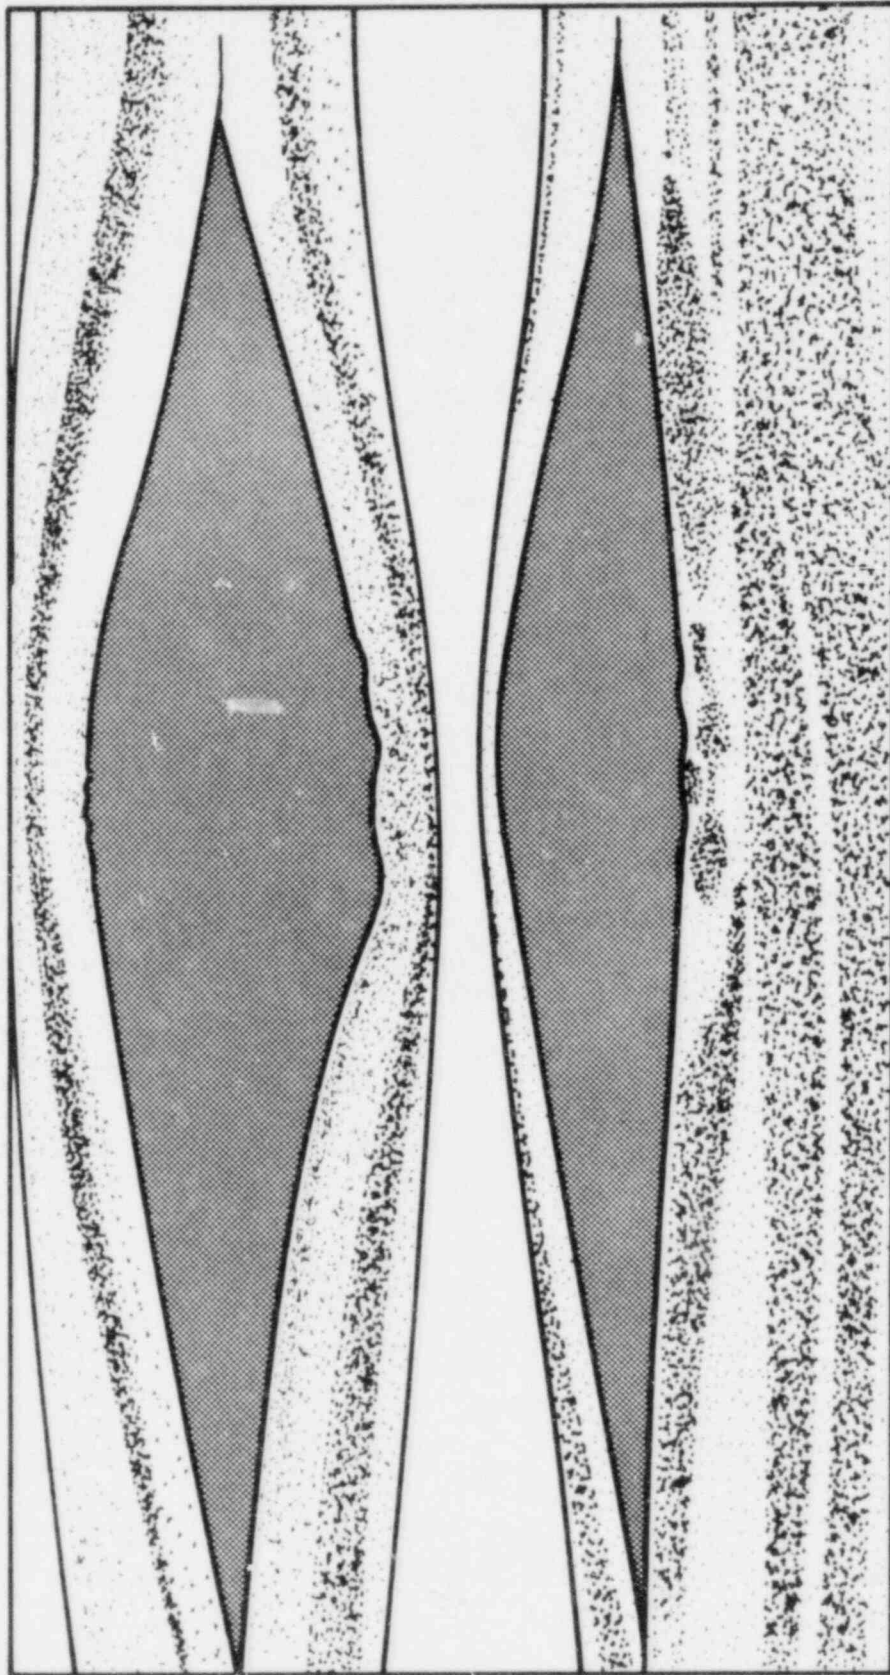
Figure 4 Two closeup views of rupture in tube R42C55
