NUREG/CR-4674
ORNL/NOAC-232
Vol. 18

Precursors To Potential Severe Core Damage Accidents: 1992 A Status Report

Appendices B, C, D, E, F, and G

Oak Ridge National Laboratory

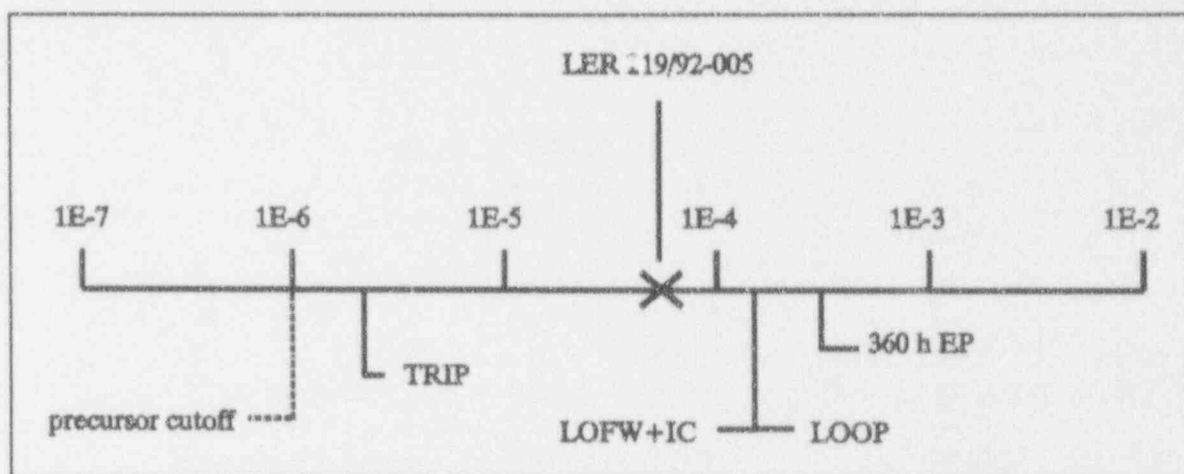
Fig. B.1. Relative significance of LER 219/92-005 compared with other potential events at Oyster Creek.

Oyster Creek lost offsite power for 5 min when a forest fire near the plant caused the offsite transmission lines to fault. The two emergency diesel generators (EDGs) operated as designed. Although offsite power was restored in 5 min, the emergency buses were supplied from the EDGs for 17 h until reliability of the offsite power supply could be assured. The conditional core damage probability estimated for this event is 7.1×10^{-5} . The relative significance of this event compared to other postulated events at Oyster Creek is shown in Fig. B.1.

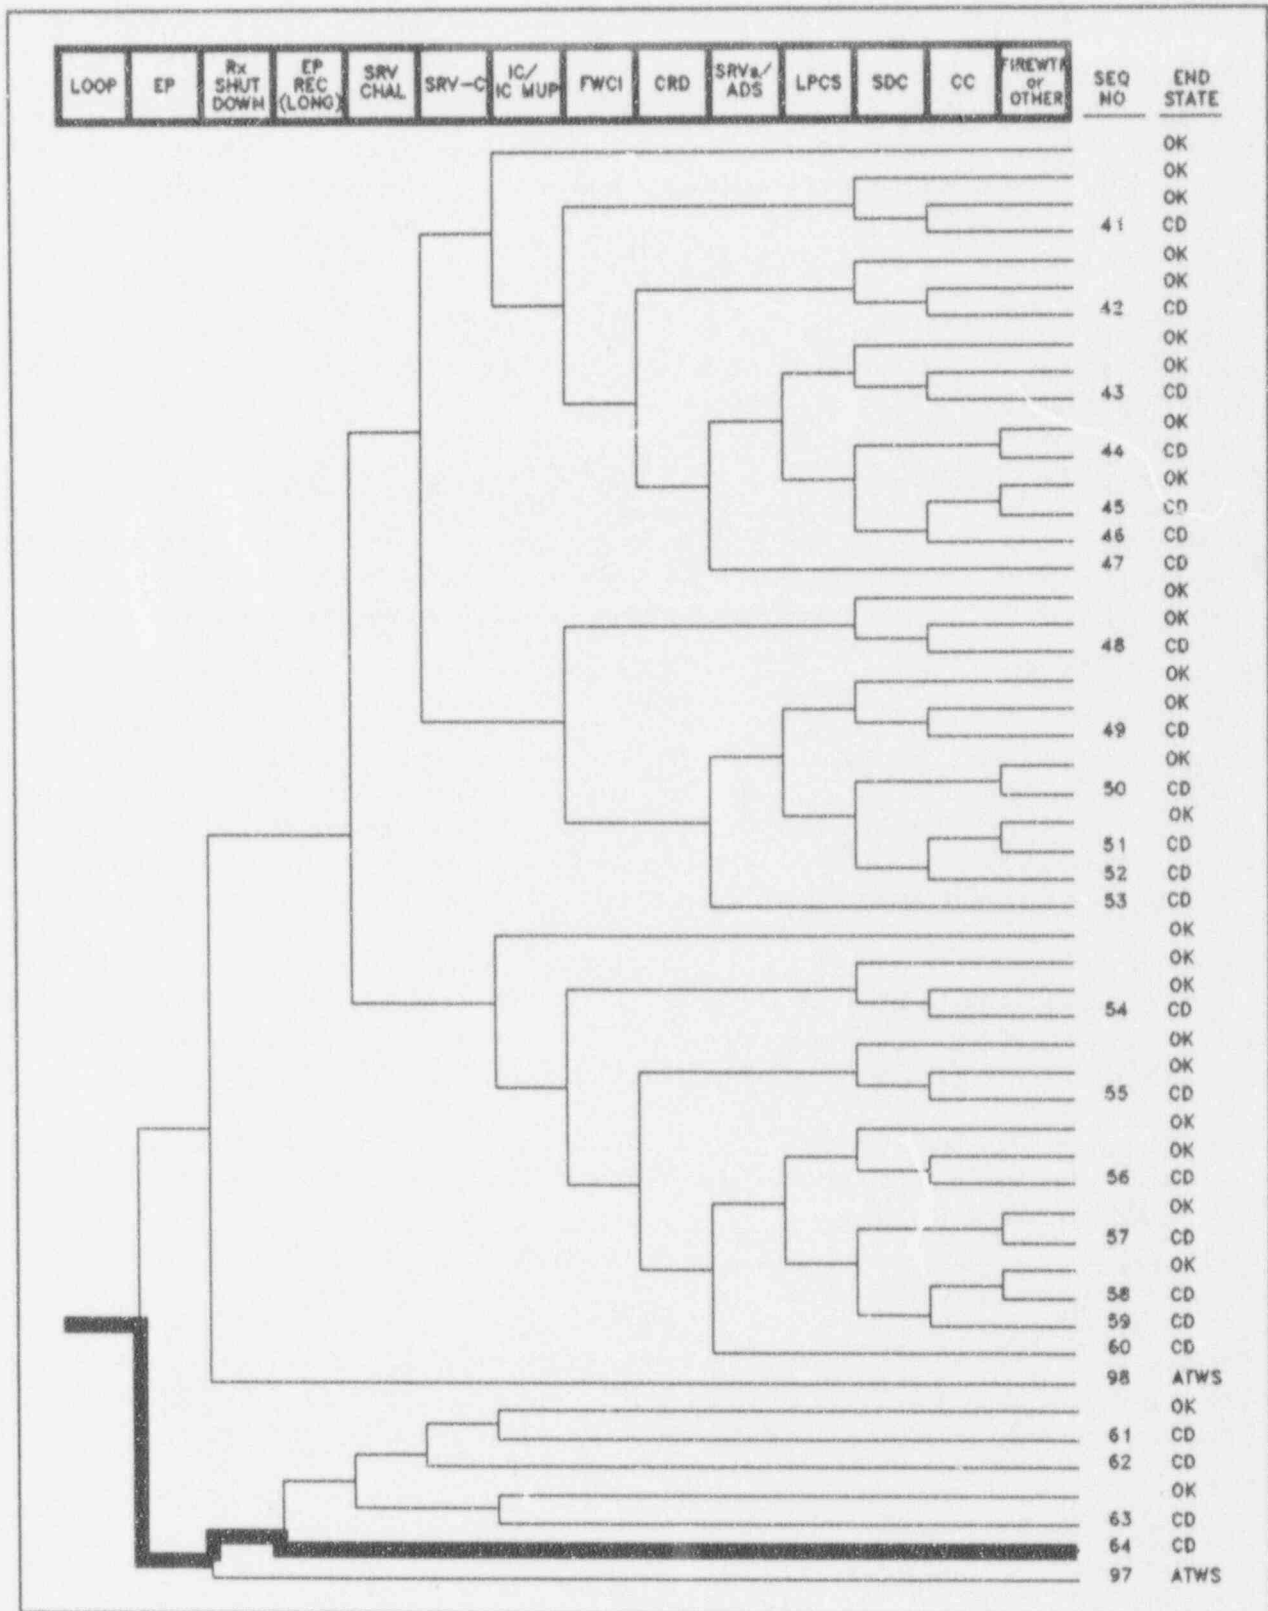
Fig. B.2. Dominant core damage sequences for LER 219/92-005.

The conditional probability of core damage estimated for this event is 7.1×10^{-5} . The dominant core damage sequence, highlighted on the following event tree in Fig. B.2, involves a LOOP with a postulated failure of emergency power and failure to restore ac power prior to battery depletion.

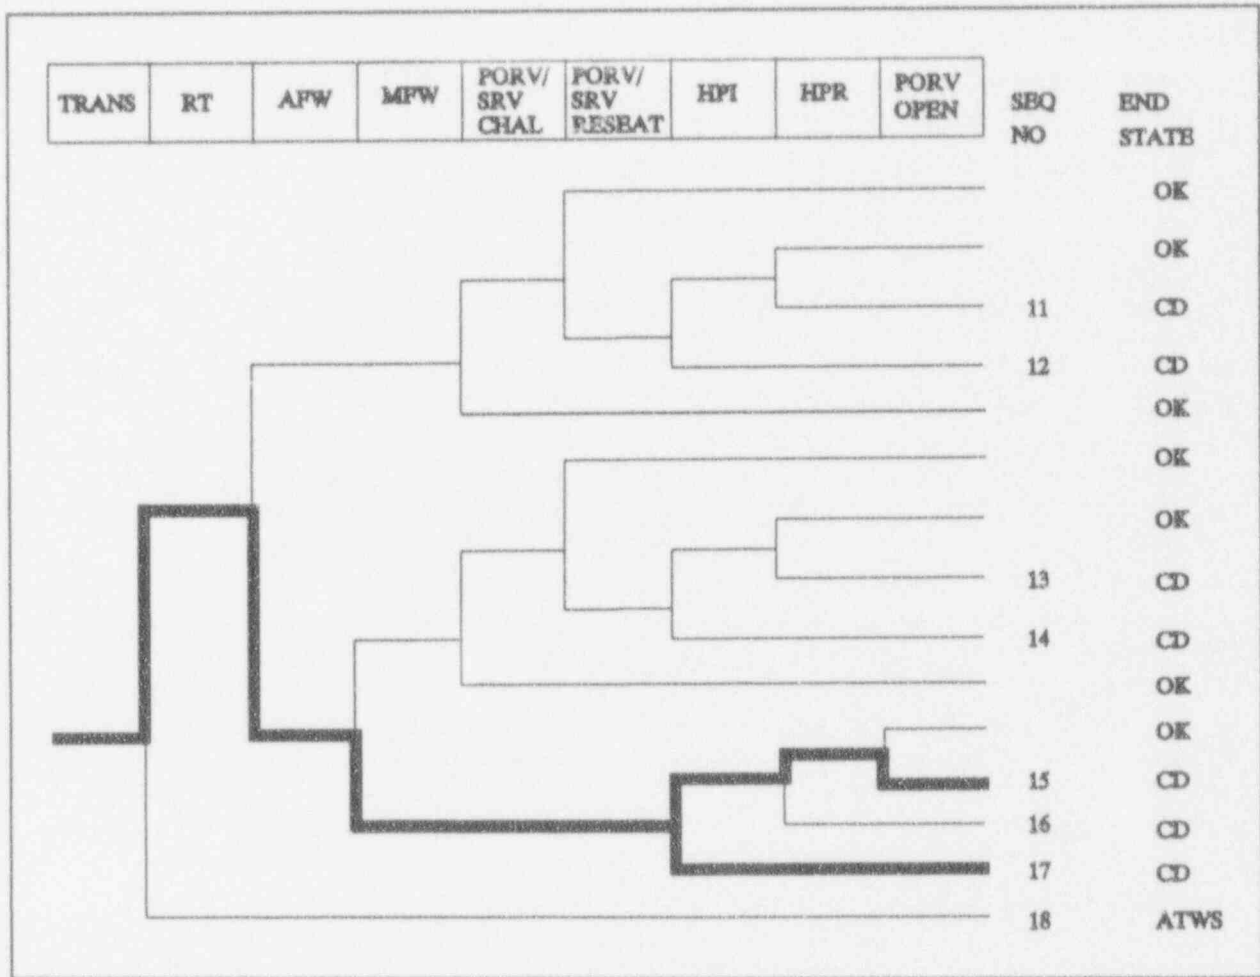
Fig. B.4. Dominant core damage sequences for LER 247/92-007

The conditional probability of core damage estimated for this event is 3.6×10^{-6} . The two dominant core damage sequences, highlighted on the following event tree in Fig. B.4, are associated with failures of MFW, AFW, and feed-and-bleed cooling. This event has been analyzed based on the information available in the referenced LER.

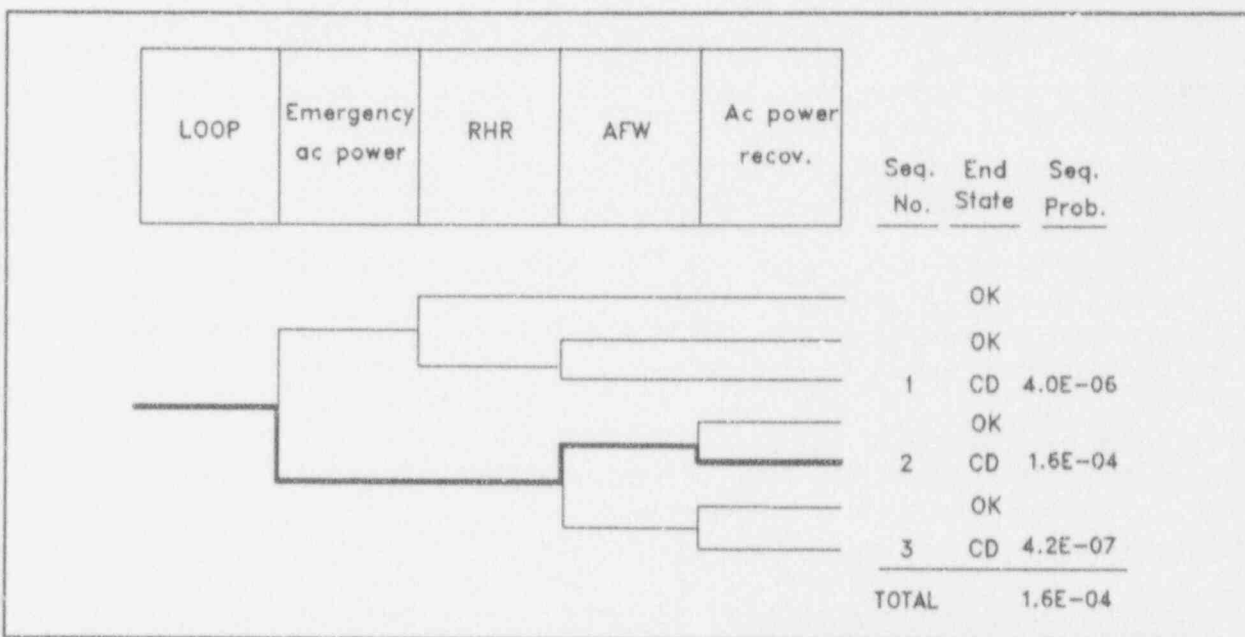
Fig. B.5. Event tree model for loss of offsite power at Turkey Point.

An event tree model of the potential sequences to core damage during the 157 h that offsite power was unavailable is shown in Fig. B.5. Three core damage sequences are addressed:

- failure of RHR and AFW with emergency power available (both decay heat removal mechanisms unavailable);
- failure of emergency power (which fails RHR) with successful AFW and failure to recover ac power prior to core uncovering (AFW is assumed to fail following battery depletion and consequent loss of dc power if ac power is not recovered); and
- failure of emergency power (which fails RHR), failure of AFW, and failure to recover ac power.

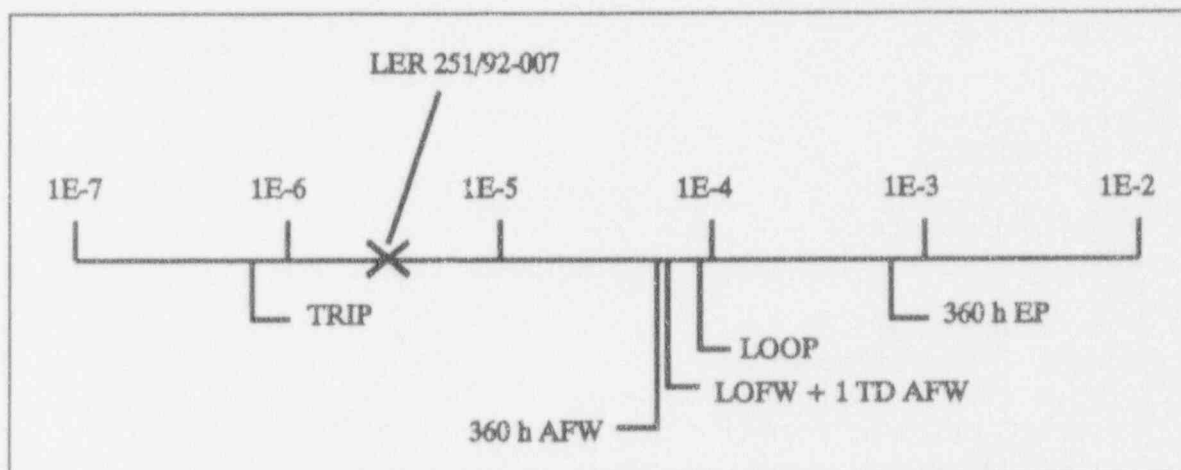
Fig. B.7. Relative event significance for LER 251/92-007 compared with other potential events at Turkey Point 4.

Turkey Point 4 was in startup at 2% power on September 29, 1992 when an operating main feedwater (MFW) pump tripped. This resulted in automatic actuation of the auxiliary feedwater (AFW) system. However, one AFW pump was out of service for post-maintenance testing. The remaining AFW pumps started and operated as designed. The conditional probability of subsequent core damage estimated for this event is 3.1×10^{-6} . The relative significance of the event compared to other postulated events at Turkey Point 4 is shown in Fig. B.7.

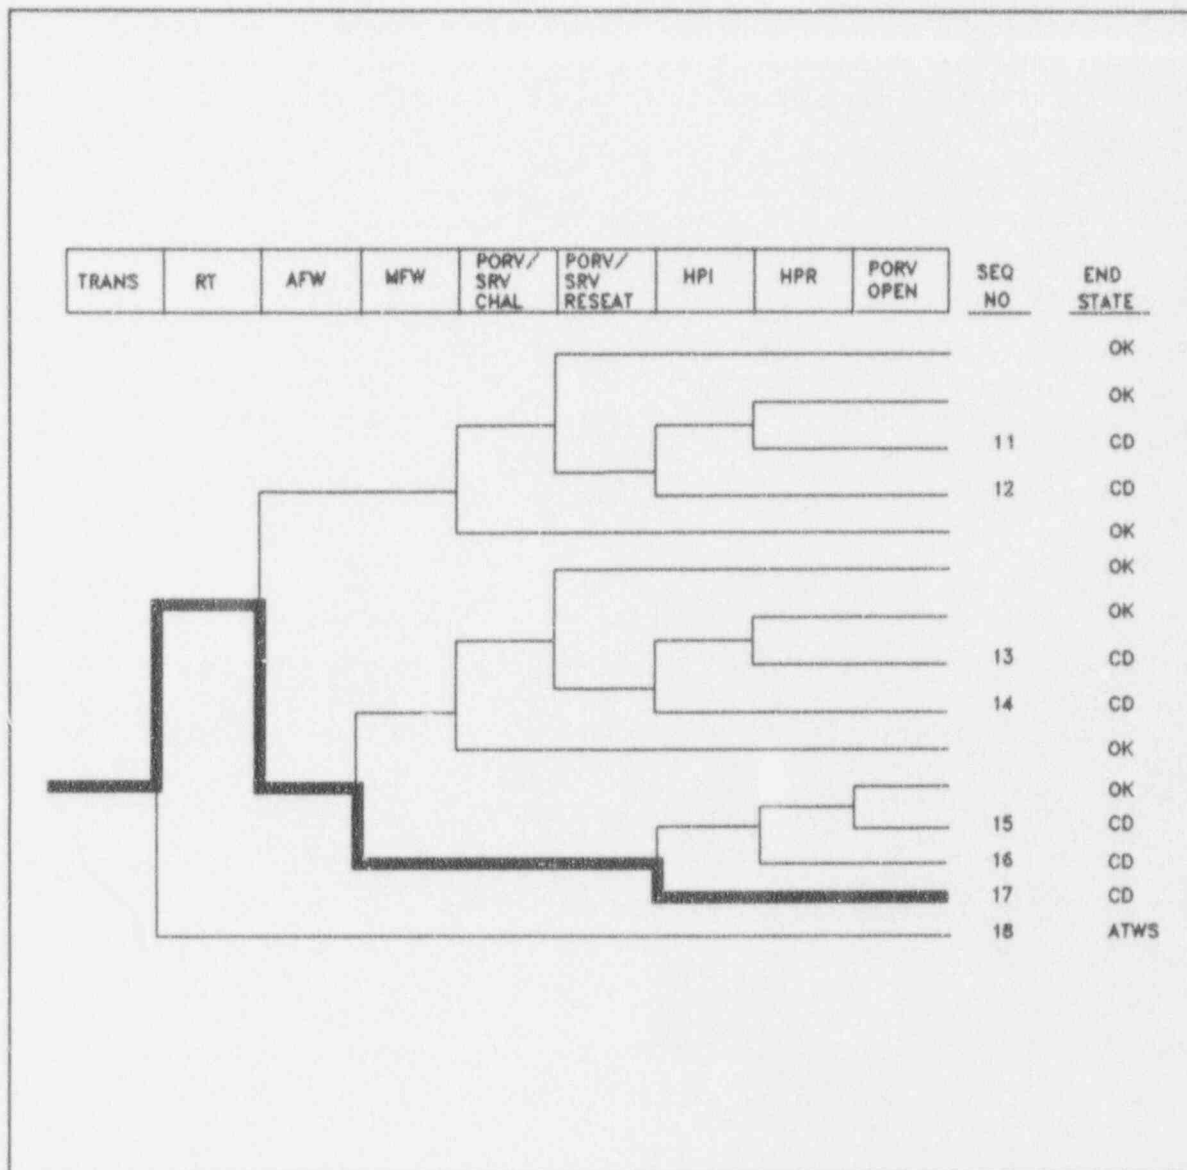
Fig. B.8. Dominant core damage sequence for LER 251/92-007.

The conditional core damage probability for this event is estimated at 3.1×10^{-6} . The dominant core damage sequence, highlighted on the event tree shown in Fig. B.8, involves a reactor trip with unavailability of secondary side cooling and failure of feed and bleed.

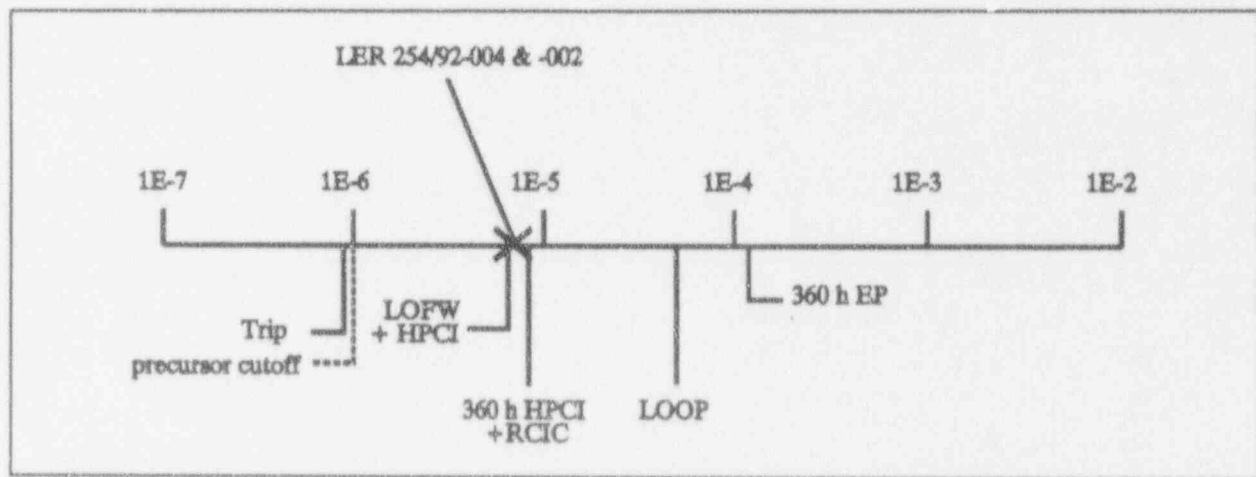
Fig. B.9. Relative event significance of LER 254/92-004 and -002 compared with other potential events at Quad Cities 1.

Quad Cities 1 was at 100% power when a spurious Group 1 isolation signal resulted in main steam isolation valve (MSIV) closure and a reactor trip. One safety-relief valve (SRV) failed to open for pressure control. Feedwater (FW) was manually isolated and reactor core isolation cooling (RCIC) was used for makeup. High-pressure coolant injection (HPCI) was out of service for maintenance and unavailable during the event. The conditional probability of subsequent core damage estimated for the event is 6.9×10^{-6} . The relative significance of the event, compared to other postulated events at Quad Cities 1, is shown in Fig. B.9.

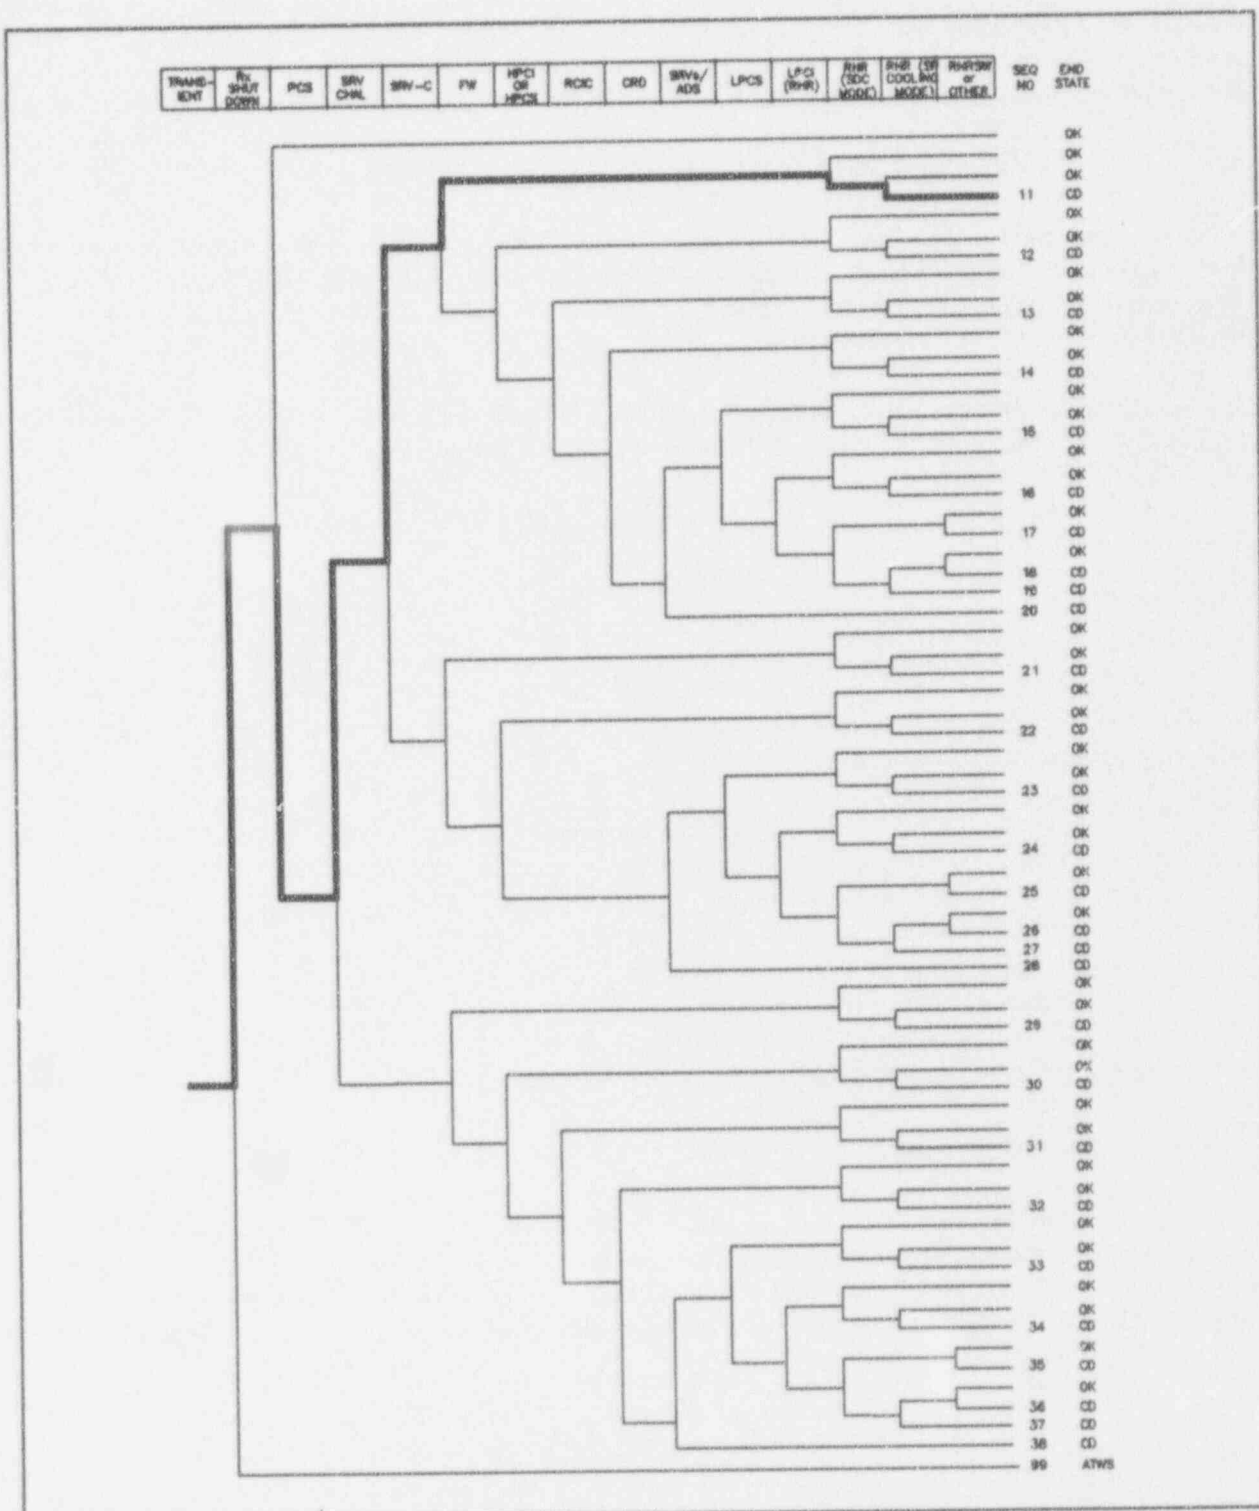
Fig. B.10. Dominant core damage sequence for LER 254/92-004.

The estimated conditional probability calculated for this event is 6.9×10^{-6} . The dominant sequence associated with the event, shown on the event tree in Fig. B.10, involves failure of long-term core cooling following successful scram and failure of continuous PCS operation, SRV challenge and successful reseal, and successful FW. Note that the core damage probabilities shown on the calculation sheets have been revised as described above.

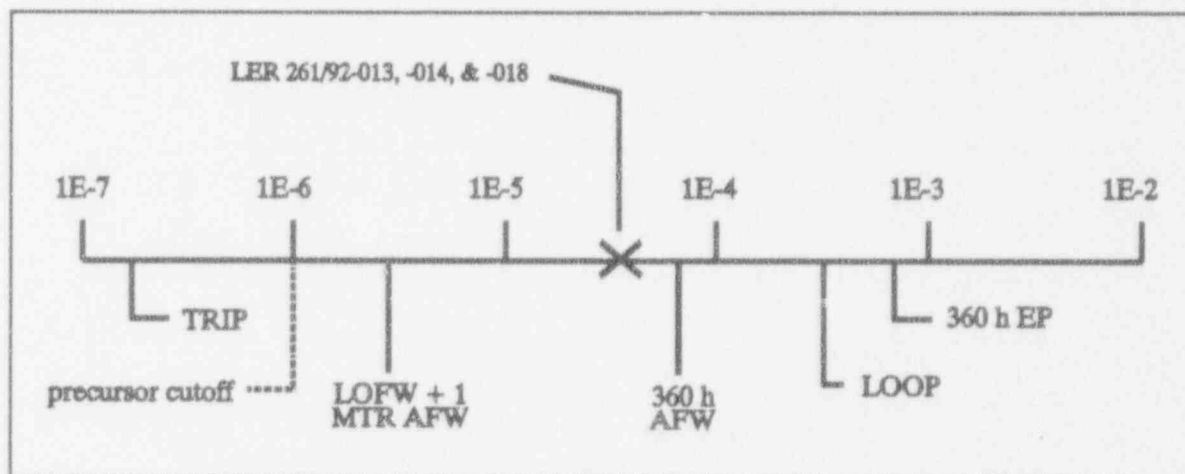
Fig. B.11. Relative event significance of LERs 261/92-013, -014, and -018 compared with other potential events at H. B. Robinson 2.

The conditional core damage probability for the 1.5 h that both SI pumps were inoperable (LERs 261/92-013 and -014) is 6.2×10^{-8} . This is below the precursor cutoff value of 10^{-6} . Therefore, this event is not a precursor but is included here since this is when the extended inoperability of the "B" SI pump began. The conditional core damage probability for the time period when the "B" SI pump was inoperable (LERs 261/92-013 and -018) is 3.5×10^{-5} . The relative significance of this event compared to other postulated events at H. B. Robinson Unit 2 is shown in Fig. B.11.

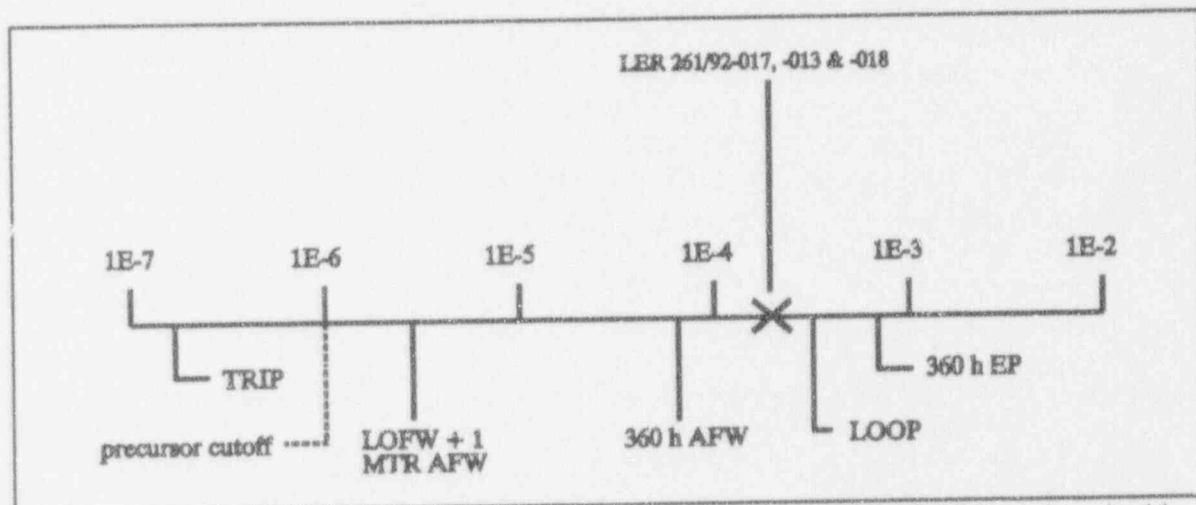
Fig. B.13. Relative event significance of LERs 261/92-017, -013, and -018 compared with other potential events at H. B. Robinson 2.

On August 22, 1992, with the plant operating at 100% power, the loss of the startup transformer resulted in loss of one of the two emergency buses and an instrument bus. Following a subsequent reactor/turbine trip, the transfer of the other emergency bus to offsite power failed and resulted in a total loss of offsite power (LOOP). Two days after the LOOP, on August 24, 1992, the "B" SI pump recirculation line was found to be obstructed with the plastic sheeting material. The plastic sheeting had been used during a design modification while in a refueling outage that ended on June 18, 1992. The conditional core damage probability for the LOOP event is 2.1×10^{-4} . The relative significance of this event compared to other postulated events at H. B. Robinson Unit 2 is shown in Fig. B.13.

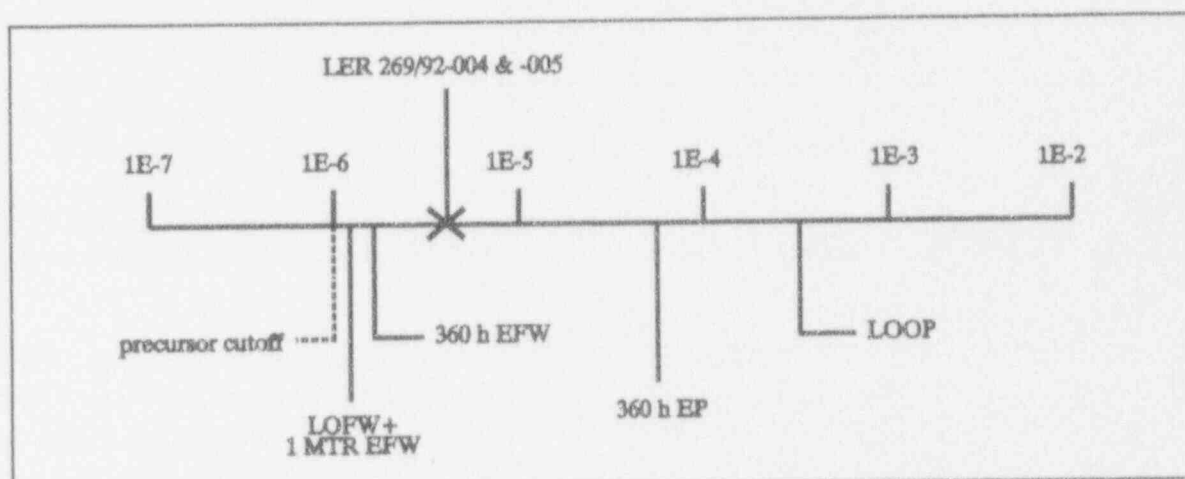
Fig. B.16. Relative event significance of LERs 269/92-004 and -005 compared with other potential events at Oconee 1.

On May 8, 1992, Oconee tripped from 14% power as a result of a pressure transient in the main feedwater (MFW) system. On May 27, 1992, it was discovered that one train of emergency feedwater had been inoperable at the time of the trip on May 8. The conditional core damage probability estimated for this event is 4.0×10^{-6} . The relative significance of this event compared to other postulated events at Oconee 1 is shown in Fig. B.16.

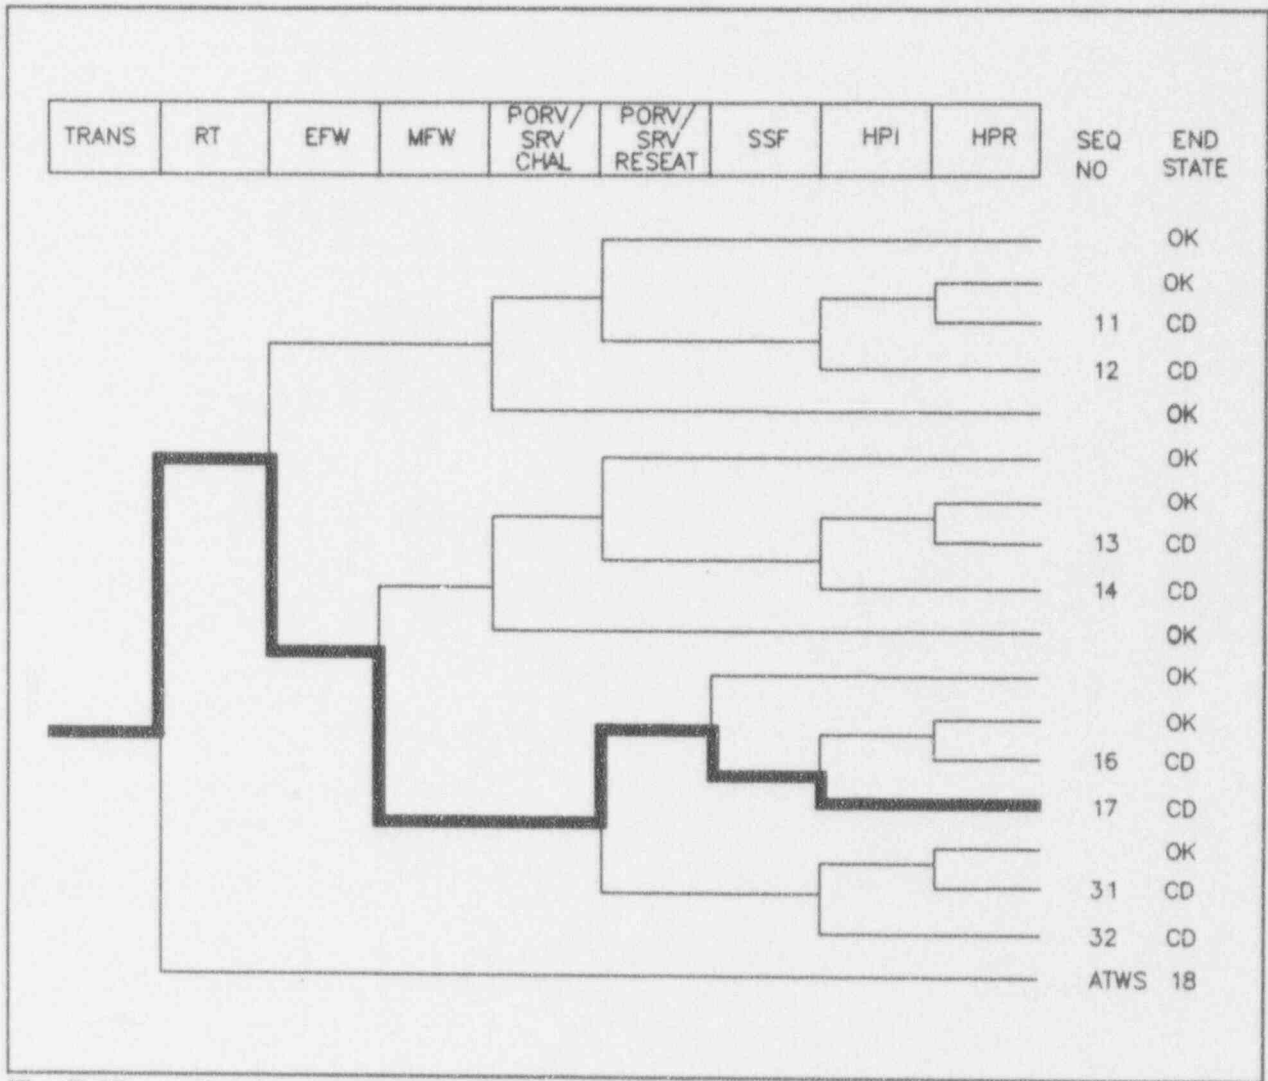
Fig. B.17. Dominant core damage sequence for LER 269/92-004 and -005.

The conditional probability of core damage estimated for this event is 4.0×10^{-6} . The dominant core damage sequence, highlighted on the event tree in Fig. B.17, involves a postulated failure of EFW and MFW, PORV challenge and reseal, failure of the SSF feedwater function, successful initial feed-and-bleed, and subsequent failure when recirculation is initiated.

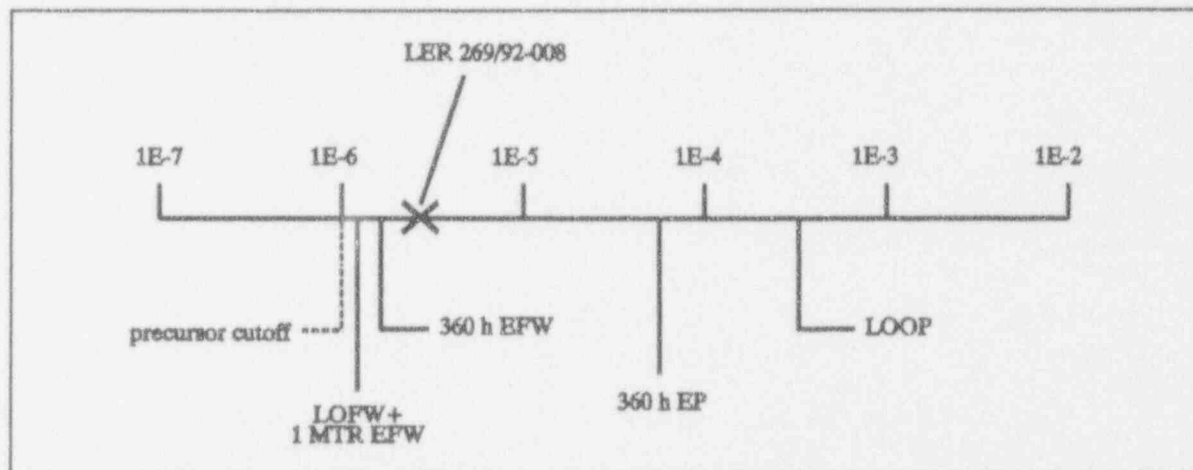
Fig. B.18. Relative event significance of LER 269/92-008 compared with other potential events at Oconee.

With all three Oconee units at 100% power and emergency power source Keowee 1 unavailable because of maintenance, a failed fuse was discovered in the control power circuit for an auxiliary power breaker on Keowee 2. This rendered Keowee 2 also unavailable. Both emergency power sources were unavailable for 34 h. The conditional core damage probability estimated for this event is 2.8×10^{-6} . The relative significance of this event compared to other postulated events at Oconee is shown in Fig. B.18.

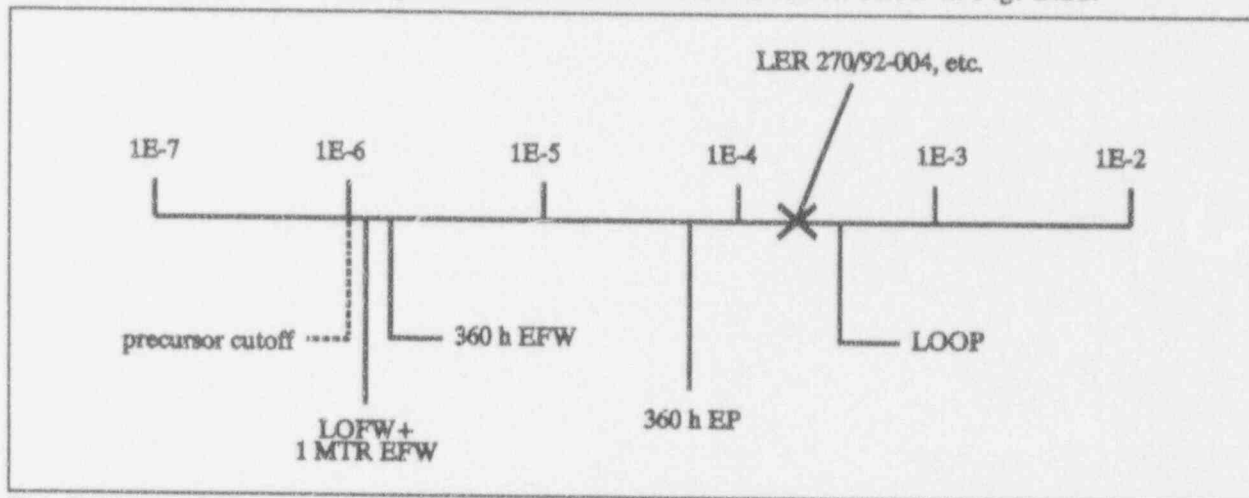
Fig. B.22. Relative event significance of LER 270/92-004, etc., compared with other potential events at Oconee.

The conditional core damage probability estimated for this event is 2.1×10^{-4} . The relative significance of this event compared to other postulated events at Oconee is shown below in Fig. B.22.

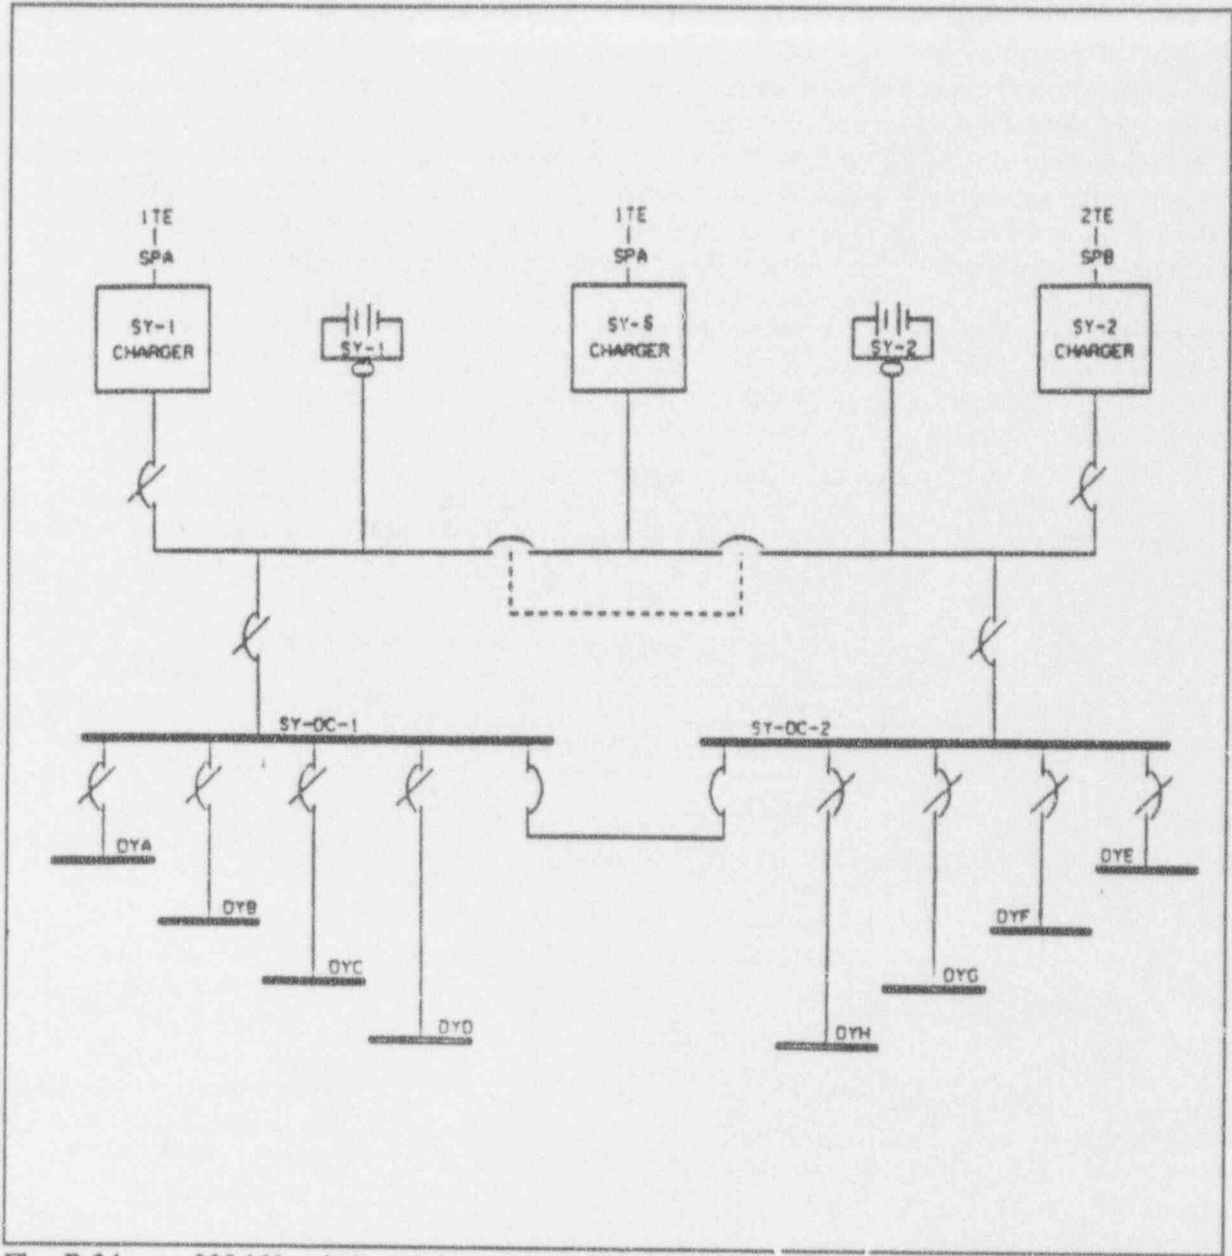
Fig. B.24. 230-kV switchyard dc power distribution at Oconee
 (Original figure was illegible.)

On October 19, 1992, Oconee 2 was operating at 100% power. Keowee Hydro Unit 1 (Keowee 1), one of the emergency power sources for the three Oconee units, was supplying power to the grid via the overhead power path (see Fig. B.23). Keowee 2 was shut down and was aligned to provide emergency power via the underground path. Replacement of the 230-kV switchyard batteries was in progress: battery SY-2 and charger SY-2 were disconnected, switchyard dc buses SY-DC-1 and SY-DC-2 were cross-tied, and charger SY-1 and battery SY-1 were powering both buses (see Fig. B.24).
