U.S. NUCLEAR REGULATORY COMMISSION

Reports No. 50-373/94003(DRS); 50-374/94003(DRS)

Type of Meeting: Enforcement Conference

## LASALLE COUNTY STATION ENFORCEMENT CONFERENCE

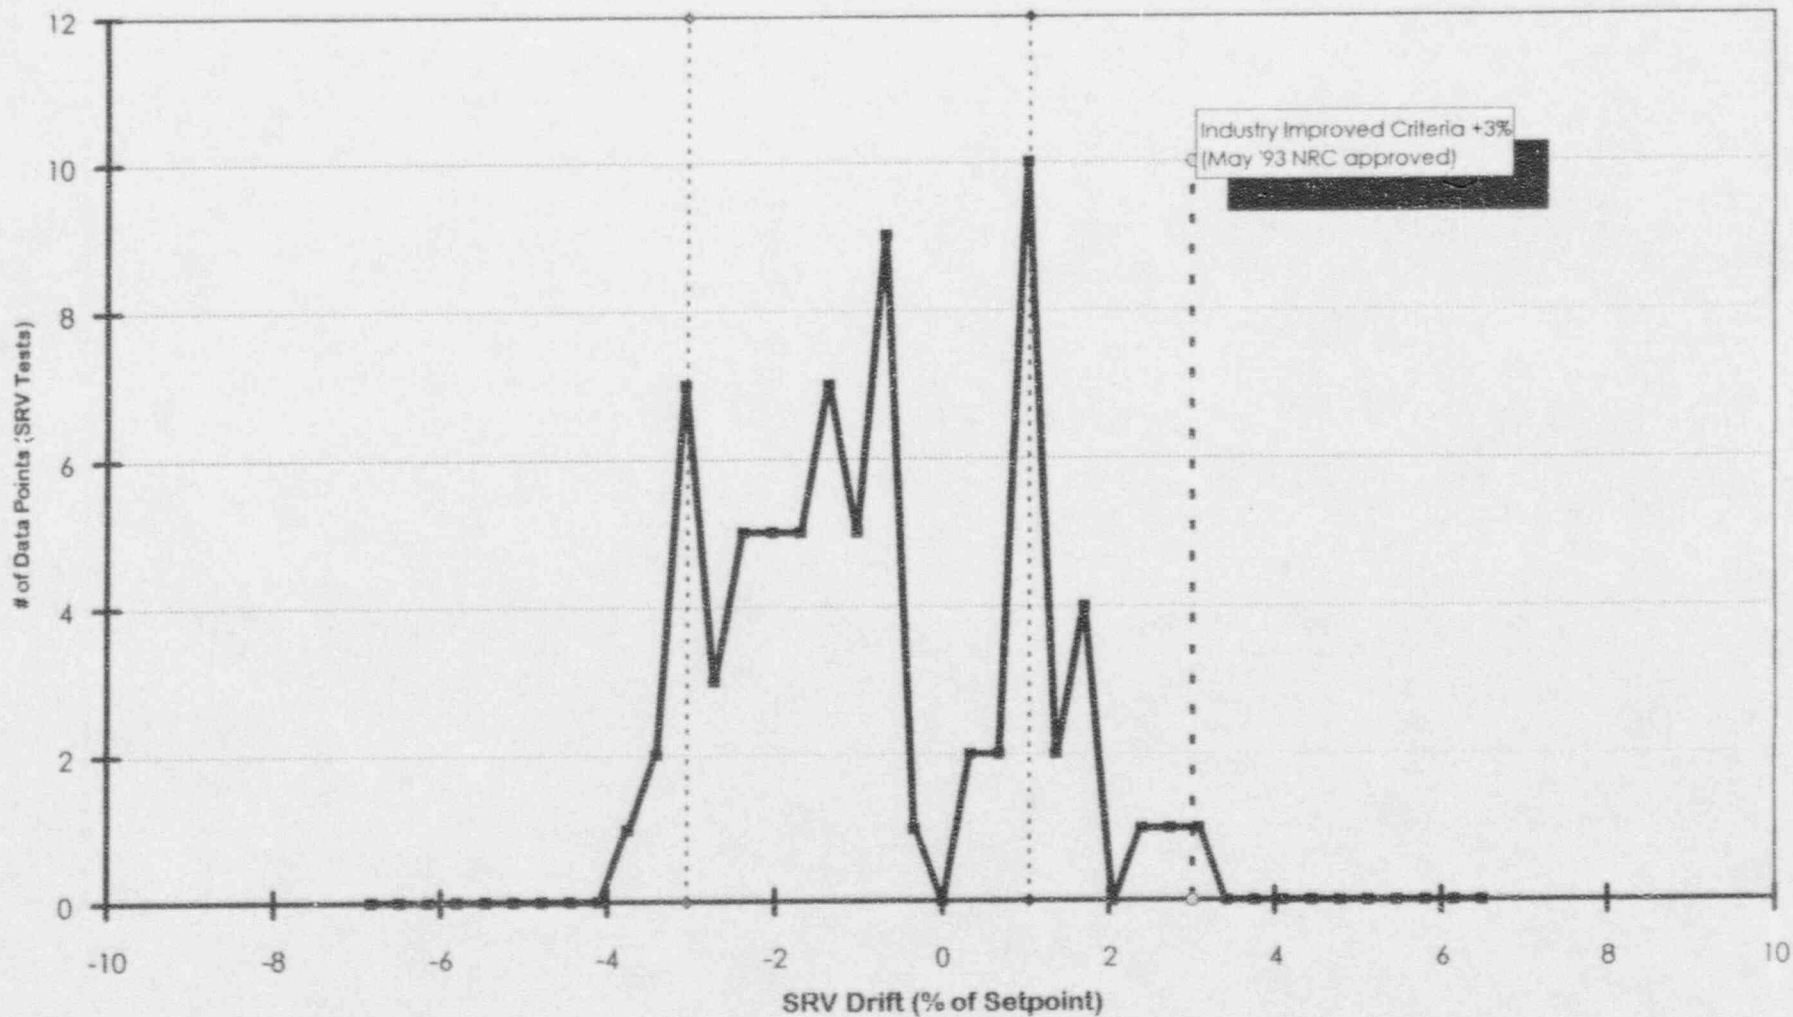
### LaSalle Station SRV Setpoint Performance Frequency Distribution

- Data comparable to Industry/Crosby valves
- Positive Drift < ASME OM1 (improved) criteria of +3%
- Negative drift caused by leakage

Industry Improved Criteria +3%  
(May '93 NRC approved)
