U. S. NUCLEAR REGULATORY COMMISSION
REGION I

Docket No.: 50-293
Report No.: 93-23
Licensee: Boston Edison Company
800 Boylston Street
Boston, Massachusetts 02199
Facility: Pilgrim Nuclear Power Station
Location: Plymouth, Massachusetts
Dates: December 7, 1993 - January 17, 1994
Inspectors: J. Macdonald, Senior Resident Inspector
A. Cerne, Resident Inspector
D. Kern, Resident Inspector
L. Kay, Reactor Engineer, Region I, DRS

Pilgrim Inspection Report 93-23

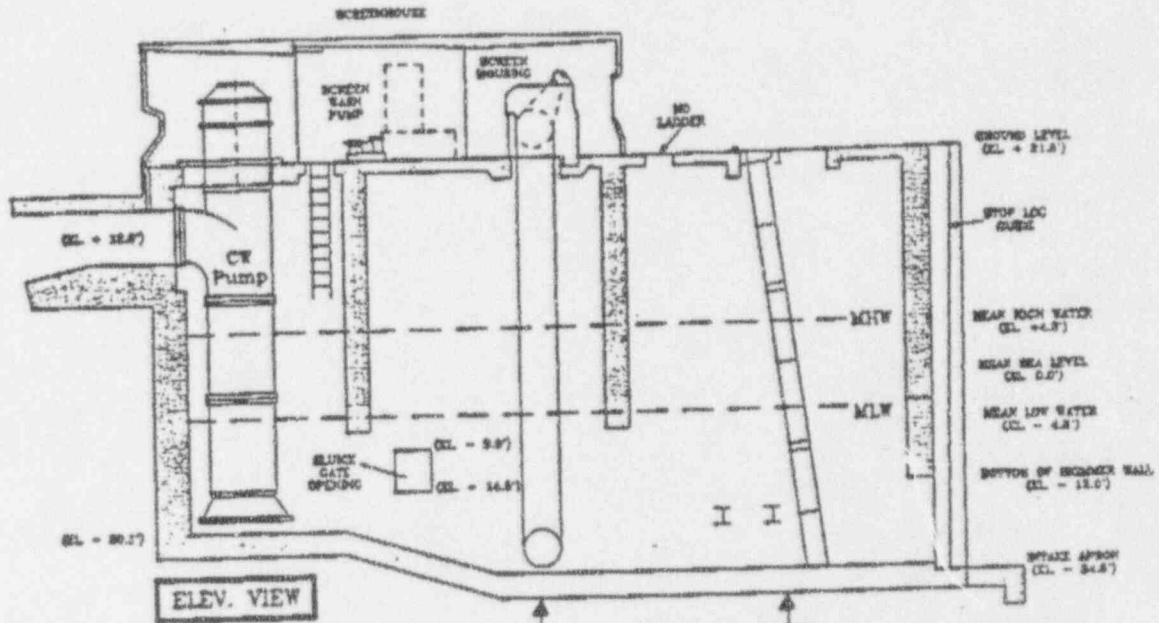
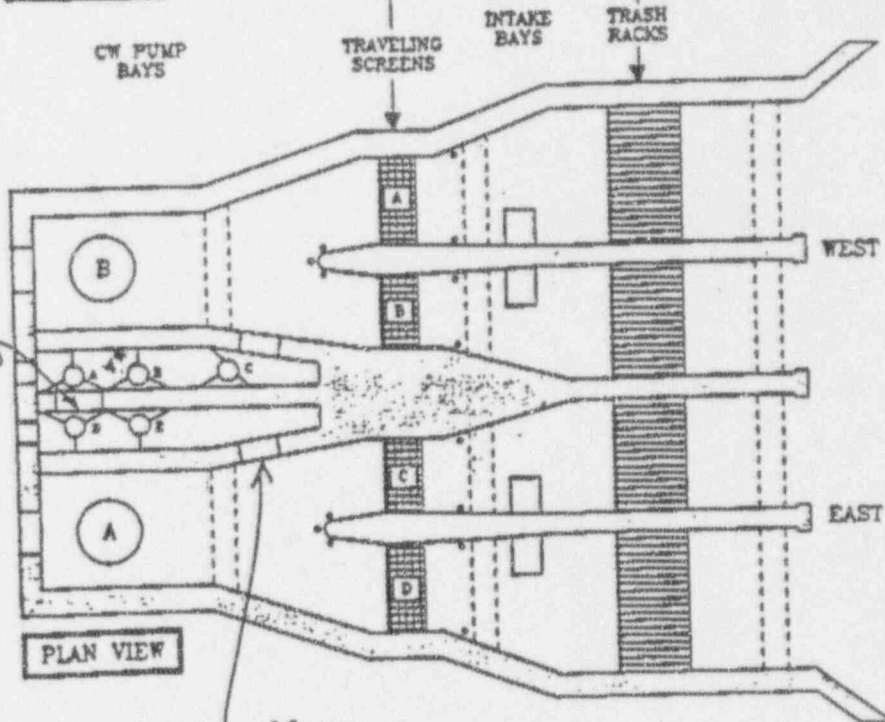
SCREENHOUSE DRAWING SECTION

*normally closed
sluice gate
connecting
service water
bays*

*normally open
sluice gate
connecting sea and
service water bays*

However, the inspector concluded that operators were not aware of the actual duration or magnitude of the decreasing level in the east bays during the event as was indicated by post-event review of the EPIC data. Due to the existing high tide conditions and the rate at which the east bay level was decreasing, the inspector estimated a minimum of nine minutes would have elapsed from the initiation of the decreasing level until the east SSW bay low level alarm setpoint of - 7 ft. would have been reached. Additionally, because the SSW rear gate was being opened at that time, the inspector also estimated the alarm condition would have cleared within a maximum of eight minutes. Control room operators indicated the alarm was intermittently present for a significantly less time period. Surging seas may have contributed to the intermittent nature of the alarm. Additionally, the alarm instrumentation appeared to have been

damaged and rendered nonfunctional when impacted by the in-rush of sea water when the rear gate was opened. The rear gate has since been maintained open (through the end of this report period) in order to provide SSW bay alarm indication for either bay via the west bay level alarm, and while the east SSW bay level instrumentation is being repaired.

The inspector expressed concern that routine plant operation with the rear gate open and the SSW bays in communication may be in conflict with the system safety design basis as described in the Final Safety Analysis Report (FSAR). Specifically, FSAR Section 10.7.6, states the SSW system is designed with sufficient redundancy so that no single active system component failure could prevent the system from achieving its safety objective. The section further states two independent closed loops of SSW, with full heat transfer capability on each loop, are provided. The FSAR does not address rear gate operation. Clearly, opening the rear gate to mitigate a potentially significant loss of SSW bay water level in accordance with properly evaluated procedures would be acceptable. However, it also would appear that operation with nonredundant (manual) cross-tying the SSW bays would create an open system versus closed loop configuration, and the open rear gate therefore introduces a single active failure vulnerability. This concern remains under review by BECo licensing personnel.

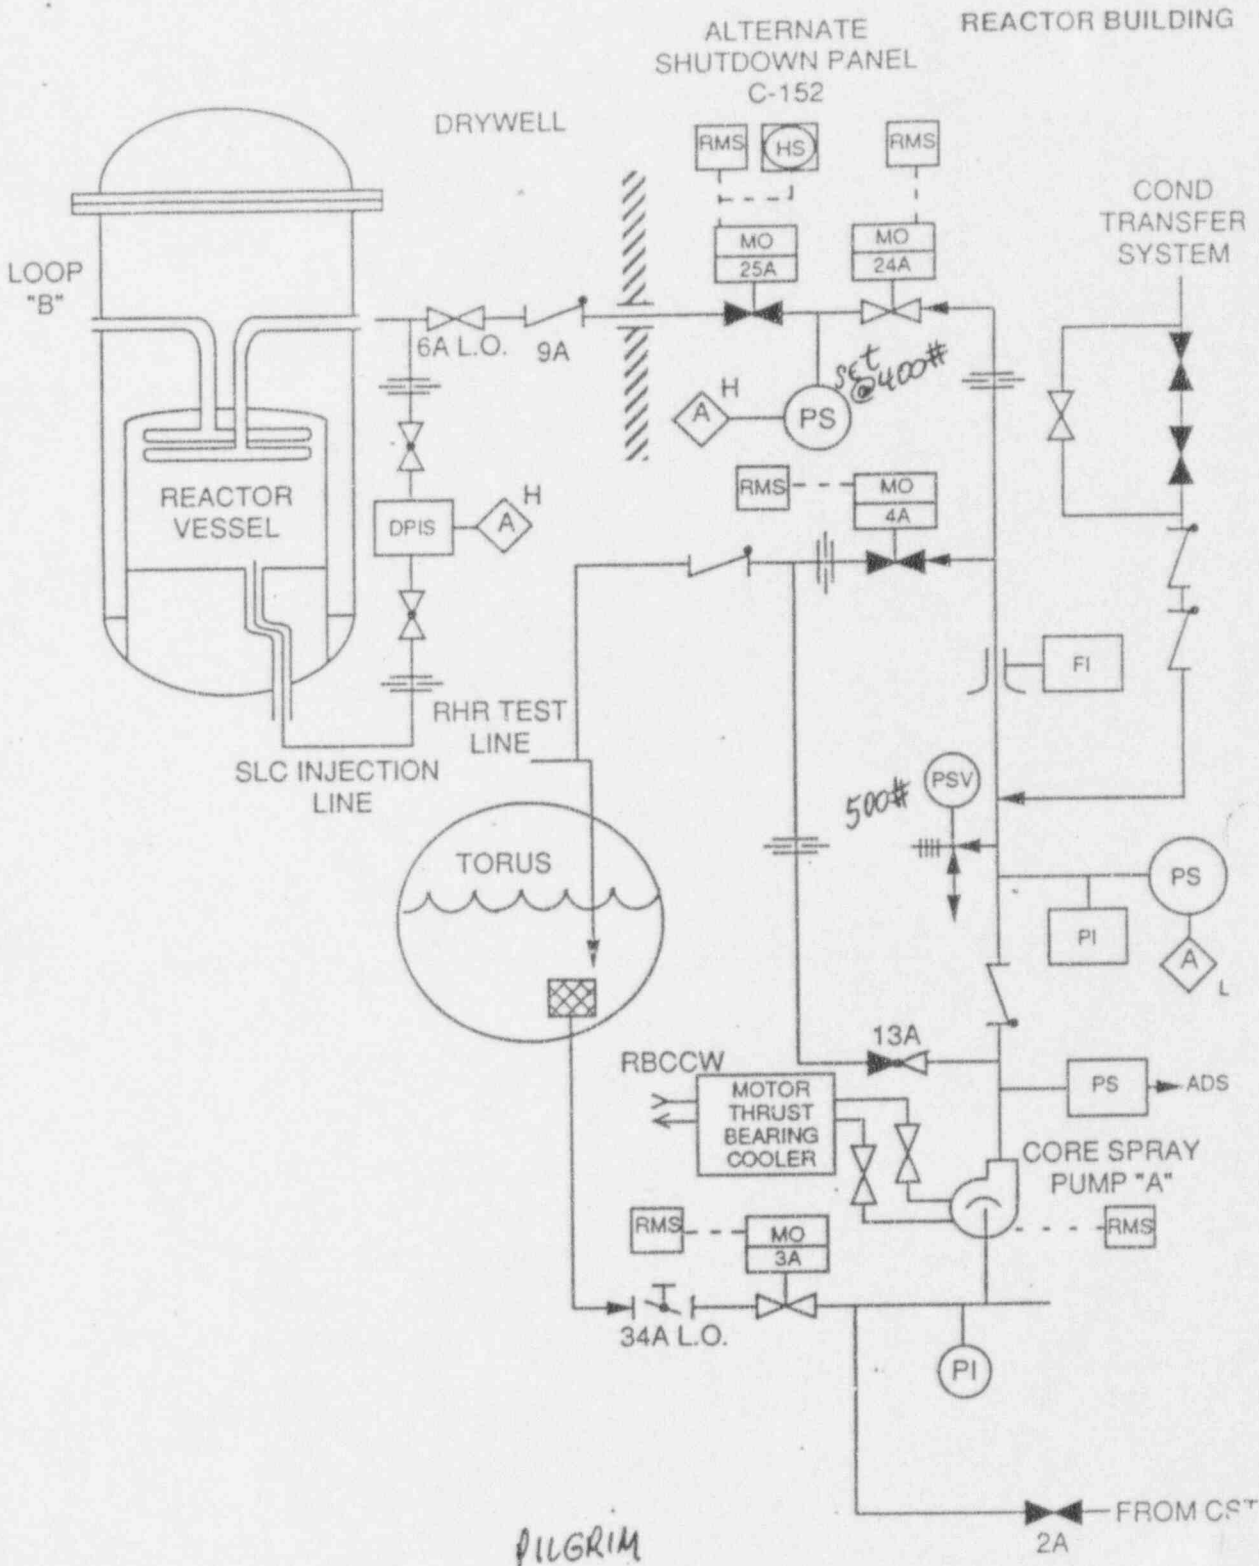
FIGURE 1 REV. 2

In late October 1993, system engineers identified slightly elevated temperatures on the upstream side of the inboard "B" loop core spray discharge isolation valve (MO-1400-25B). Piping temperature was approximately 130 degrees F (50 degrees F above ambient room temperature). Core Spray loop "B" header pressure remained normal (110 pounds per square inch gage (psig)). This was characteristic of minor backleakage from the reactor vessel (RV) past a normally closed injection check valve (1400-9B) and the normally closed MO-1400-25B. System engineers initiated monitoring of core spray (CS) pressure and temperature to determine the extent of the leakage. Significant backleakage from the RV to systems with lower design pressures, such as core spray, could increase the likelihood of an intersystem loss of coolant event. In addition, excessive leakage could result in void formation within CS system piping, resulting in a hydrodynamic effect called water hammer which can cause piping damage during system operation. The inspector noted that CS piping temperature remained approximately 200 degrees F below that necessary to cause boiling at the current system pressure. Therefore, the likelihood of void formation and subsequent water hammer is very low.

In late December, the inspector observed that "B" loop CS pressure had risen approximately 15 psi over a ten day period. "B" CS piping temperature had remained at 130 degrees F and "A" loop pressure remained at 110 psig. Although the "B" loop pressure was of concern, CS loop pressures both remained well below the high pressure alarm setpoint of 400 psig and the CS relief valve setpoint of 500 psig. The inspector discussed the pressure rise with licensee engineers who had been reviewing recent CS system maintenance history. The inspector noted that the pressure increase began following the monthly CS pump operability surveillance on December 20, 1993. BECo system engineers proposed that the pressure increase did not necessarily represent greater leakage past MO-1400-25B, but may indicate that other "B" loop boundary valves (operated during the pump surveillance) were now seated tighter than before the surveillance; the CS full-flow test line isolation valve (MO-1400-4B) was a likely candidate. A test plan was developed to better identify and trend the "B" loop CS leakage. On December 30, the piping upstream of MO-1400-25B was vented to establish a baseline value. At the close of this report period, loop "B" CS pressure remained unchanged at 110 psig.

Engineers further discussed the long term effect of continued seat leakage on the performance of MO-1400-25B. The valve seat is made of stellite, a material susceptible to steam cutting as water leaks from the high pressure side of the seat to the low pressure side. However, the seat will not degrade quickly. In parallel with efforts to better assess the "B" loop CS leakage, the licensee prepared a temporary modification to the CS system lineup as a contingency in the event that the MO-1400-25B leakage became significant. The modification would shut MO-1400-24B and open MO-1400-25B as the normal CS system standby lineup. Both of the CS injection isolation valves indicated good leak tightness during their latest IST program leak tests. Engineers intend to perform leak rate tests on MO-1400-24B, 25B, and 9B during the next midcycle maintenance outage (November 1994). The inspector concluded that licensee actions to assess elevated CS piping temperature were comprehensive. Operations, Maintenance, and Engineering personnel coordinated efforts effectively to monitor CS leakage and determine operability.
