Report Nos. 50-269/82-28, 50-270/82-28, and 50-287/82-28

Facility Name: Oconee

Inspection at Oconee site near Seneca, South Carolina

Inspection on July 6-7, 1982

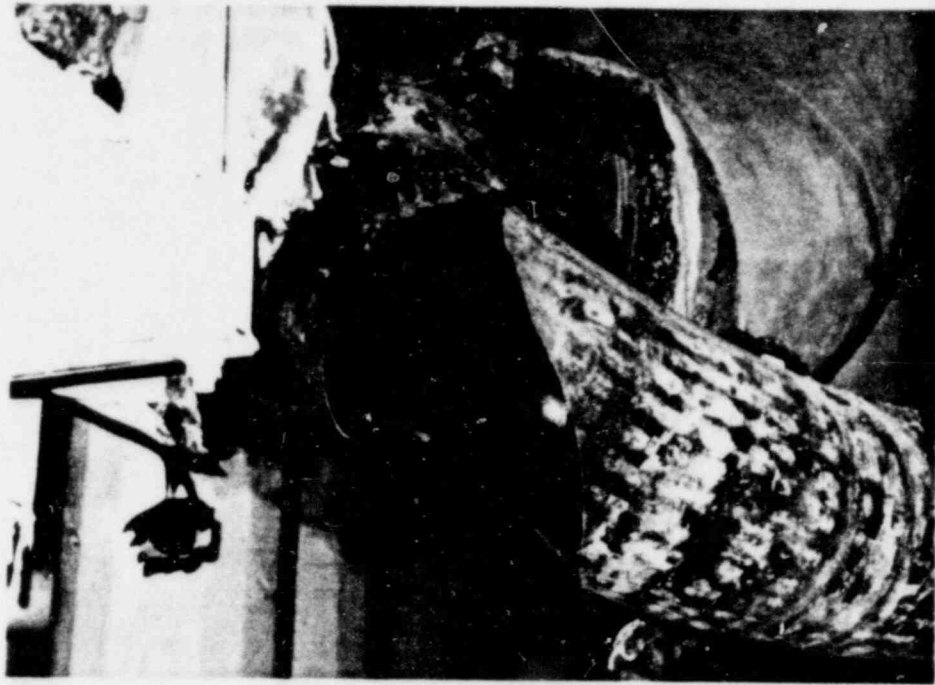
On June 28, 1982, the first 24-inch elbow down stream of the 42-inch high pressure discharge pipe turbine end left side C-extraction line ruptured (see figures 1 and 2). The inspector observed the failed component section that was located in the turbine building and noted that the work effort to replace the failed section had been completed.

Figure-1
Photograph depicting general view of steam turbine heat extractor pipe elbow where failure occurred. The point of failure appears to be near the 12 o'clock position. The torn pipe section is folded under the pipe.

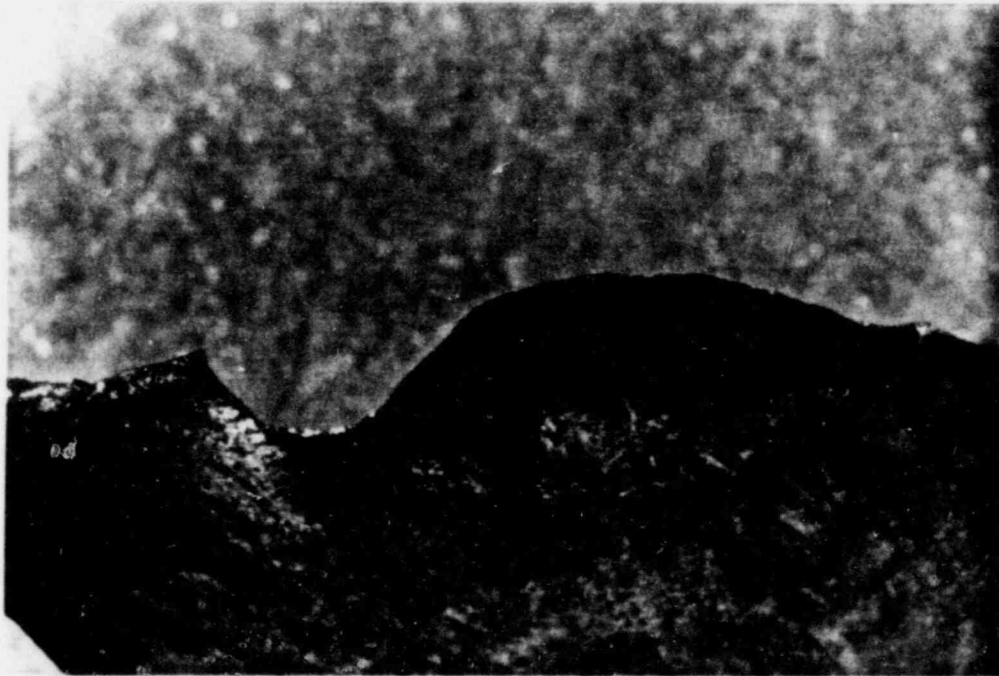
Figure-2
Photograph depicting closeups view (grooved areas) of pipe flap location where failure initiated.
