**TMI-1**  
**Steam Generator**  
**Recovery Program**  
**Task 7**  
**Primary System Review**  
**Reactor Coolant System Inspections**  
**And Requalification**

**Appendix C**  
**Examination Results**

APPENDIX C

Examination Results and Validation

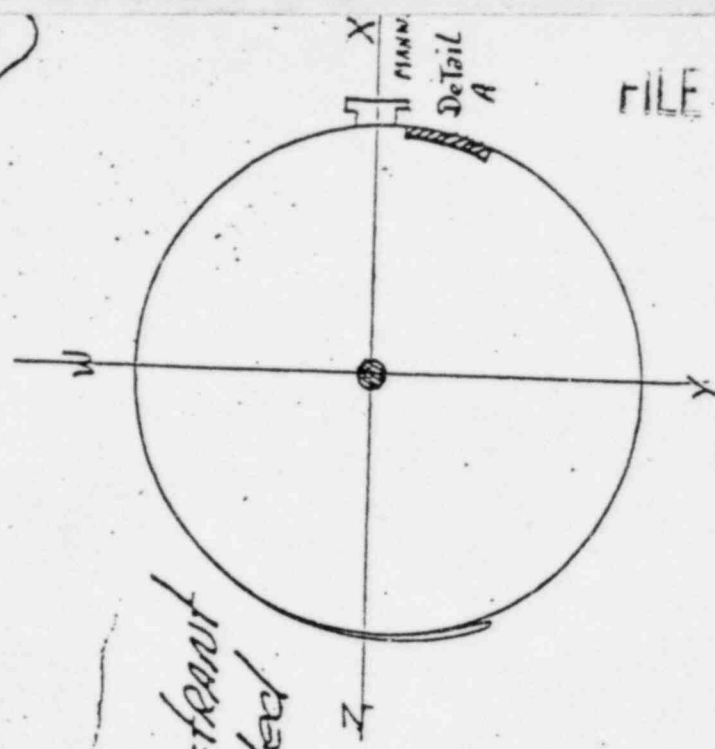
Detail  
A  
Area Penetrant  
Inspected

P.T. INSPECTION IN CENTER OF  
Tubesheet. Approx. 5" dia. Circle  
Detail A - Approx 18" Long, 2" wide

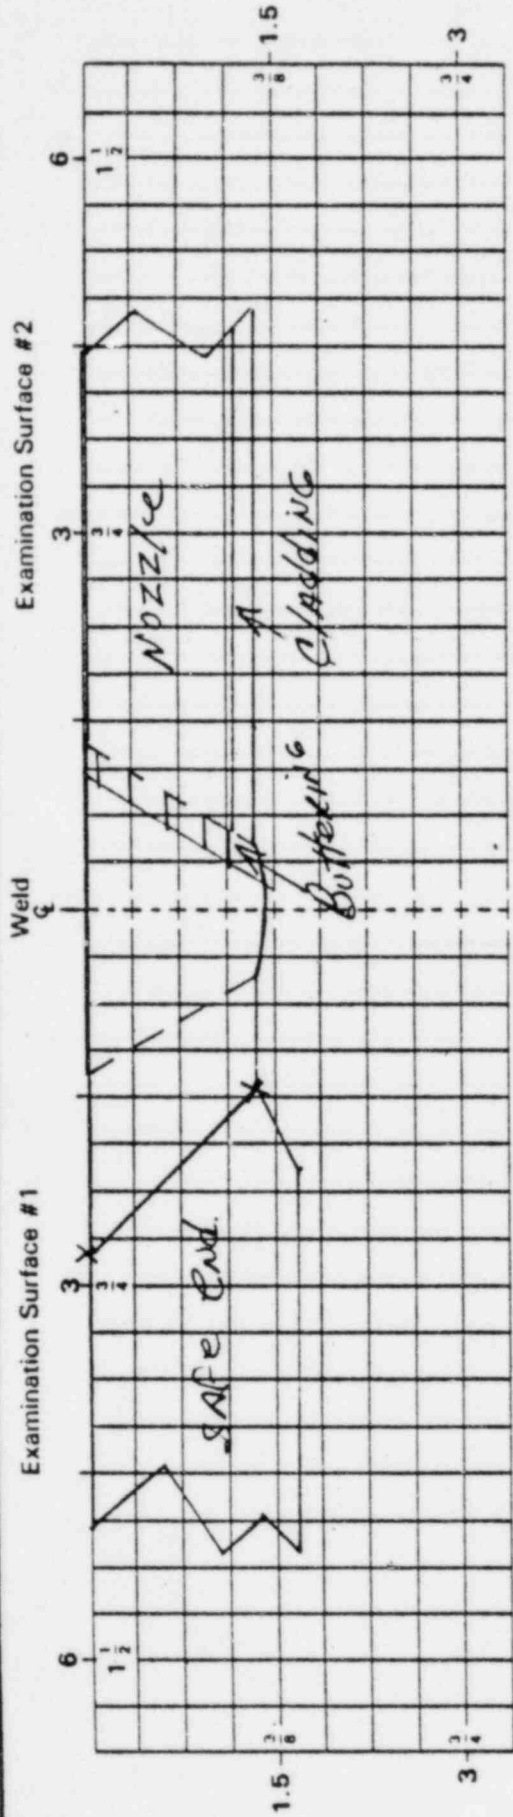
Examiners Comments: INDICATION APPEARS 360° AT DIFFERENT AMPLITUDES, PLOT OUT AS  
C DIMENSION THICKNESS CHANGE.

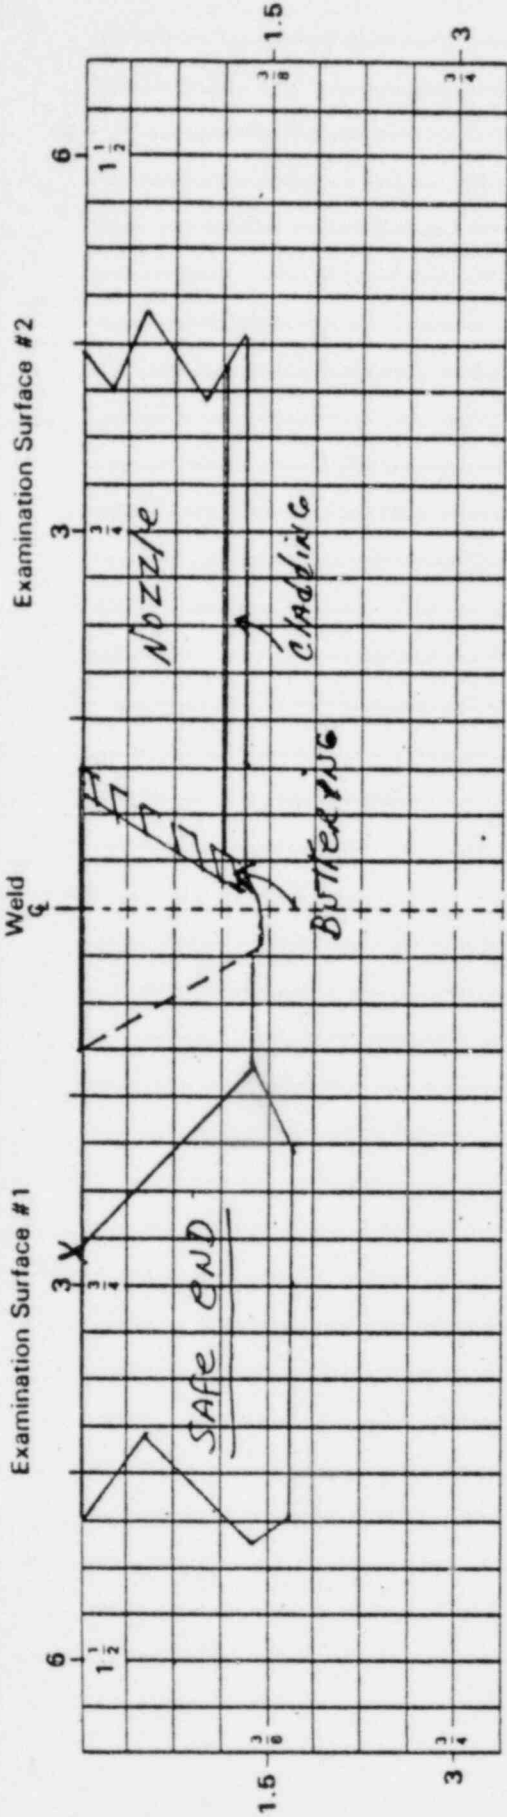
Examiners Comments INDICATION APPEARS 360° AT DIFFERENT AMPLITUDES, SHOWS OTHER SAFE ENDS, PLOT AS GEOMETRIC, CHANGE IN THICKNESS AT 6' DIMENSION.

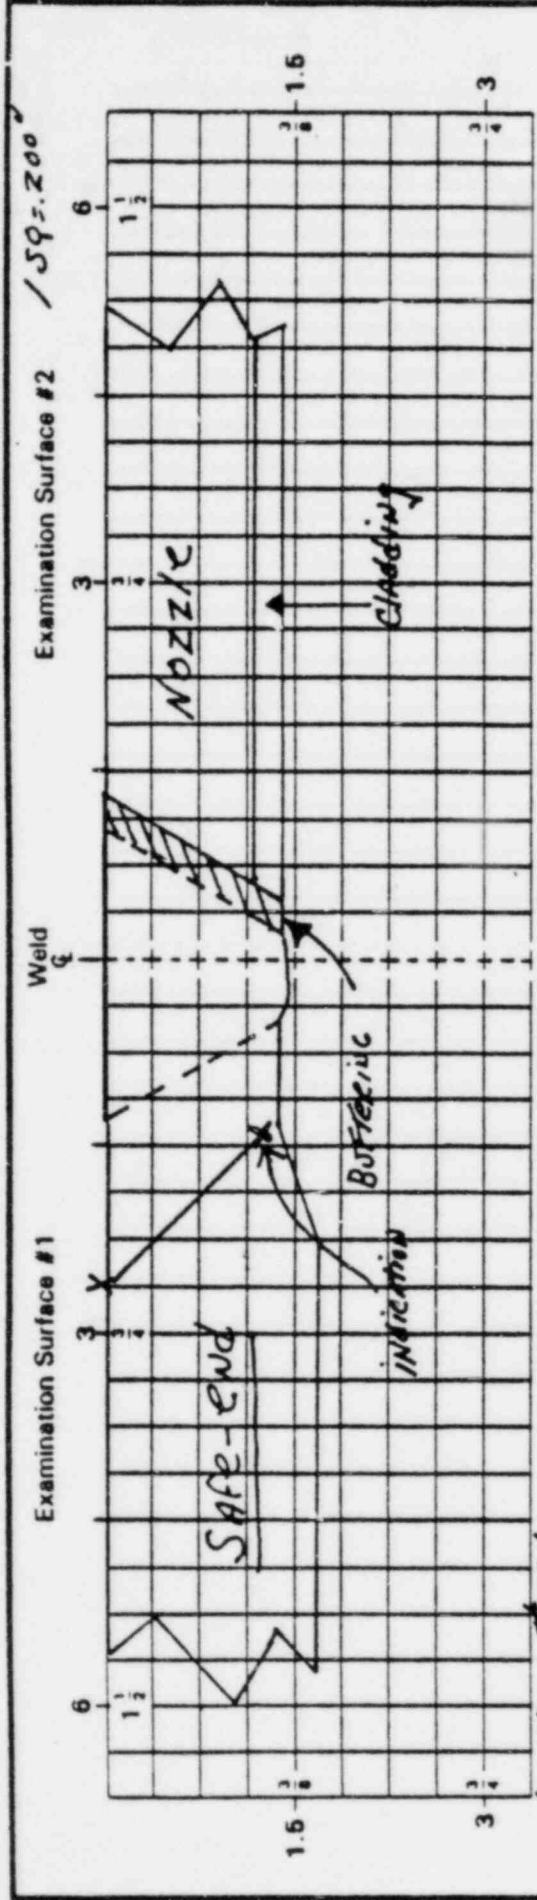
INDICATION #201

Examiners Comments INDICATION APPEARS TO BE A SHARP CORNER IN SAFE-END

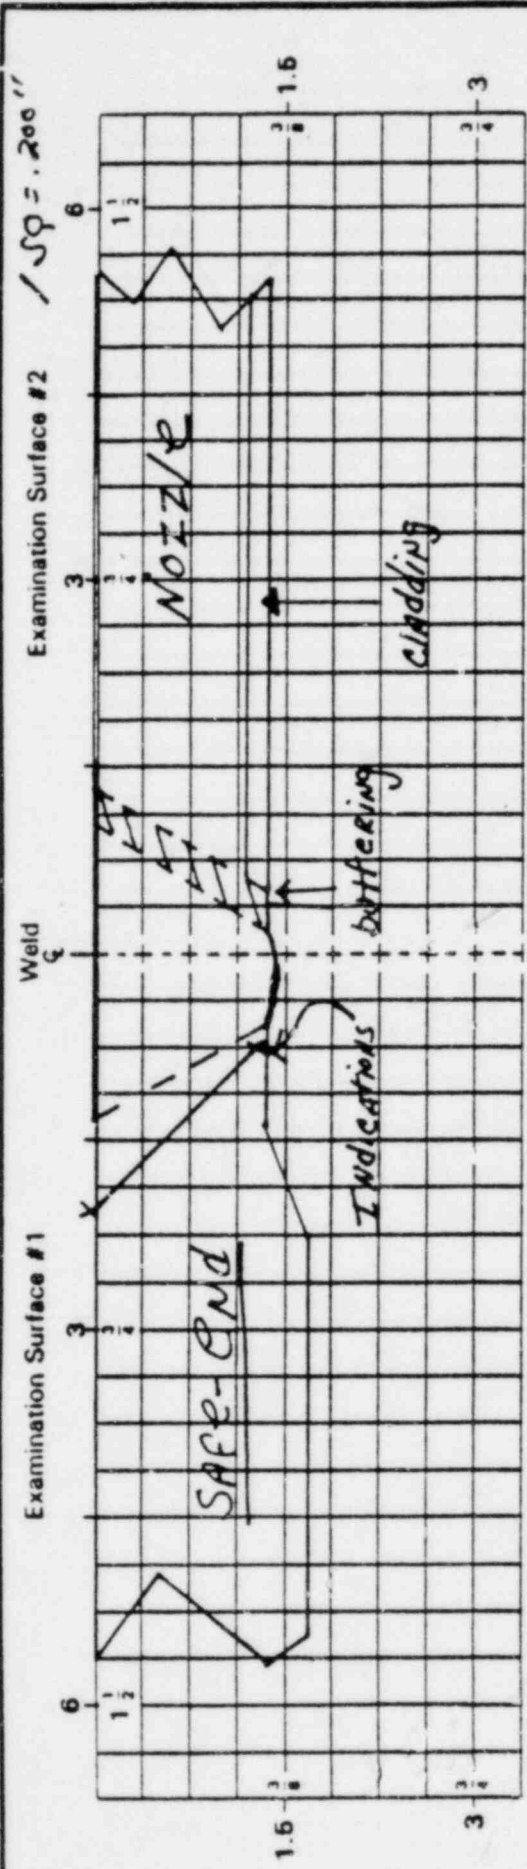
**Indication # 202**

Examiners Comments low level indication at weld loop appears as slier

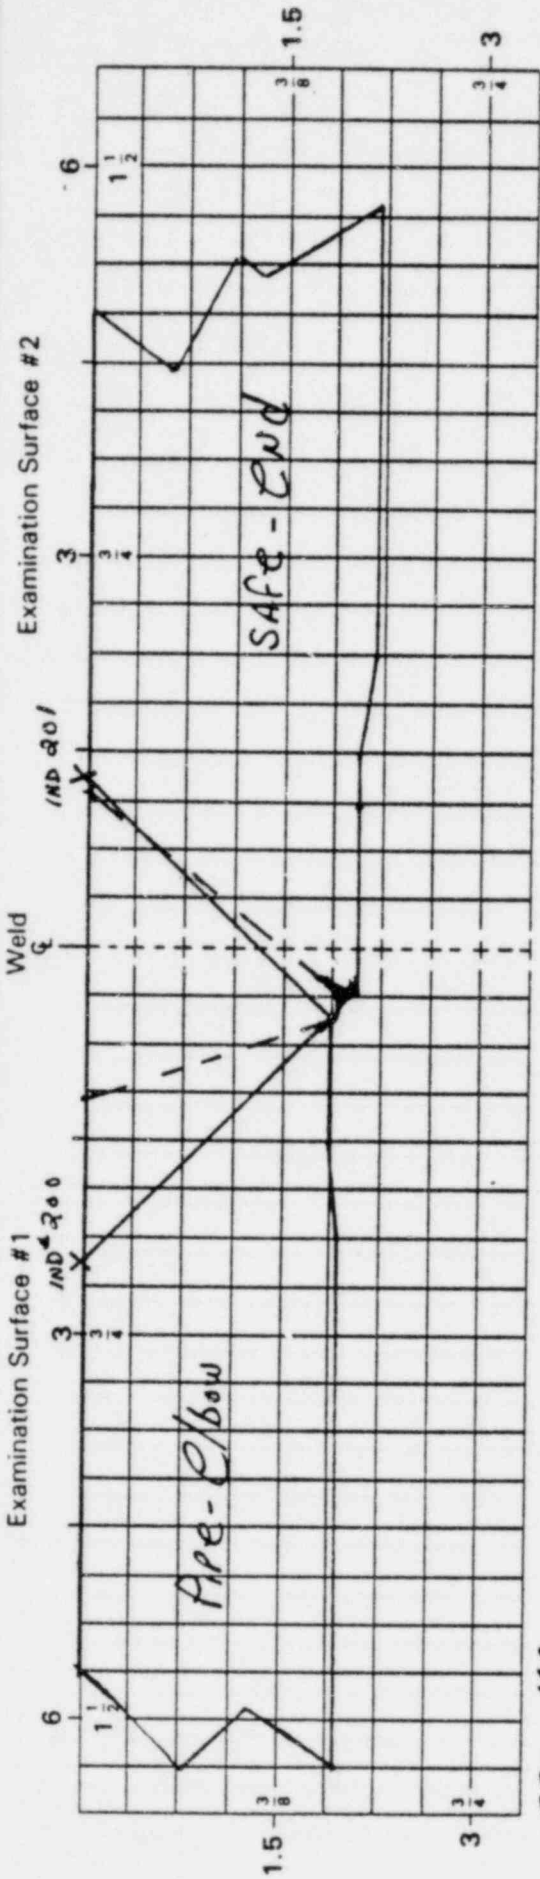
Examiners Comments BOTH SIGNALS ARE DUE TO GEOMETRIC REFLECTORS AT THE ROOT AREA. BASE LINE RADIOGRAPHS SHOW A POOR FIT UP CONDITION AS WELL AS A TOOL MARK.

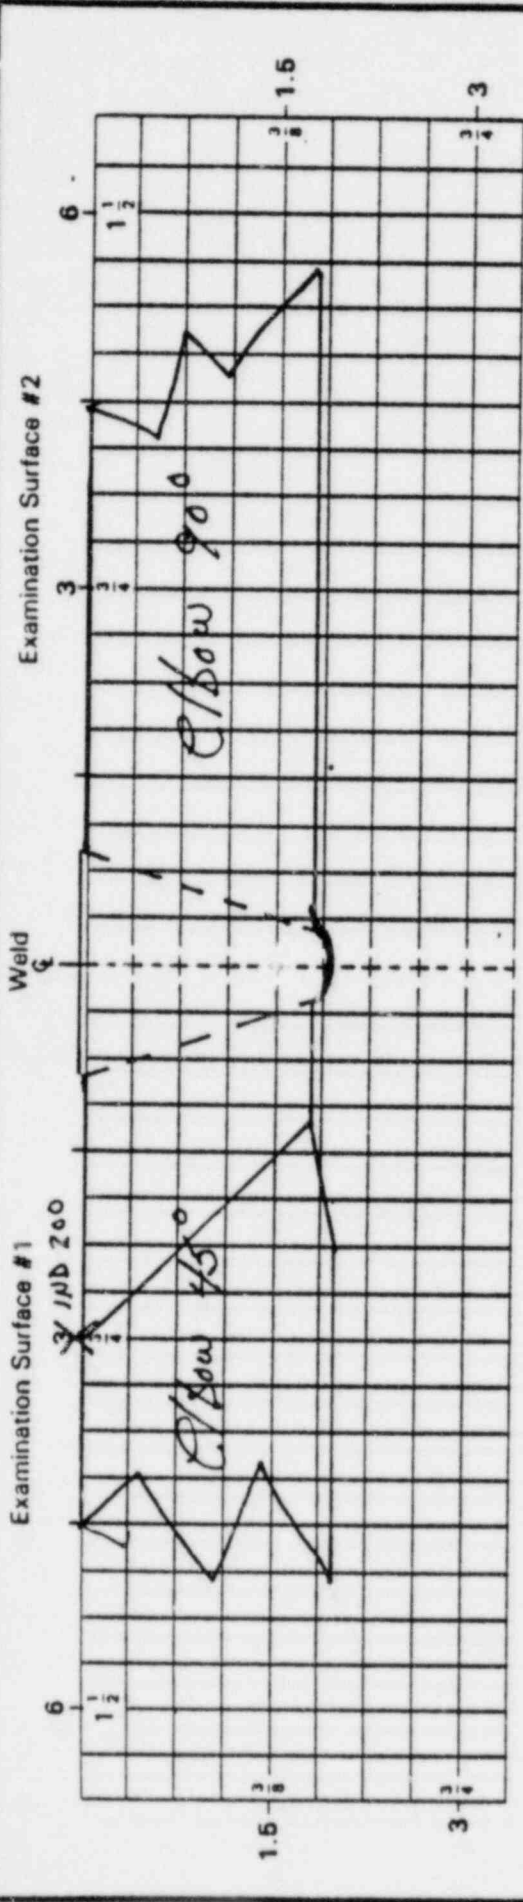
Examiners Comments Reflector is from change in thickness transition and is geometric.

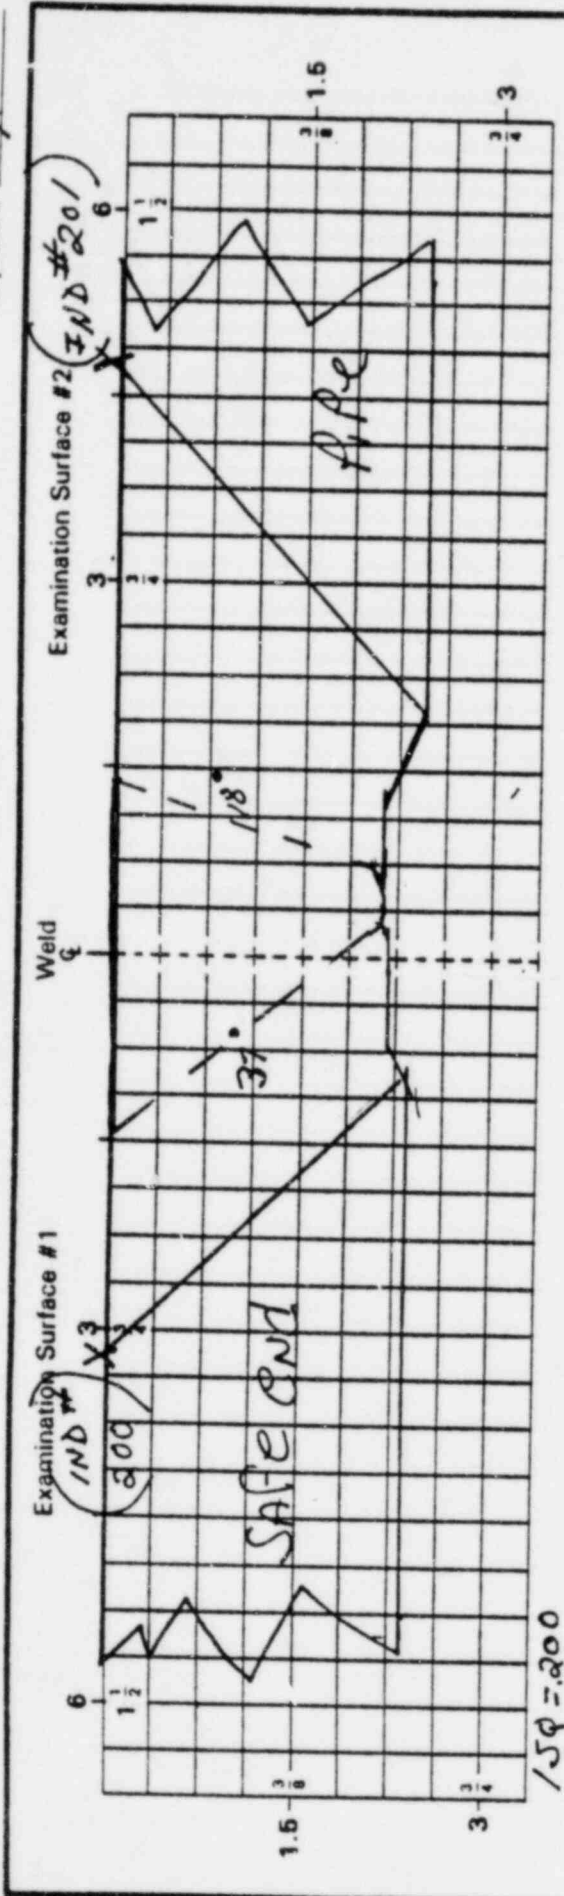
Examiners Comments BOTH INDICATIONS ARE REFLECTIONS FROM COUNTERBORE & POOR FIT UP OF SAFE END TO ELBOW. REVISITATION OF COUNTERBORE PER BASELINE RADIOGRAPH.

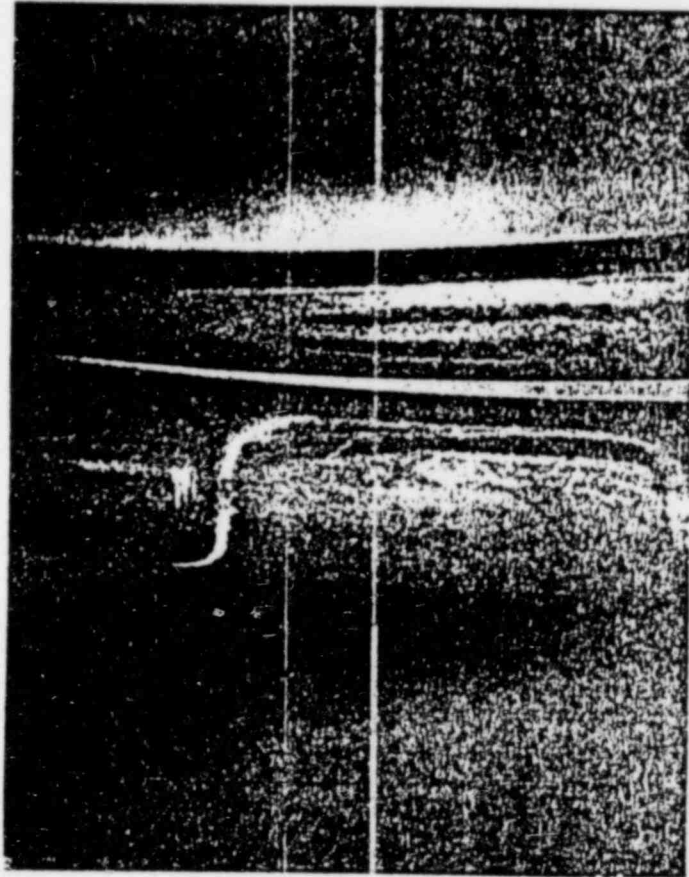
Figure 5. Crud and Boron Crystal  
Deposits on Spring From  
Retainer L106

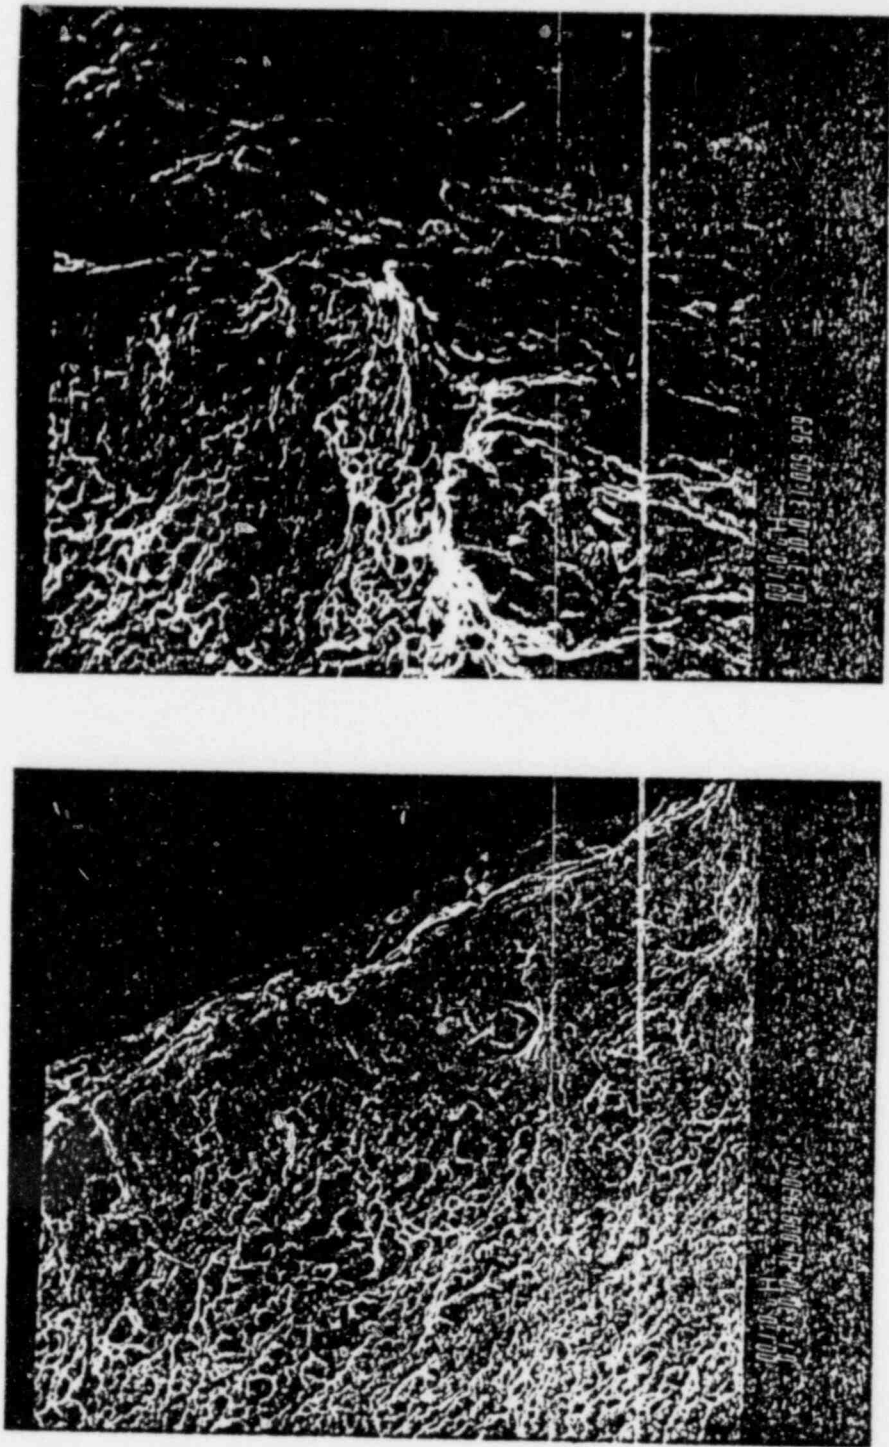
Figure 7. Typical Appearance of Inconel X750 Spring Fracture Surface (1000X)

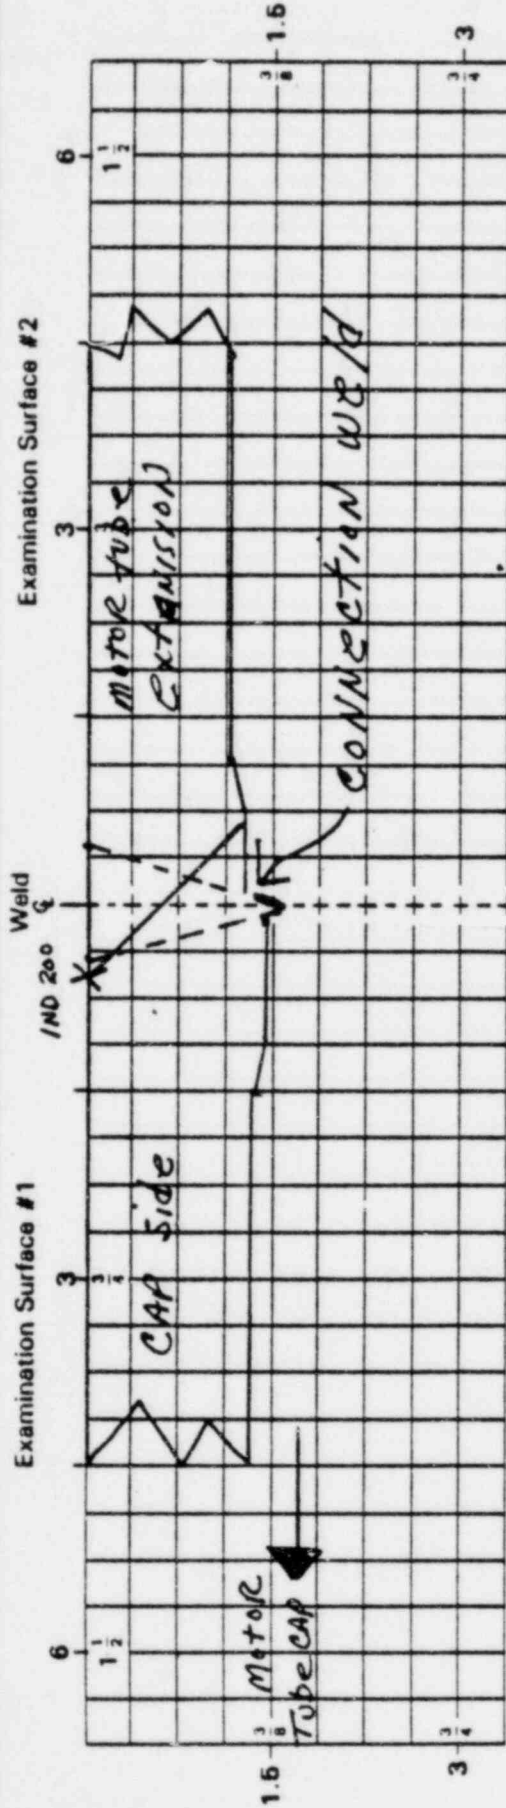
Examiners Comments DATA SHT. 000070 INDICATIONS APPEAR INTERMITTED 360°. REFLECTORS ARE FROM CHANGE IN THICKNESS SECTION, VERIFIED BY 0° PROBE, REFLECTORS ARE GEOMETRIC SIGNALS

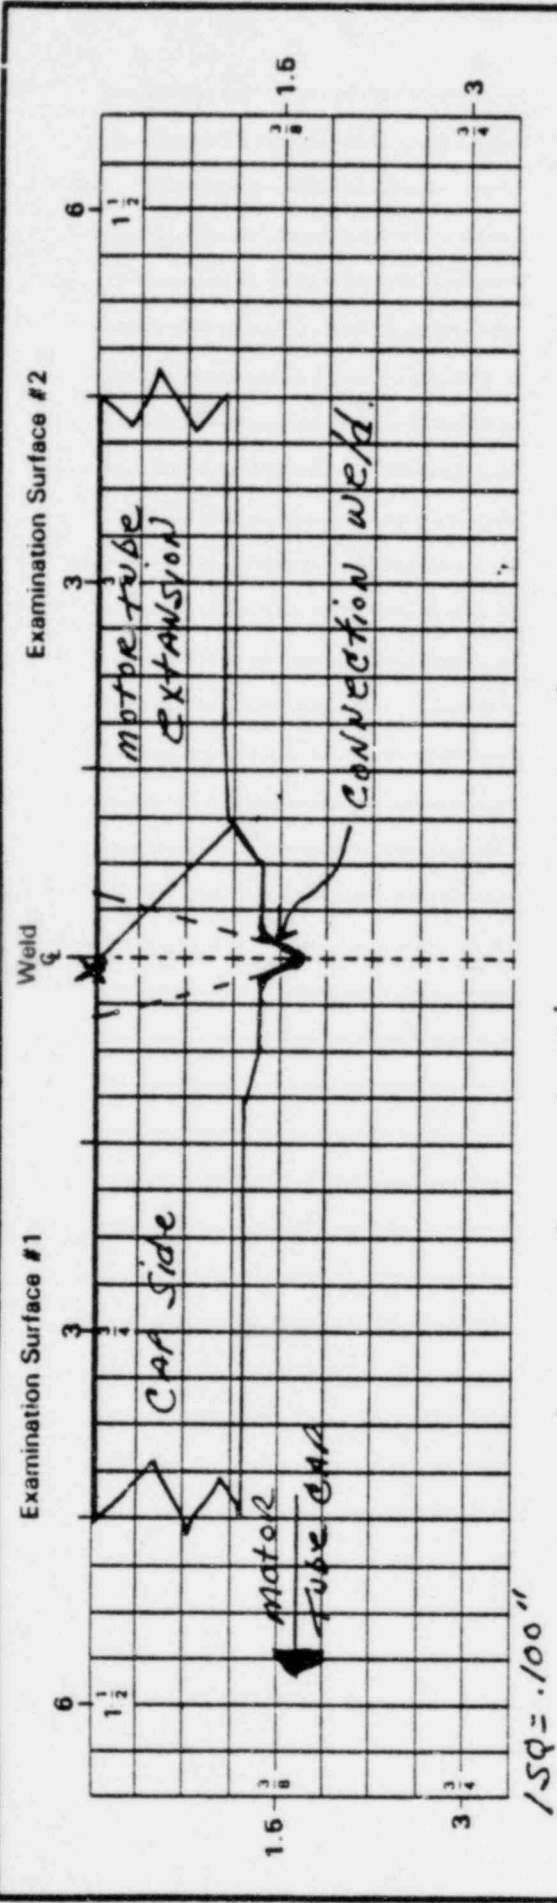
Examiners Comments DATA SAT. 000071 INDICATIONS ARE 360° AND ARE ATTRIBUTED TO A SEVERE CHANGE IN THICKNESS SECTION. INDICATIONS ARE GEOMETRIC.

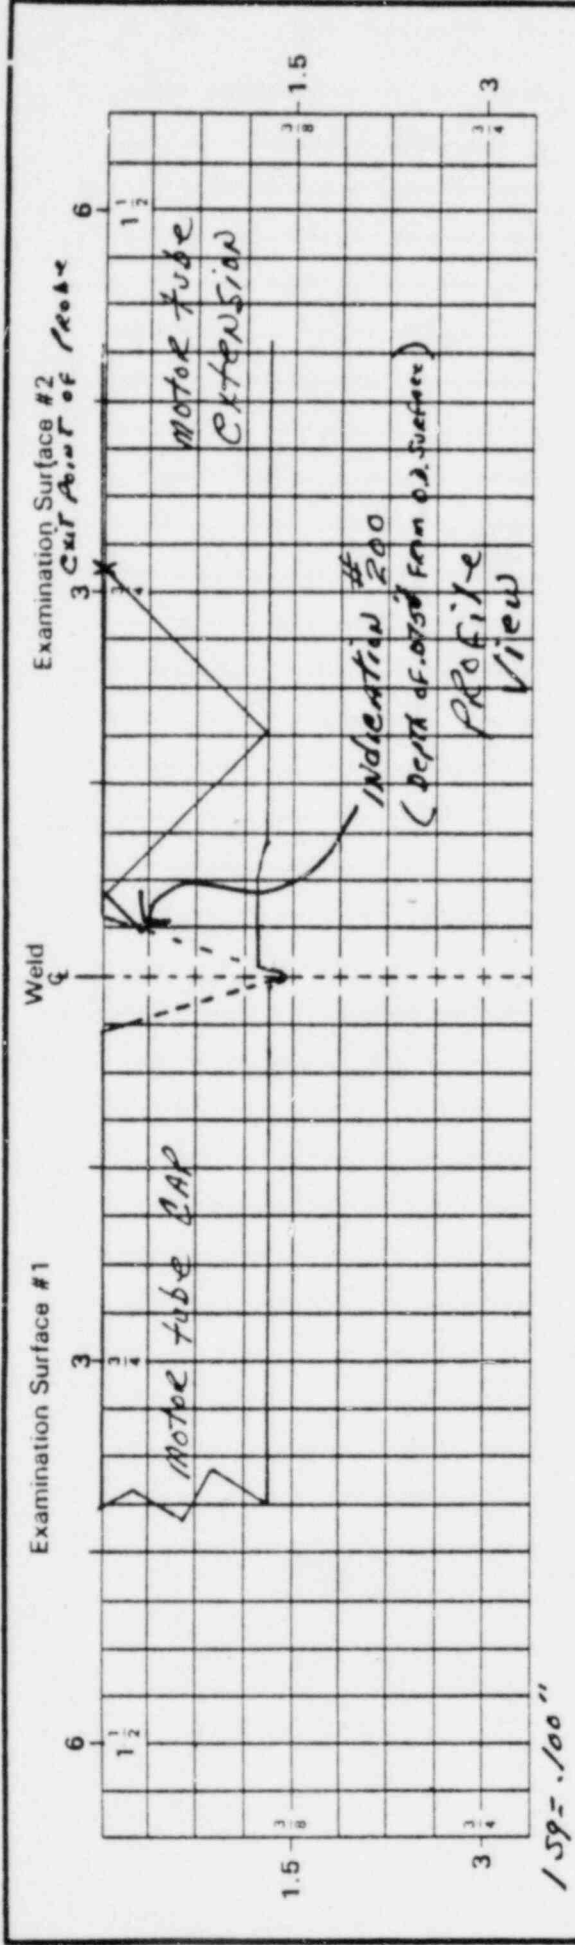
Examiners Comments INDICATION HAS A GENERAL AMPLITUDE OF 100% OF DAC, INDICATION DIPS TO 50% OF DAC IN SOME AREAS AND RISES TO 60% OF DAC IN OTHER AREAS, ALSO CONTAINS TWO SPURIOUS SIGNALS IN AREAS. DEPTH OF .075" FROM O.D. SURFACE.

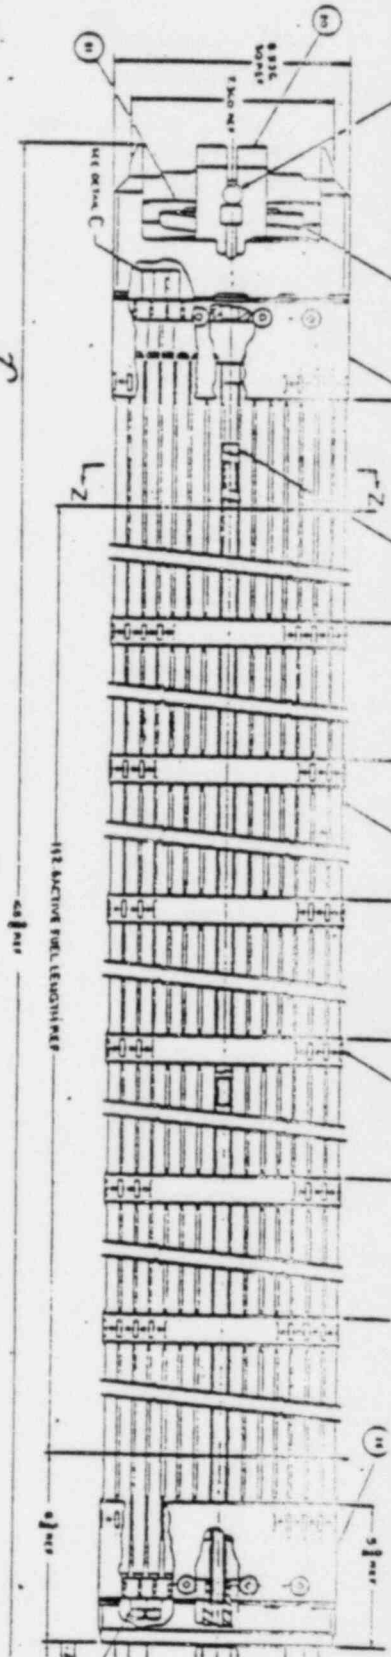
CONVENTS ① THESE WERE DETERMINED TO BE BORON (WHITE) FLAKES BEING PICKED UP FROM THE WATER IN THE DEEP END - THEY HAD NOT ORIGINALLY BEEN ON THE FUEL. HOWEVER, SOME DEPOSIT OF YELLOW MATERIAL WERE NOTED ON AND NEAR THE GRIDS BY NAKED EYE

IN GENERAL THE CONDITION OF THE ASSEMBLY APPEARED NORMAL FOR NEW FUEL EXCEPT FOR YELLOW DEPOSITS AS NOTED.
