# H. C. NUTTING COMPANY

November 4, 1993

Re: Accident - Nuclear Gauge  
Troxler Model 3411B  
Serial No. 17368  
H. C. Nutting Company, Owner

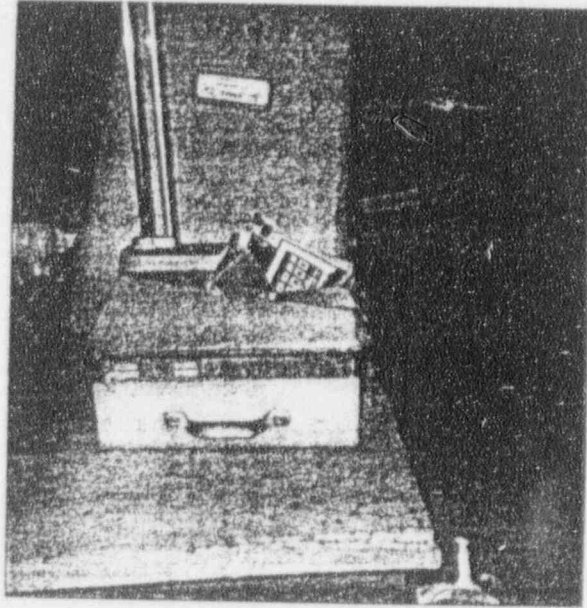
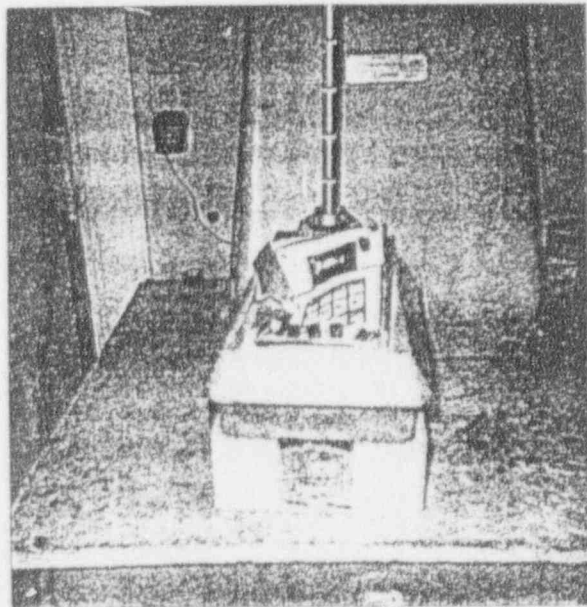
The accident occurred on October 6, 1993, at approximately 2:05 p.m. at the H. C. Nutting Project, Drug Emporium, Buttermilk Crossing, Alexandria, Kentucky. A Liebherr 641 loader partially backed over the gauge resulting in damage to the upper housing and key pad. (See enclosed photographs.) Prior to the accident occurring, the gauge was sitting on a mound of dirt 2½' to the east of and 4'-4½' above an undercut being backfilled and compacted. The gauge was sitting close to the technician's personal vehicle while the technician was standing, observing the work being performed. It was necessary for the technician to move his vehicle in order to route a concrete truck onto the site. Inadvertently, the technician moved his vehicle out of the way of the concrete truck without moving the nuclear gauge. The technician was approximately 20' from the gauge location, within eyesight of the gauge when the loader backed up out of the excavation, with the track damaging the gauge as noted above. Noise from the loader engine and on-site concrete trucks prevented the technician's warning from being heard by the loader operator.

The technician immediately stopped all traffic in the area and surveyed the gauge. The gauge was in a safe position when the accident occurred and neither the source rod nor the lower part of the gauge had been damaged. Technician notified the supervisor who advised him to thoroughly observe the gauge and the condition where it was, which was still in an upright position and to visually determine if there was damage to the source rod. The source rod worked in and out of the meter as a normal operation of an undamaged meter. There was no visible damage to the source rod. The supervisor advised the technician to put the meter in the transportation case, lock the source, lock the case and transport the meter immediately to the office. Once the meter arrived at the office, the writer used a survey meter to determine the activity of the meter as it now existed. The activity measured around the meter was normal to those described in Troxler Electronic Laboratories drawing C102191.

We are in the process of obtaining warning flags similar to those used on bicycles which we are going to attach to the meter with the intent of the warning flag being more visible to all parties involved on a construction site.
