CALVERT CLIFFS NUCLEAR POWER PLANT
1650 CALVERT CLIFFS PARKWAY • LUSBY, MARYLAND 20657-4702

SUBJECT: Calvert Cliffs Nuclear Power Plant
Unit Nos. 1 and 2; Docket Nos. 50-317 and 50-318;
License Nos. DPR 58 and DPR 69
Licensee Event Report 94-001
Reactor Trip Due to Opening of 13.8 Kilovolt Feeder Breaker

LICENSEE EVENT REPORT (LER)

TITLE (4)
Reactor Trip Due to Opening of 13.8 Kilovolt Feeder Breaker

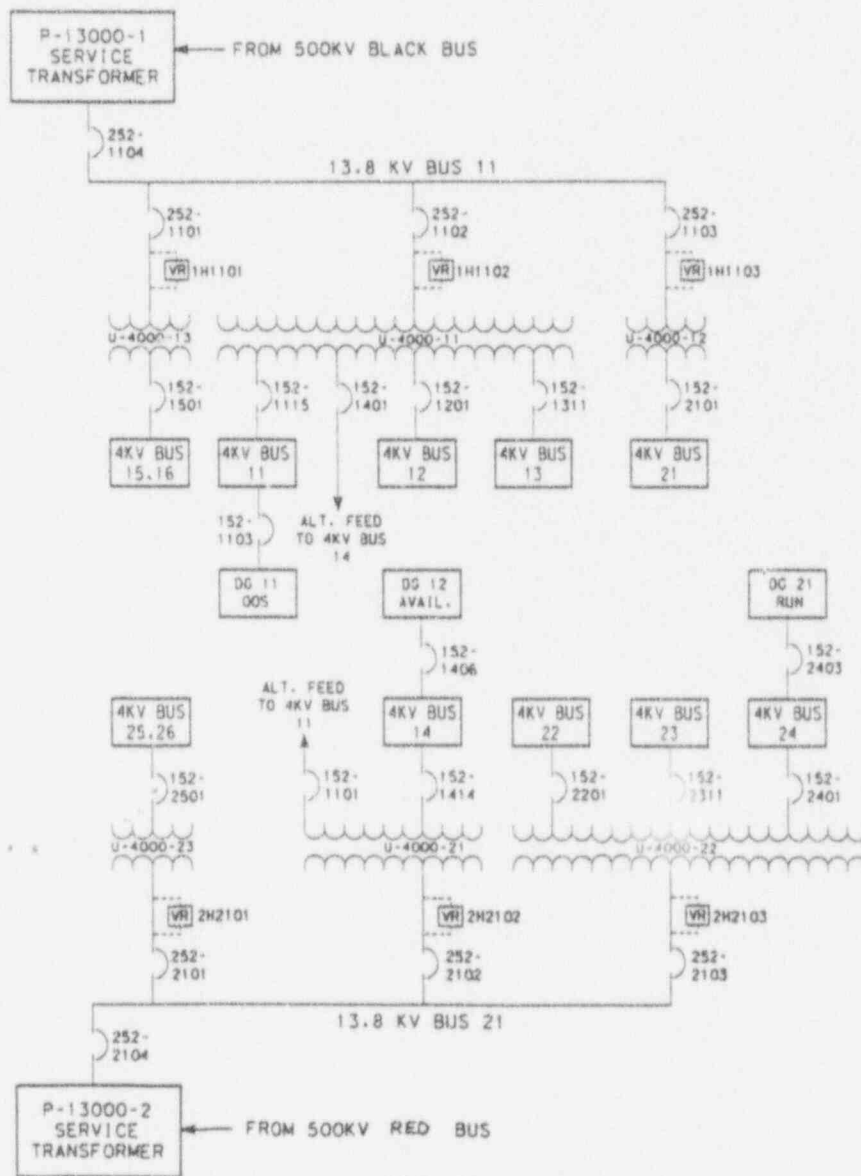
FIGURE 1

Figure 1 provides a schematic of the power supply scheme discussed in this Licensee Event Report (LER).
