SUBJECT: OPERATING REACTORS EVENTS BRIEFING
 FEBRUARY 9, 1994 - BRIEFING 94-06

OPERATING REACTORS EVENTS FULL BRIEFING (94-06)

OPERATING REACTORS EVENTS BRIEFING 94-06

DRESDEN UNIT 1
COLD WEATHER IMPACT ON DECOMMISSIONED REACTOR FACILITY
JANUARY 24, 1994

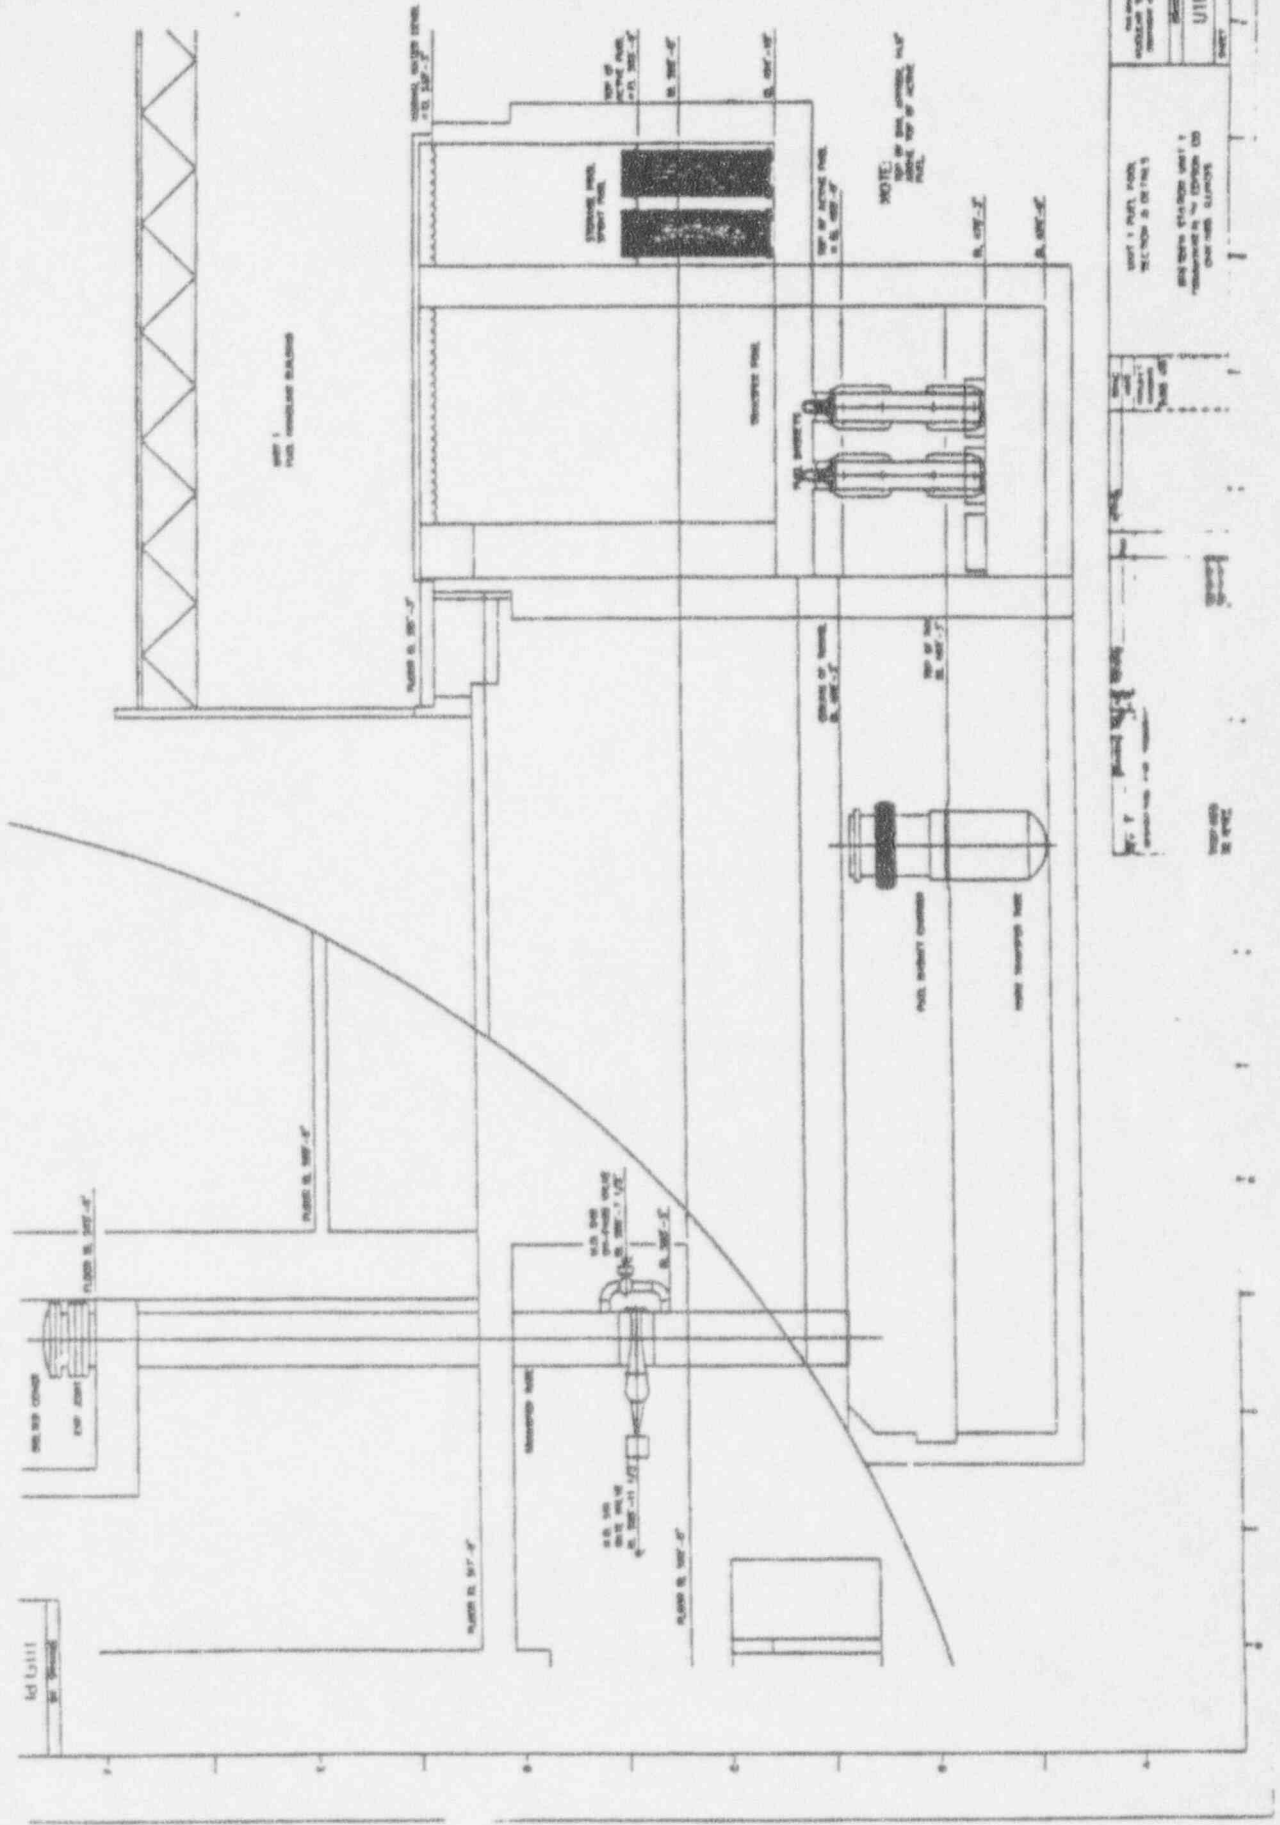
DRESDEN 1
BRIEFING 94-06

BREAKS IN THE SERVICE WATER SYSTEM WERE DISCOVERED AND APPROXIMATELY 55,000 GALLONS OF WATER WAS SPILLED TO THE CONTAINMENT. SUBSEQUENT INVESTIGATION BY LICENSEE IDENTIFIED THAT THE SPENT FUEL POOL TRANSFER SYSTEM LOCATED INSIDE CONTAINMENT WAS ALSO SUSCEPTIBLE TO FREEZING AND COULD HAVE RESULTED IN DRAINING THE SPENT FUEL POOL TO SEVERAL FEET BELOW TOP OF THE FUEL.

FAILURE OF THE 42" FUEL TRANSFER TUBE COULD RAPIDLY DRAIN THE SPENT FUEL POOL TO A LEVEL SEVERAL FEET BELOW THE TOP OF THE FUEL BUNDLE. PRELIMINARY RADIOLOGICAL CONSEQUENCES ASSESSMENT INDICATES THAT DOSE RATES AT FUEL POOL RAIL WOULD HAVE BEEN ABOUT 2700R/HR AND 19 R/HR 100 YARDS FROM THE FUEL POOL (DISTANCE TO THE NRC RESIDENT'S OFFICE). HAD THE FUEL BECOME UNCOVERED, THIS EVENT MAY HAVE AFFECTED THE OPERATION OF UNITS 2 AND 3.

- LICENSEE DISCOVERED THAT SPENT FUEL TRANSFER SYSTEM INSIDE CONTAINMENT WAS SUSCEPTIBLE TO FREEZING AND IF IT HAD FAILED, COULD HAVE DRAINED SPENT FUEL POOL TO TWO TO THREE FEET BELOW ACTIVE FUEL.

- LICENSEE IMMEDIATELY INSTALLED SPENT FUEL POOL GATES TO ISOLATE 660 FUEL BUNDLES IN SPENT FUEL POOL FROM SPENT FUEL TRANSFER SYSTEM.
- 23 FUEL BUNDLES REMAINED AT BOTTOM OF SPENT FUEL TRANSFER POOL IN A RELATIVELY SAFE CONDITION.

- LICENSEE INSTALLED LOCAL REDUNDANT SPACE HEATERS NEXT TO FUEL TRANSFER TUBE ISOLATION AND BYPASS VALVES LOCATED IN CONTAINMENT--NO DAMAGE TO SYSTEM HAS BEEN OBSERVED TO DATE (PIPE TEMPERATURE UPSTREAM OF VALVES WAS 62F AND DOWNSTREAM WAS 34F AT TIME FLOODING WAS DISCOVERED; HOWEVER, BY THAT TIME, OUTSIDE TEMPERATURES HAD RISEN SUBSTANTIALLY).
- LICENSEE PRELIMINARY EVALUATION INDICATES THAT THE MOST LIKELY FAILURE WOULD HAVE BEEN TO THE EIGHT INCH BYPASS LINE AND FUEL POOL LEVEL DROP WOULD HAVE TAKEN 40 MINUTES.
- LICENSEE FORMED A LARGE TEAM TO INVESTIGATE THIS EVENT AND IS HEADED BY AN EX-DRESDEN PLANT MANAGER FROM THE CORPORATE OFFICE--THEY PROVIDED A DETAILED BRIEFING TO THE NRC TEAM ON FIRST DAY AT SITE.

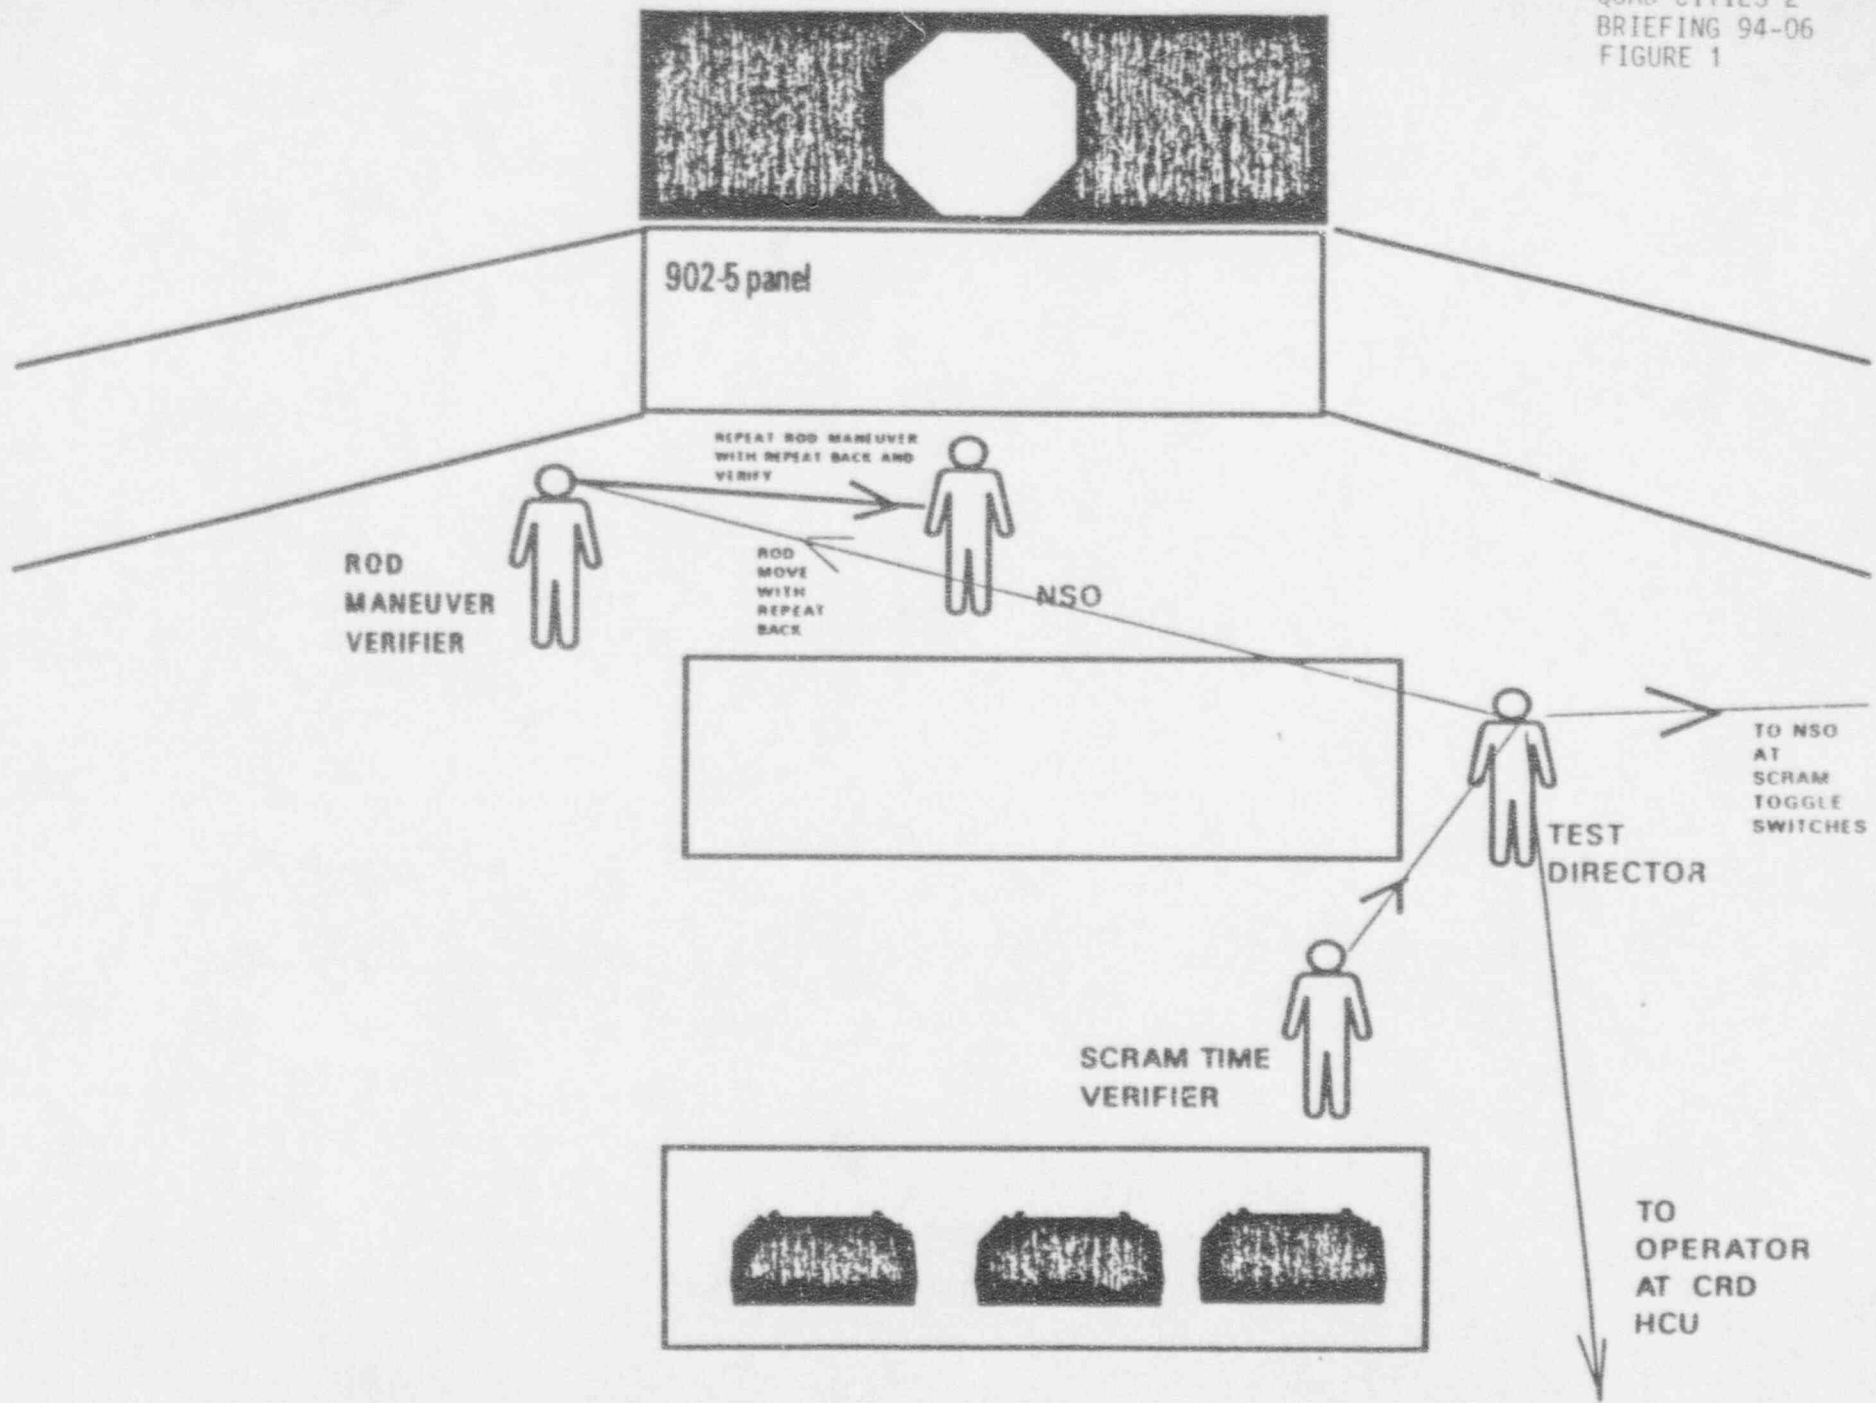
FIGURE 1 - TEST PERSONNEL POSITIONS (THURSDAY MORNING)

- UNIT 2 WAS AT 20-25% POWER AND HOLDING SINCE THE PREVIOUS DAY FOR CONTROL ROD SCRAM TIME TESTING. TESTING PROCEEDED THROUGHOUT THE MORNING WITH PERSONNEL POSITIONED AS SHOWN IN FIGURE 1.
- 1:30PM - THE TEST DIRECTOR LEFT TO FILL OUT PAPER WORK. NEW TEST DIRECTOR (QNE1) HAD NOT PERFORMED THIS FUNCTION BEFORE. QUALIFIED NUCLEAR ENGINEER (QNE2) WHO HAD BEEN ACTING AS THE ROD MANEUVER VERIFIER BECAME THE SCRAM TIME VERIFIER. IT WAS NOT CLEAR WHO WAS ROD MANEUVER VERIFIER (FIGURE 2).

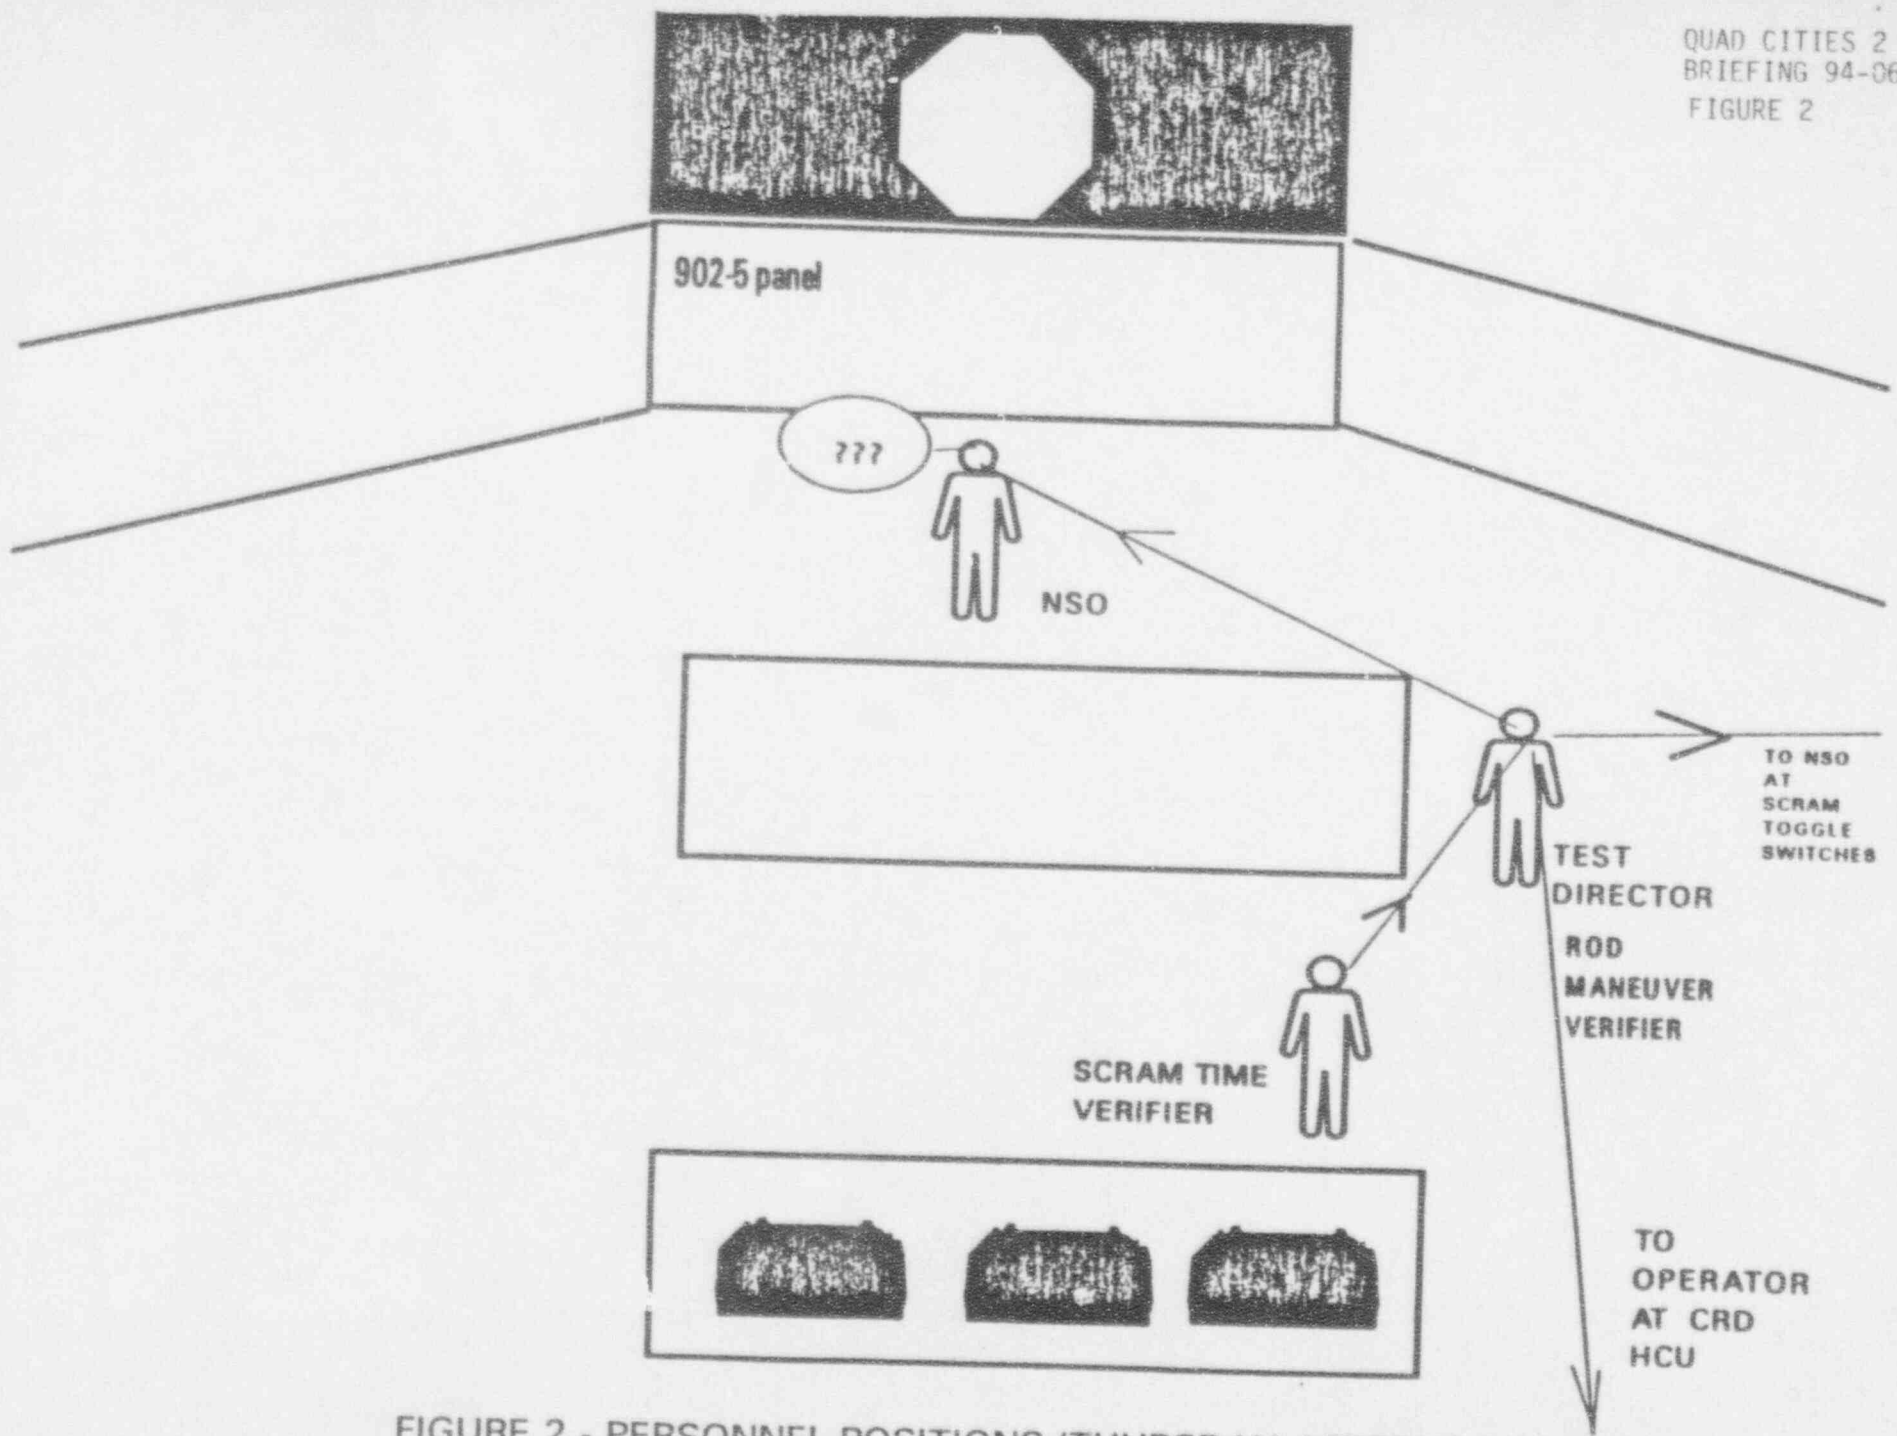
FIGURE 2 - PERSONNEL POSITIONS (THURSDAY AFTERNOON)

- LICENSEE INVESTIGATION IDENTIFIED THE FOLLOWING FINDINGS:
 - ROD M-8 WAS REPOSITIONED WITHOUT WRITTEN INSTRUCTIONS.
 - THE INDIVIDUAL RESPONSIBLE FOR SECOND VERIFICATION OF ROD MANEUVERS WAS NOT CLEARLY IDENTIFIED.

- THE TEST DIRECTOR DID NOT HAVE A CLEAR VIEW OF THE SPECIAL MANEUVER SHEET AND SHOULD NOT HAVE BEEN PROVIDING DIRECTION AND CONFIRMATION OF CONTROL ROD MANEUVERS.

- THE LICENSEE FORMED A SPECIAL TEAM TO INVESTIGATE THE EVENT. PERSONNEL INVOLVED WERE REMOVED FROM SHIFT AND GIVEN REMEDIAL TRAINING.
