SUBJECT: REQUEST FOR ADDITIONAL INFORMATION CONCERNING C-E OWNERS  
GROUP REQUEST FOR ESFAS SUBGROUP RELAY TEST INTERVAL  
EXTENSIONS (TAC NO. M81374)

SUBJECT: POTTER & BRUMFIELD MODEL MDR ROTARY RELAY FAILURES

POTTER & BRUMFIELD MODEL MDR ROTARY RELAY FAILURES

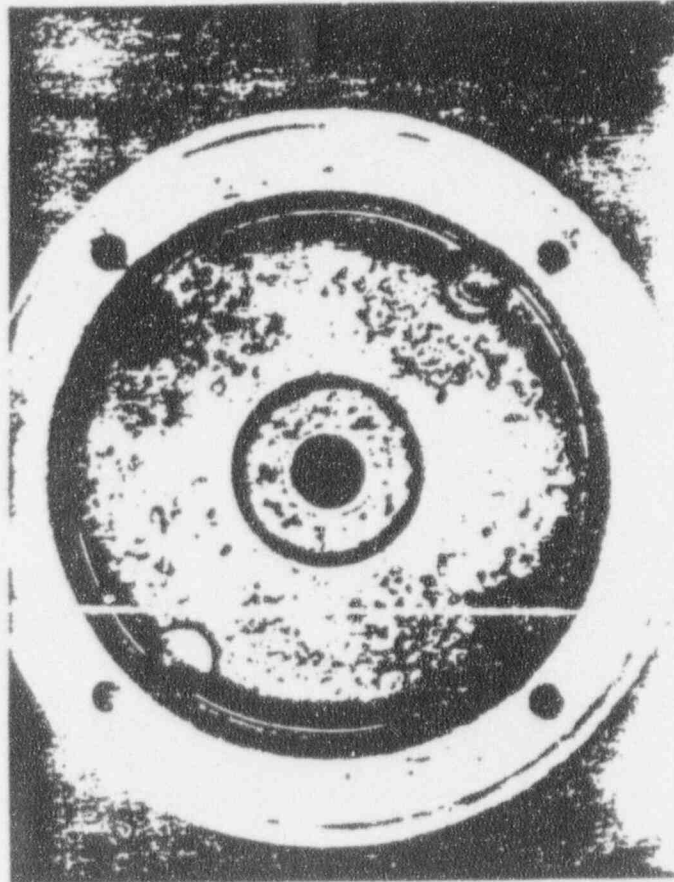
Figure 3-1 P&B MDR relay stud bell and bearing assembly

The hole in the center is the "bearing" and the four semi-circular areas are the bottom of the studs that hold the switch assembly in place. Varnish and corrosion products are shown as the irregular, darker deposits on the inside surface of the stud end bell.

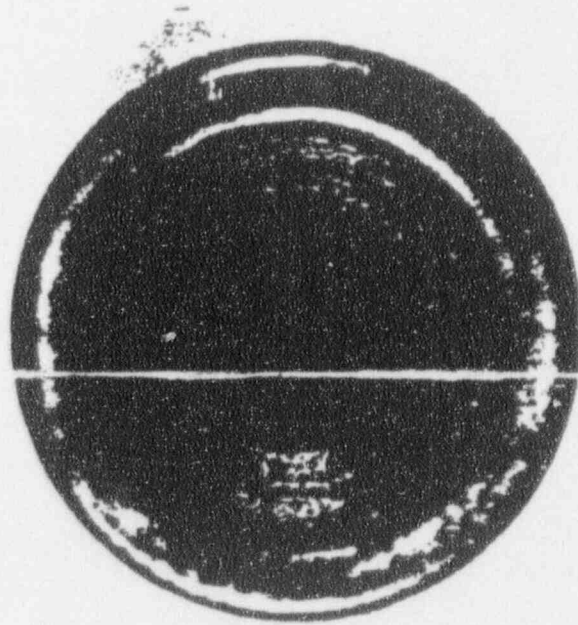
Figure 3-3 P&B MDR relay bottom spacer

The dark circle in the center of the bottom spacer is the hole for the rotor assembly upper shaft. The next concentric circular area is the relief area of the bottom spacer, where varnish and corrosion product deposits are shown as irregular lighter areas. The outer concentric circular area is the bottom spacer mating surface with the bottom shock plate, which is free of deposits.
