REPORT ON CABLE INSTALLATION

MIDLAND PLANT UNITS 1 AND 2

JUNE 4, 1982

BECHTEL POWER CORPORATION

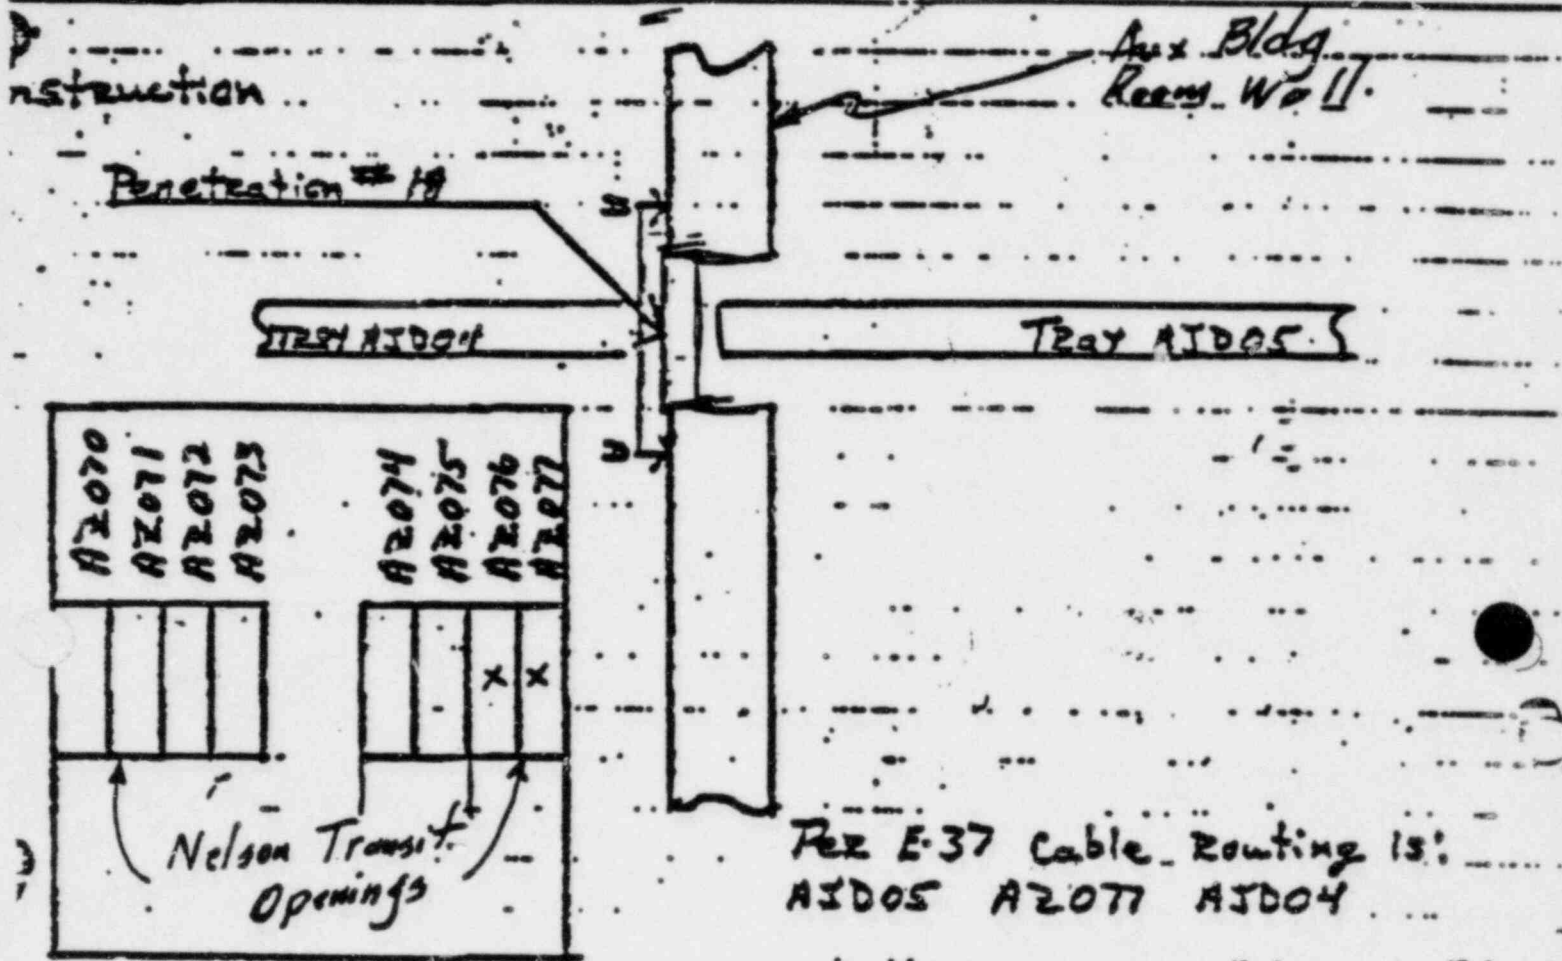
SK# 1

Per E-37 Cable Routing is:  
AID05 AZ077 AID04

This cable was passed through the wrong Nelson transit (cable seal) window. Both the right and wrong window were for power cables. However, because of the closeness of power and instrument penetrations in the plant, our basic concern was a possible voltage violation if this problem were repeated with a power cable being passed through an instrument cable window.

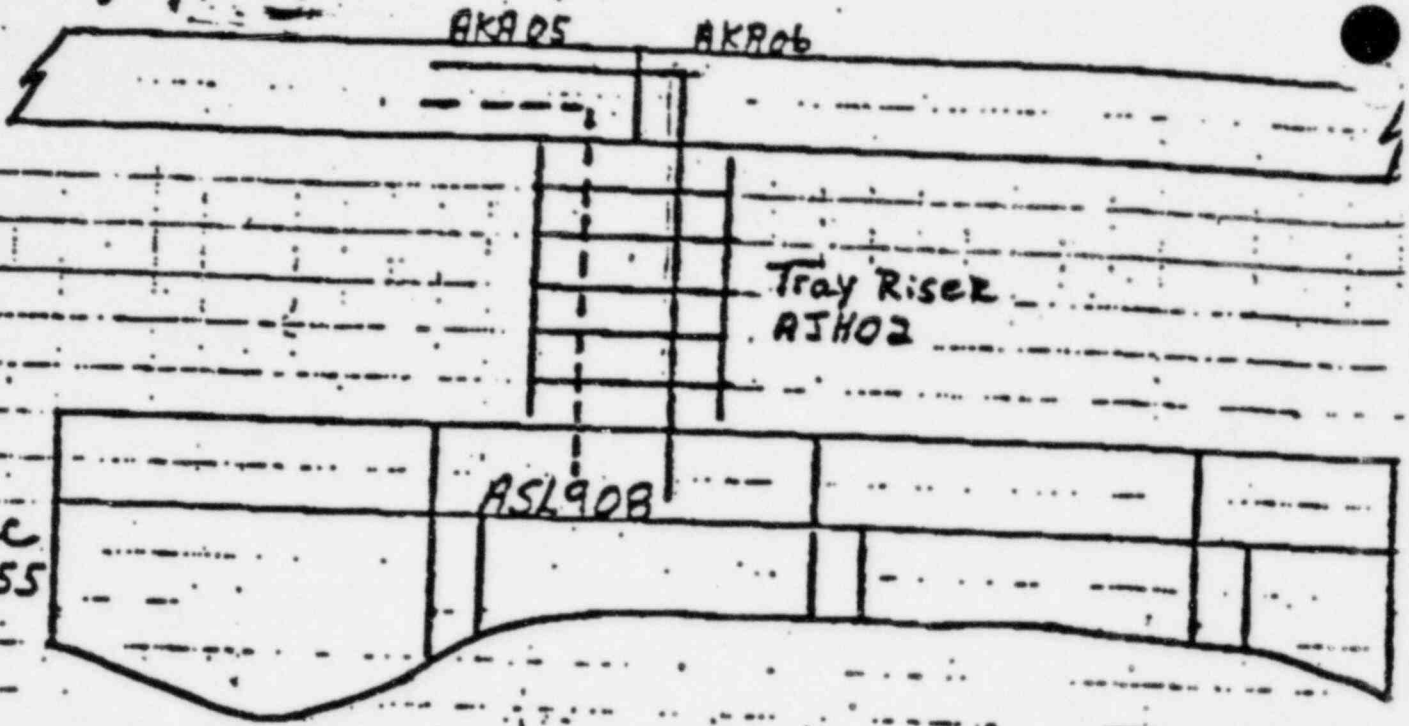
SK-5-A  
Midland Plant Units 1 and 2  
Attachment 3 to  
Report on Cable Installation

When a cable enters the confines of additional vias, the tray wrapping criteria would require wrapping to the edge of the violation and approximately 12 more inches at each end for safety.

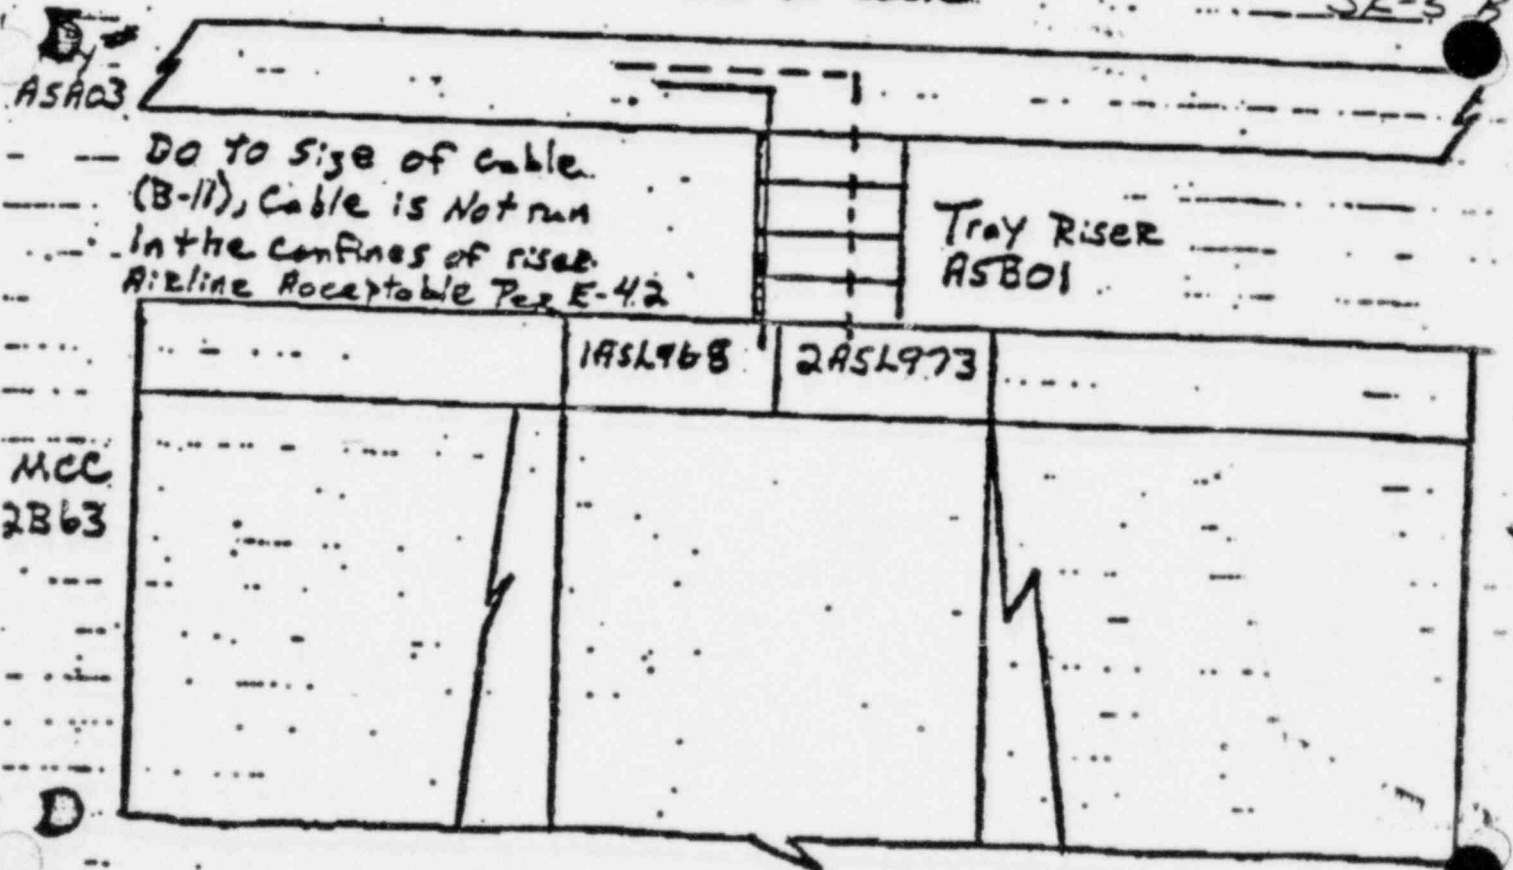
SK-5-B

When a cable enters the confines of additional vias, the tray wrapping criteria would require wrapping to the edge of the violation and approximately 12 more inches at each end for safety.

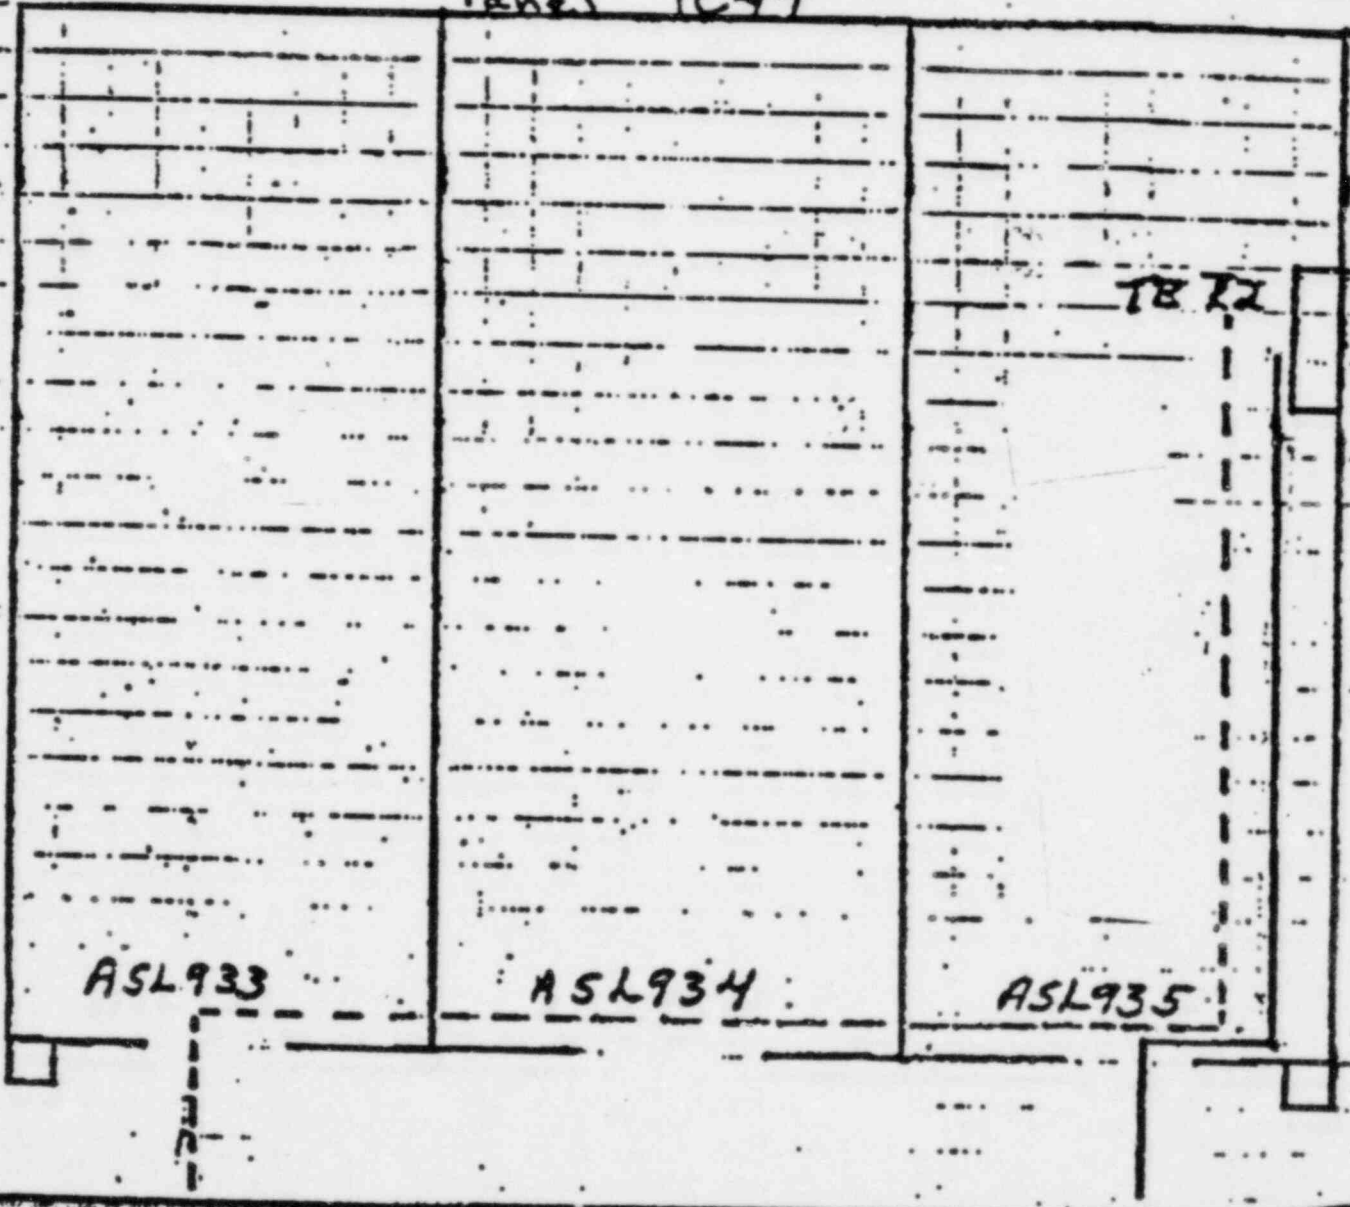
SK-8

Cable was routed to the wrong compartment of the control panel. Field discovered E37 error then pulled and terminated cable at the correct compartment. E37 did not reflect as-built condition.

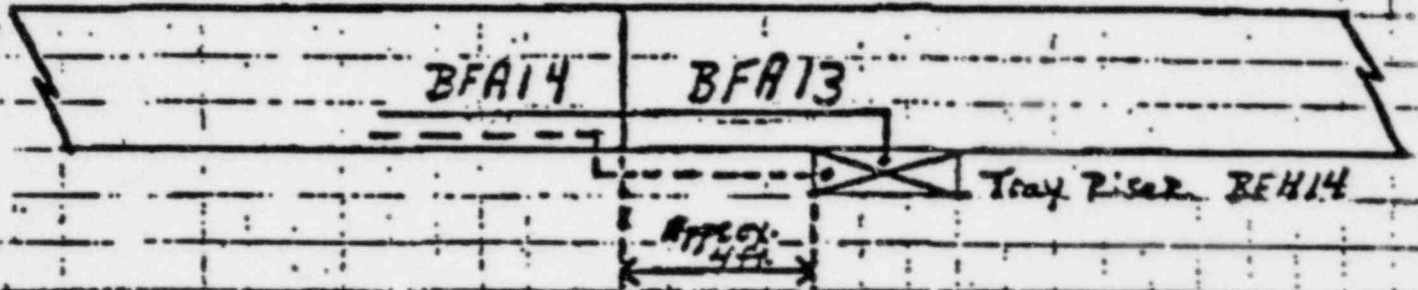
SK-9

Engineering designed the cable to be airlined between E37 designated vias. The criteria, when in a case like this a Class 1E cable leaves the confines of a raceway, the subject cable will be visually inspected for possible separation violation. This inspection will discover this problem.

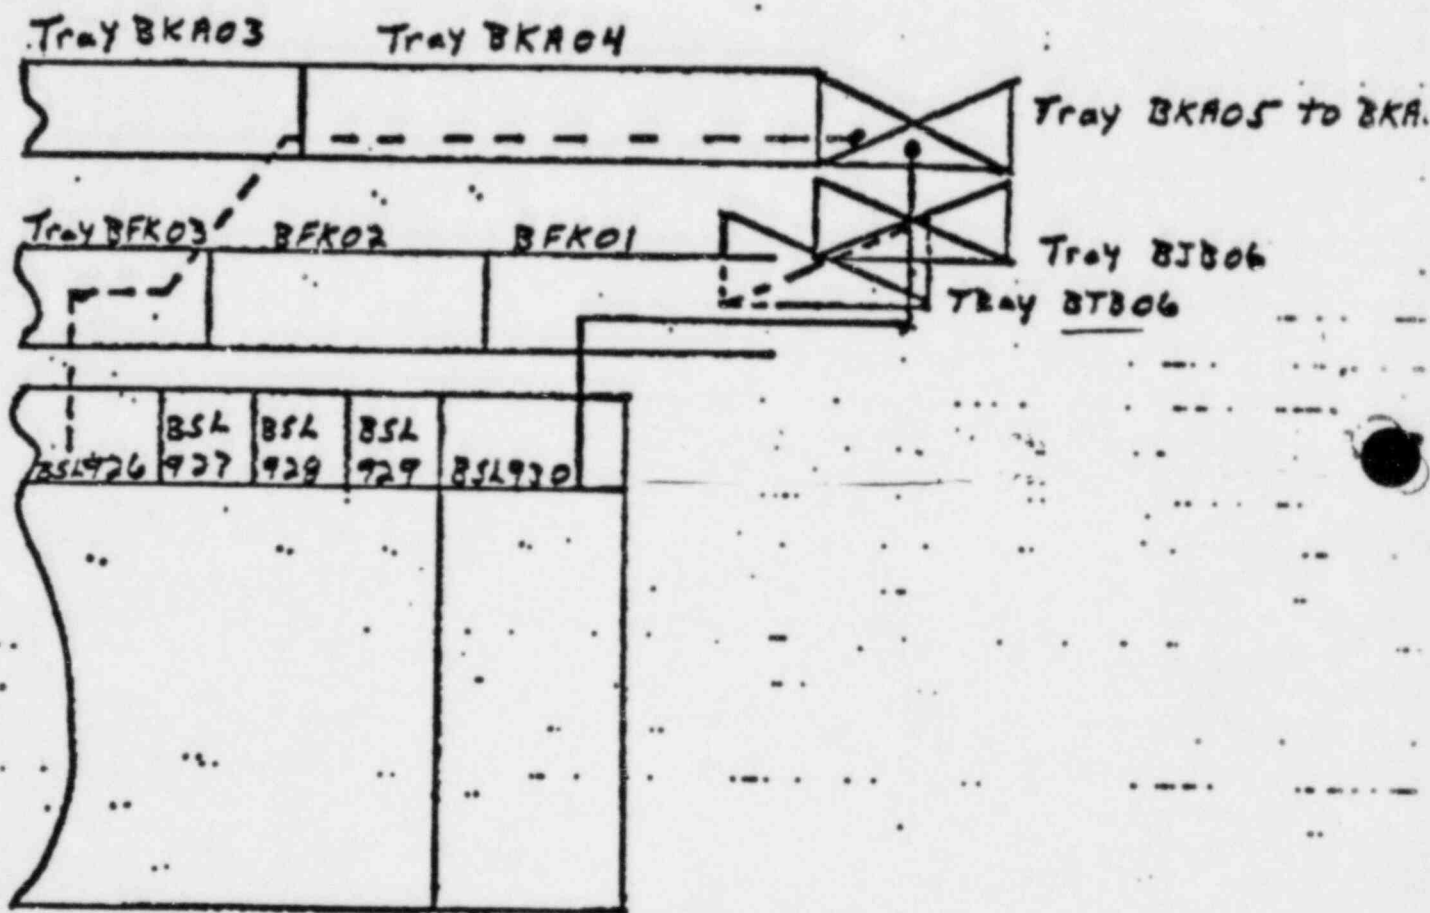
SK.12

Cable was not installed as routed in E37 and a voltage violation was created when a power cable was run in an instrumentation tray.

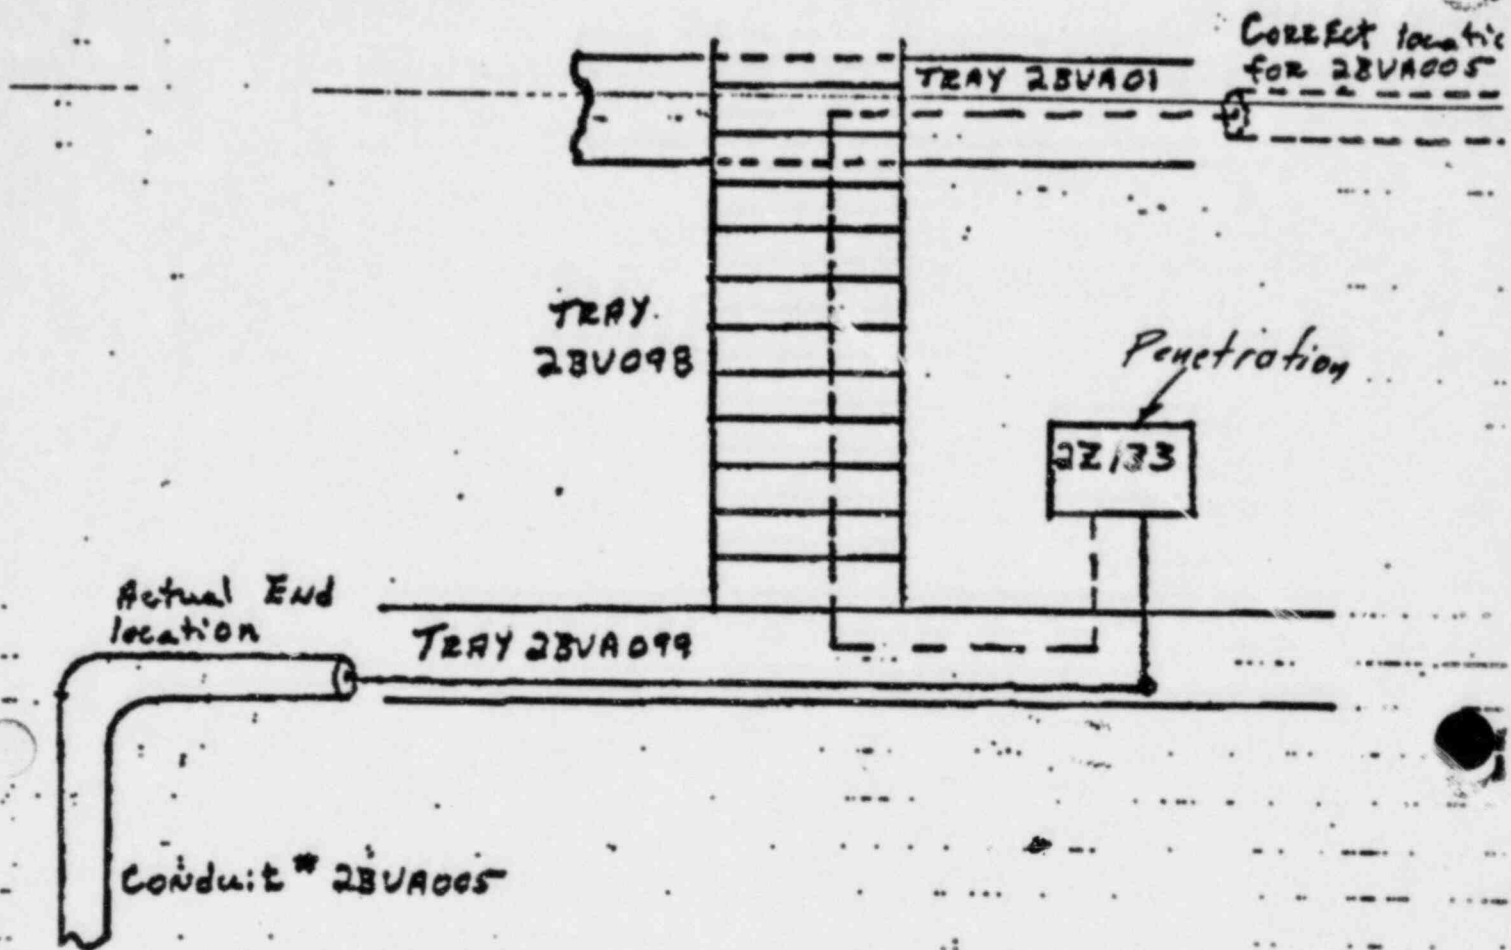
SK. 18

CONDUIT # 2BVA005 installed at incorrect End location  
 Should run to 2BVA01 ± 18" into adjoining tray section

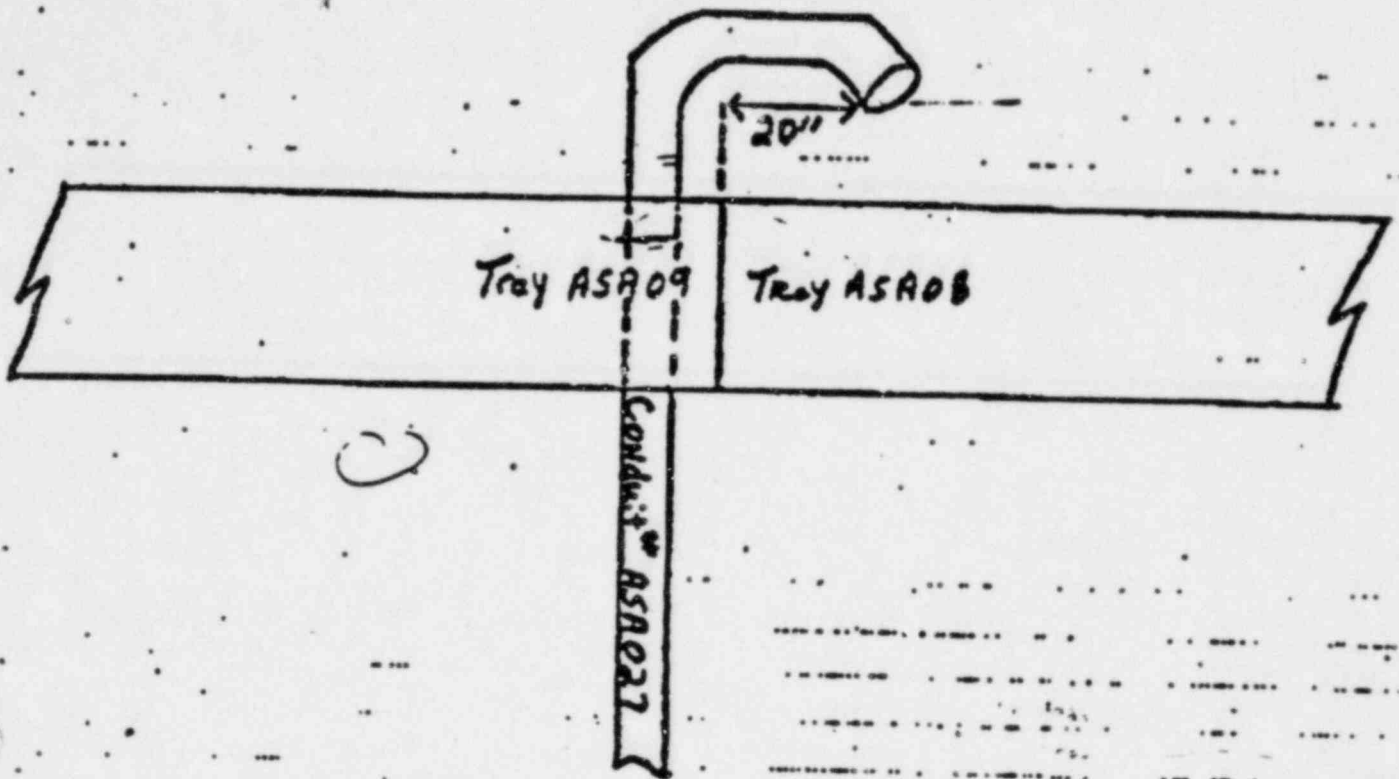
SK-19

CONDUIT # ASA027 installed at incorrect END location.  
Should run to ASA09 ± 18" into adjoining tray section.  
Cable vias per K-37 are: ASA027 ASA09 ASA08  
Due to incorrect END location: ASA027 — ASA08

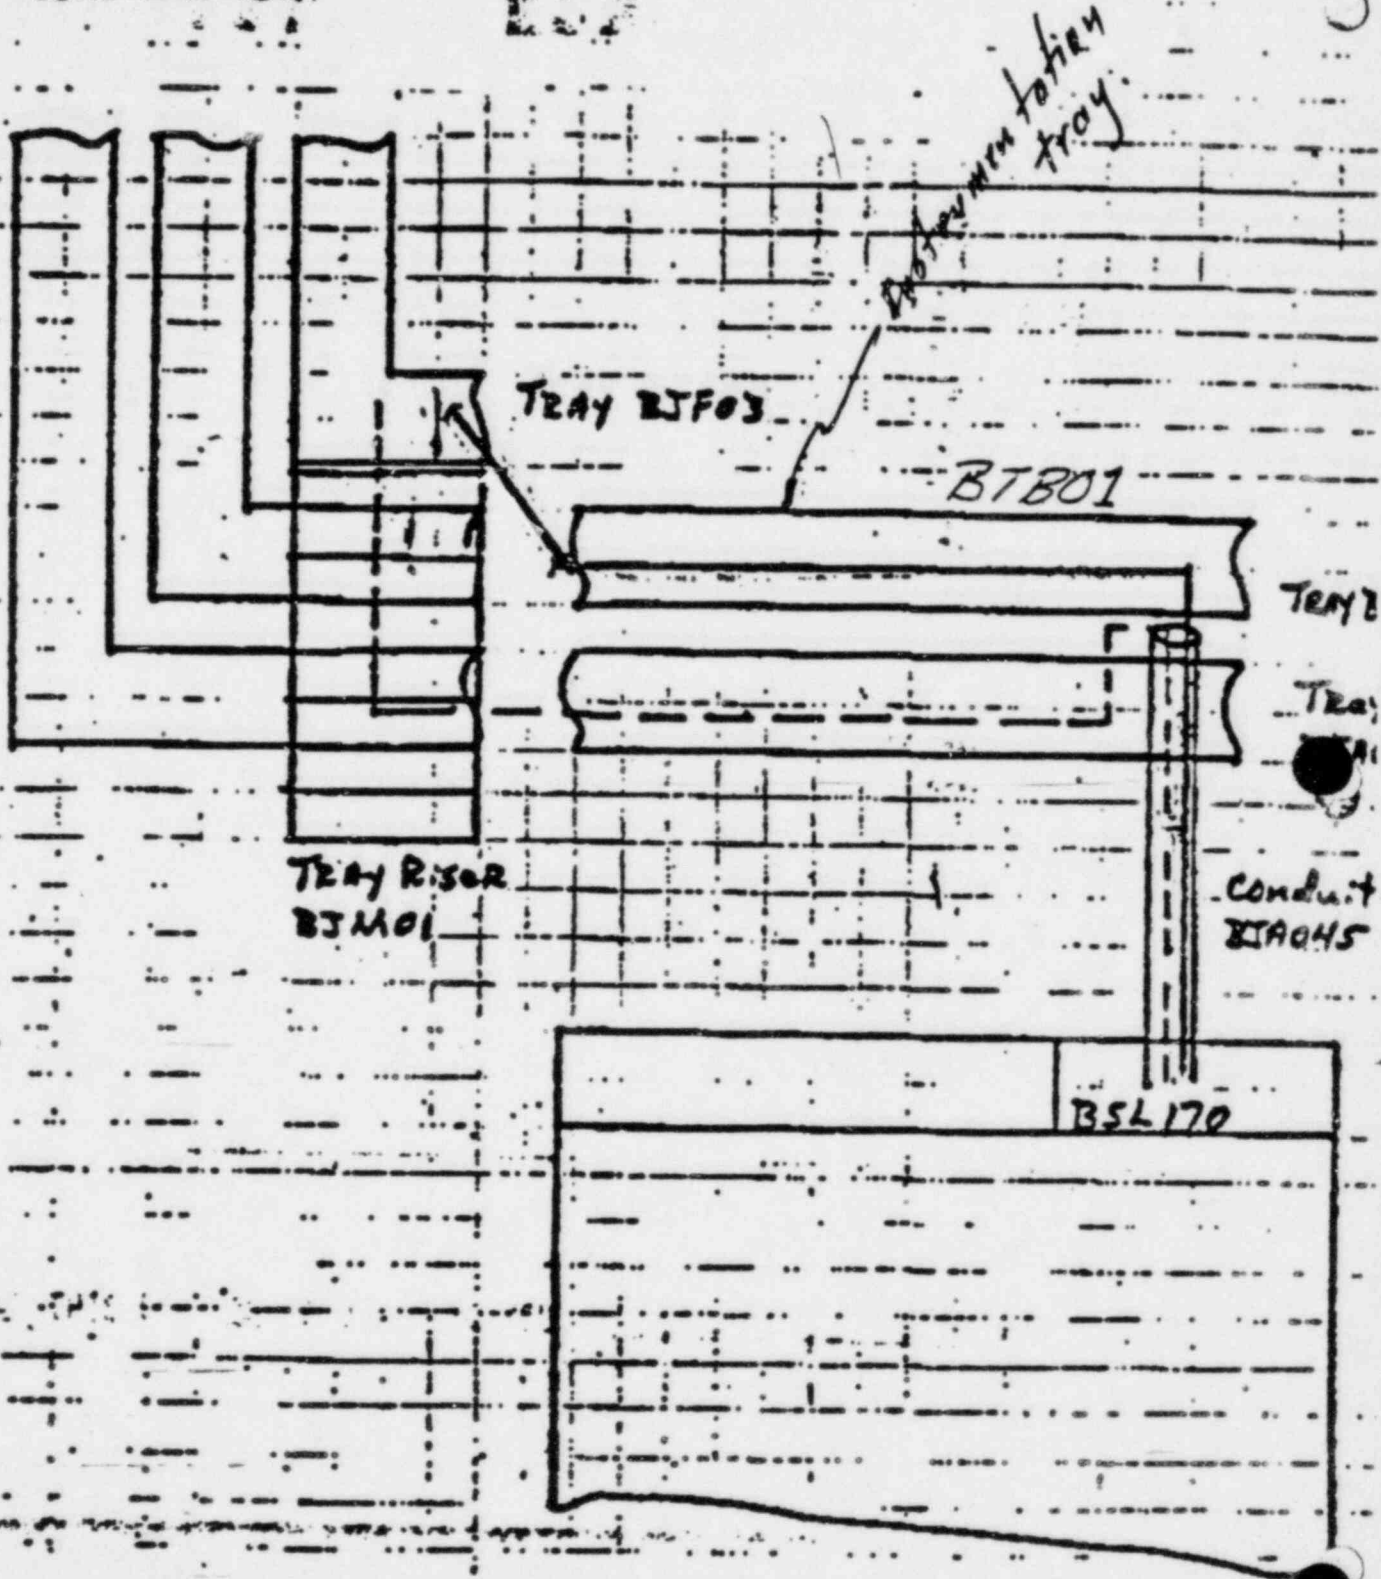
SK-24

Voltage violation - Control cables used instrumentation raceway.

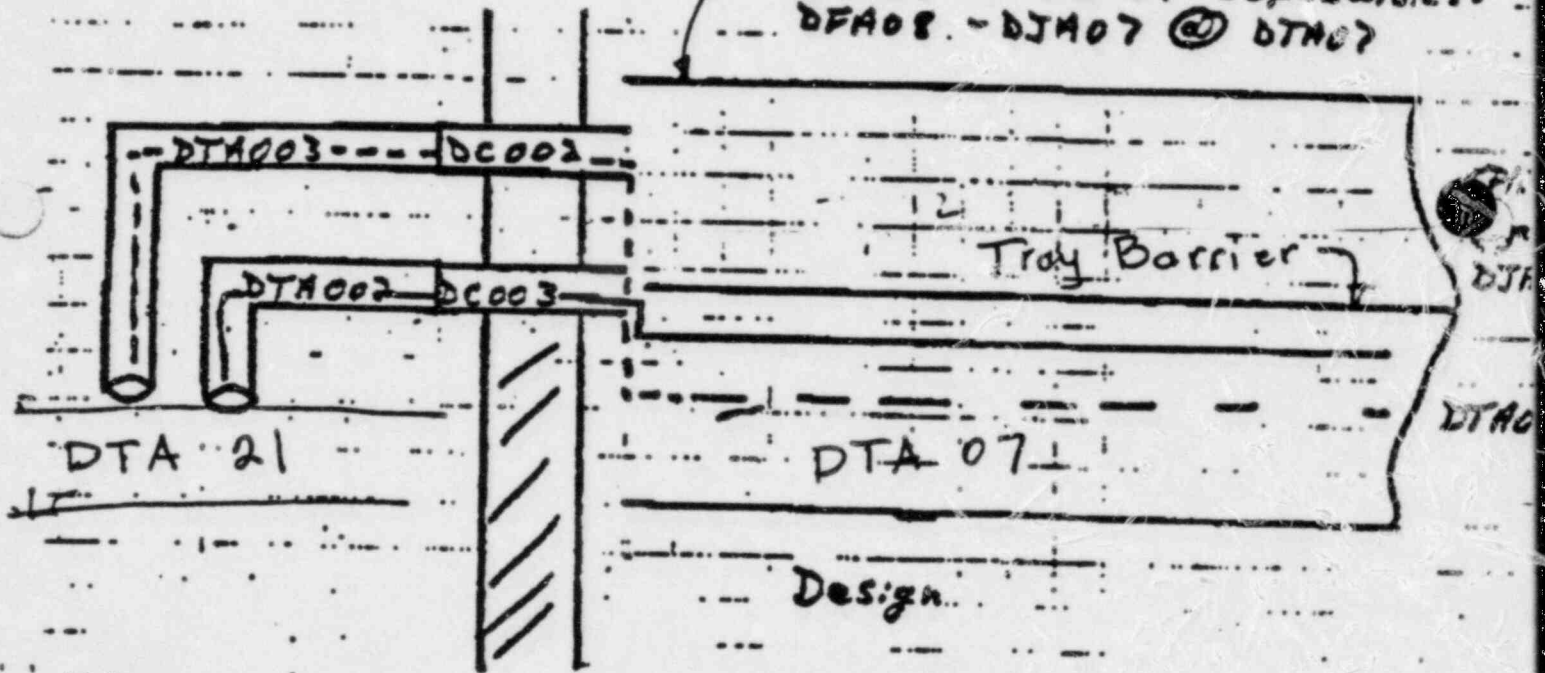
Troy Construction  
CROSS OVER OF SEPARATORS  
DTA08 - DJA07 @ DTA07
