U. S. NUCLEAR REGULATORY COMMISSION
REGION I

Report No. 50-247/82-11

Facility Name: Indian Point Nuclear Generating Station, Unit 2

Inspection Conducted: June 1-4, 1982 and July 14-16, 1982

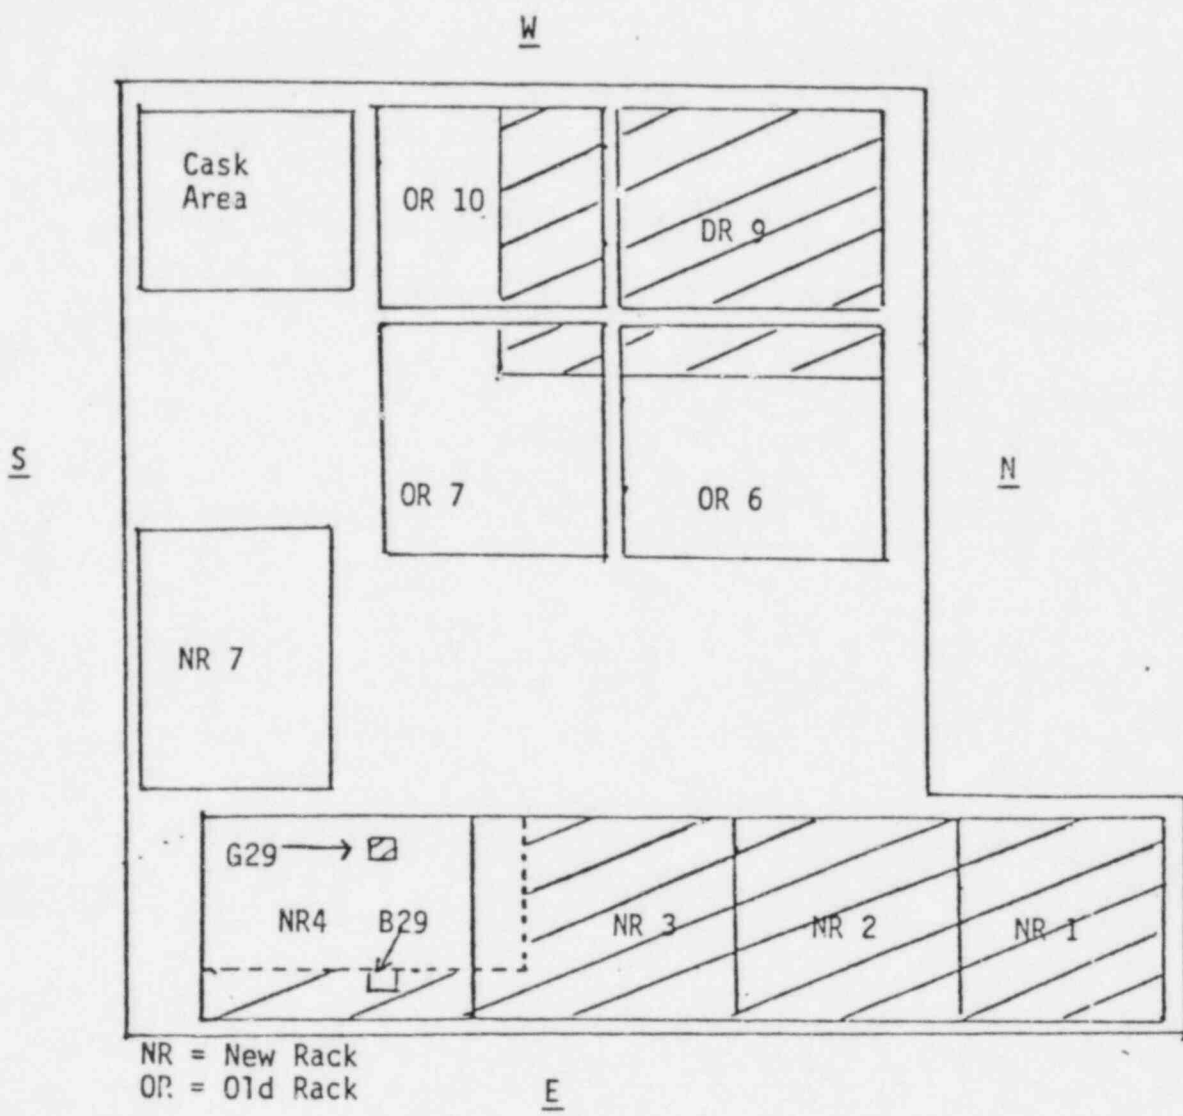
<u>Date and Time*</u>	<u>Event</u>
May 31, 1982	Irradiated fuel assembly D55 was placed in cell G29 (new rack #4), located two to four feet from the position where new rack #7 was scheduled to

Date and Time	Event
May 31, 1982 (continued)	be installed (Figure 1). The licensee later determined that this fuel assembly created radiation fields of 300 to 600 R/hr two to three feet from the northeast corner of rack #7. The shielding effect of the water decreased the radiation field from 600 to 2 R/hr in two feet of pool water (spatial attenuation accounted for a factor of 2 decrease, at most).
June 1, 1982 - 0600	A health physics technician conducted a radiation survey of the spent fuel pool with a Technical Associates CPMU survey instrument in preparation for the installation of new rack #7. The maximum radiation field detected in the dive work area near rack #7 was 1 R/hr.
0800	A Radiation Work Authorization for Radiation Work Permit 5122, reauthorizing the diving operation, was issued.
1000	A second radiation survey of the dive work area was conducted. In this survey, Diver A placed the survey probe at various underwater locations and Diver B, a health physics technician, and a diving supervisor monitored a remote survey meter readout. The maximum exposure rate detected in the dive area was said to be approximately 1 R/hr. The survey results were not recorded.

On May 31, 1982, two operators moved spent fuel assembly D55 into cell G29 in new rack #4 during a fuel shuffle in the spent fuel pool (see Figure 1).

In spite of this effort, a 600 R/hr radiation field two to four feet from the dive work area near the northeast corner of new rack #7 was not detected. The radiation field was not homogeneous, and decreased from 624 R/hr to 2 R/hr over a two foot radial distance from a point one foot west of rack #4. The radiation levels one foot above the pool floor were approximately an order of magnitude less than levels three feet above the floor.

Figure 1. Configuration of spent fuel pool during installation of new fuel rack seven on June 1, 1982. Irradiated fuel is indicated by shaded area.

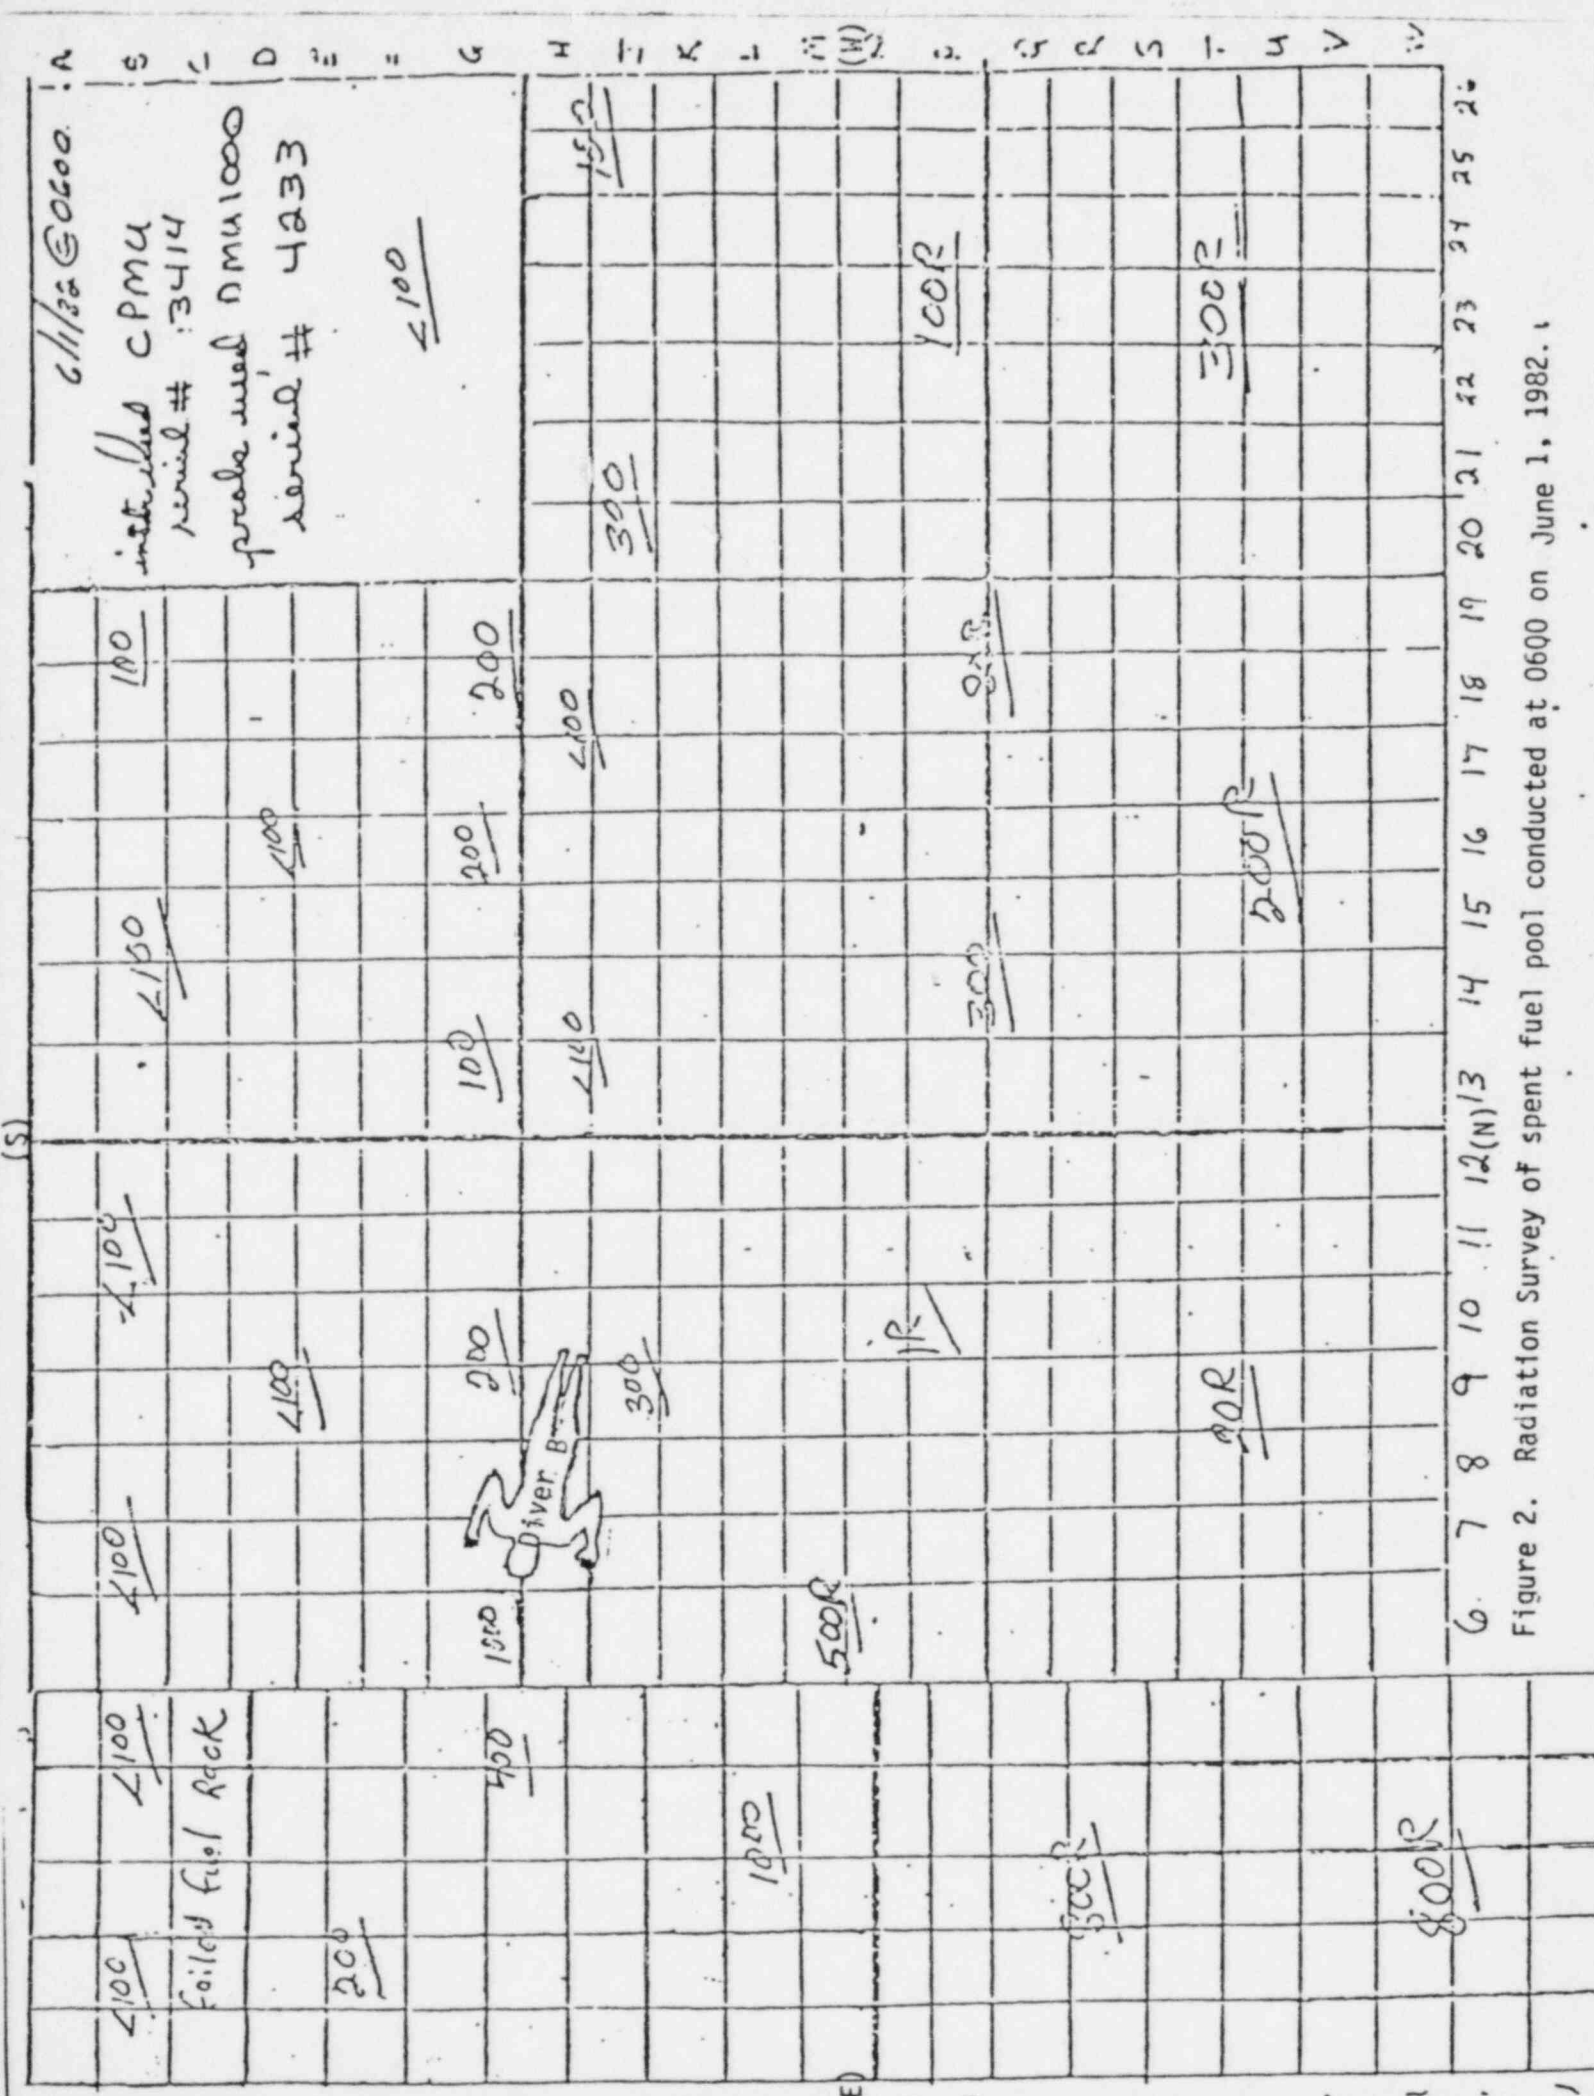
A health physics technician conducted the first pre-dive radiation survey of the spent fuel pool at 0600 on June 1 (Figure 2). The technician stated that prior to the survey, the survey instrument was source checked

The 0600 survey of the spent fuel pool indicates the maximum radiation field in the general dive work area was 1 R/hr (Figure 2). However, the exact location of the 1 R/hr field cannot be determined because the 0600 survey map does not accurately depict the spent fuel pool layout on June 1. The locations of the new fuel racks which were installed in the pool prior to the dive as well as open pool areas where old fuel racks had been removed, are not shown on the 0600 survey map. Additionally, the pool depths corresponding to the survey points and the pool location of the June 1 dive work area are not shown. While the 0600 survey map indicated general pool radiation levels, it was not sufficiently detailed to document survey results for the June 1 dive work area, given the localized nature of radiation fields in the pool. The 0600 survey was subsequently used by a health physics supervisor to document the pool radiation fields for a Radiation Work Authorization covering the June 1 diving operations.

The technician who conducted the 0600 survey stated that the maximum radiation field in the dive work area, 1 R/hr, was detected just west of new rack #4, three feet above the pool floor. He stated that this field was in the general area of, but not adjacent to, fuel assembly D55. The technician said he saw the D55 fuel assembly in new rack #4 as his utility light passed over the rack cell during the 0600 survey. He said he reported the assembly to his supervisor and to two diving contractor supervisors, prior to the day's dives. The technician further stated that he did not survey the D55 fuel assembly or record its presence on the 0600 survey because he felt the appropriate supervisors had been notified.

Figure 2. Radiation Survey of spent fuel pool conducted at 0600 on June 1, 1982.
