Subject: Dresden Station Units 2 and 3
 Quad Cities Station Units 1 and 2
 Reports Associated With NUREG 0619,
 "BWR Feedwater Nozzle and CRD Return
 Line Nozzle Cracking"
NRC Docket Nos. 50-237/249 and 509-254/265

Subject: Dresden Station Units 2 and 3
Quad Cities Station Units 1 and 2
Implementation of NUREG 0619
Concerning BWR Feedwater and CRD
Return Line Nozzle Cracking
NRC Docket Nos. 50-237/249 and
50-254/265

Subject: Dresden Station Unit 2
Feedwater Nozzle/Sparger and
Control Rod Drive Return Line
Nozzle Inspection Programs
NRC Docket No. 50-237

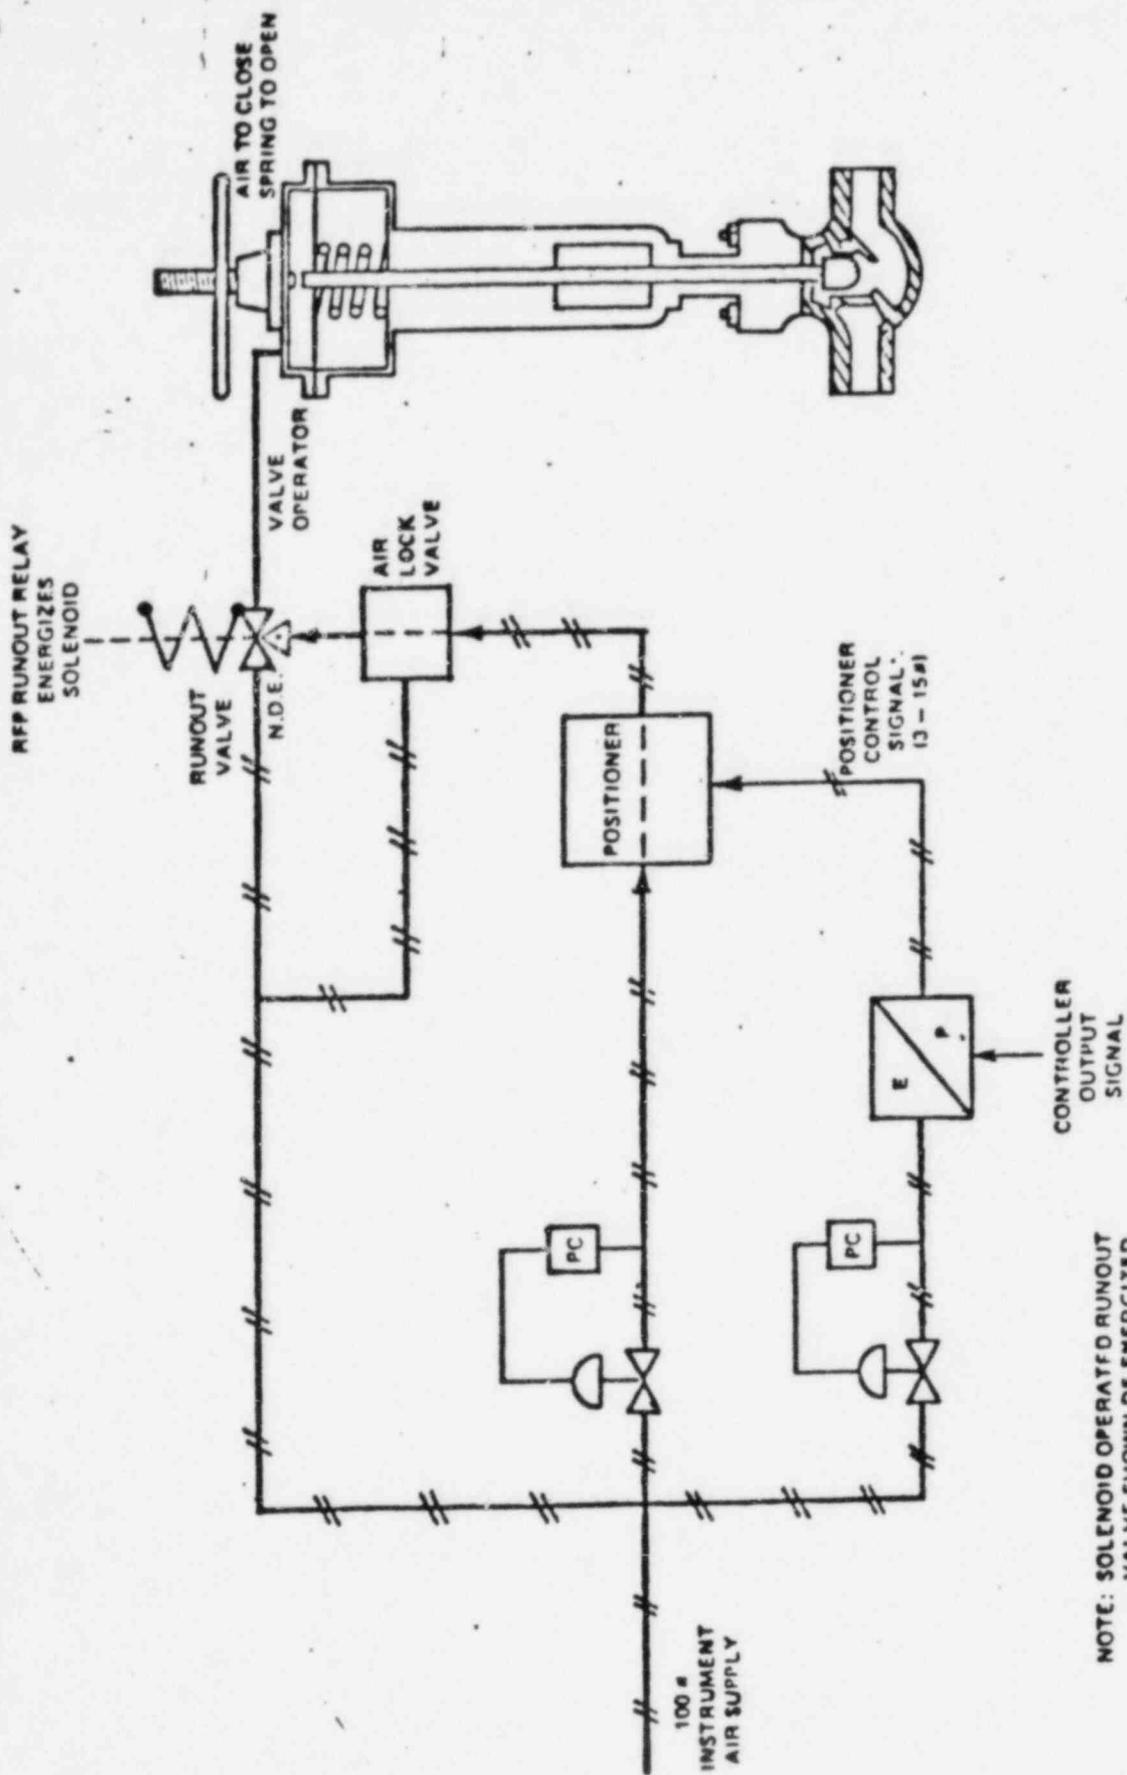
Figure 1. Feedwater Regulating Bypass Valve Control System

The bypass valve is an air operated, globe type valve which is controlled by the single element control system illustrated schematically in Figure 1. The control system opens or closes the valve gradually in response to an electric input signal which is proportional to the difference between reactor water level and the desired level set point.

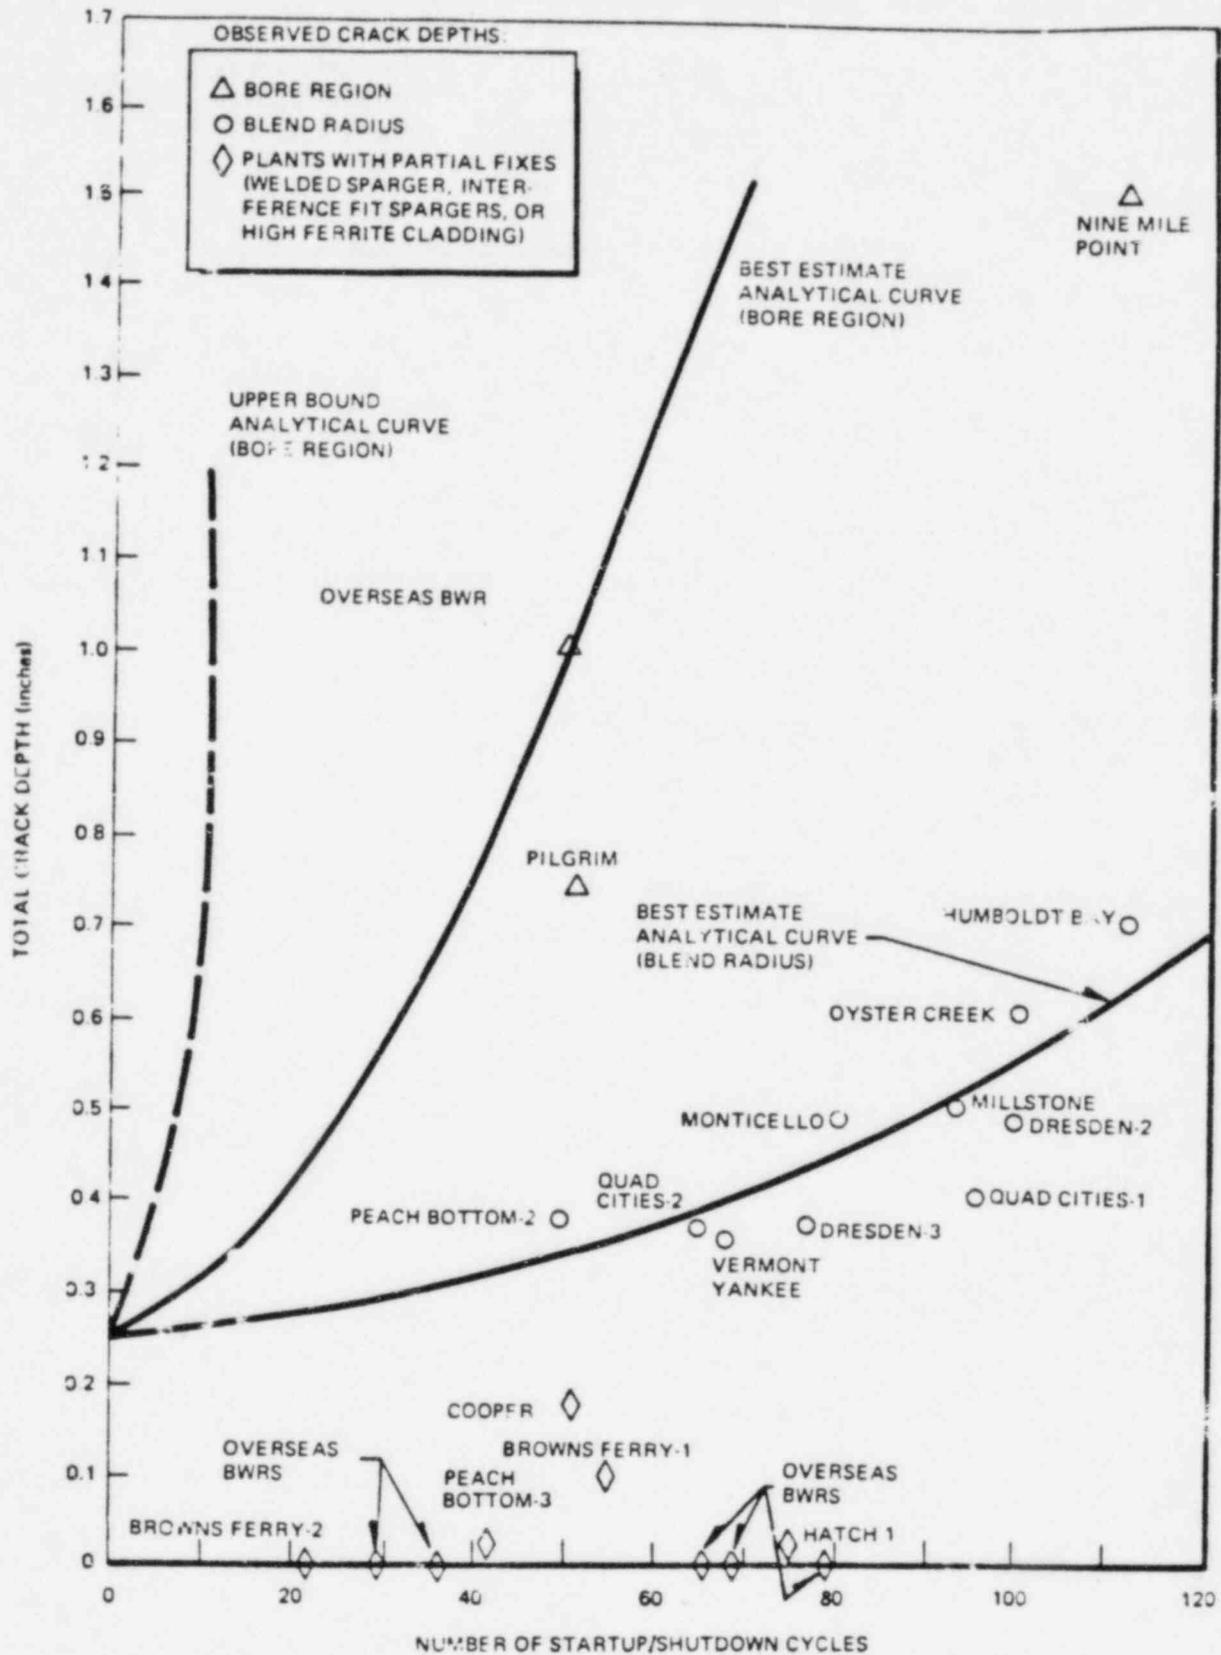
Experience accumulated with the new interference fit sparger, however, has pointed out the conservatism even in the CECO. crack growth curves. Figure 1 contains data accumulated by General Electric on crack depth for up to 75 SU/SD cycles with the interference sparger in use. A curve established using the G.E. generic SU/SD cycle is compared to this actual interference fit data. It can be seen that the worst case of the 10 units with the interference fit sparger has a maximum crack depth of 0.2", with only one other unit having a maximum crack depth of 0.1". The remaining eight units, however, had maximum crack depths that were much smaller or nonexistent. The above data points out the effectiveness of the interference fit sparger in eliminating the leakage flow which is the mechanism initiating the cracking in the feedwater nozzles.

Previous inspections on Dresden Unit 2 and Quad-Cities Unit 2 have confirmed the above trend for plants with interference fit spargers. As reported above, Dresden 2 had cracks less than 1/16" after 33 SU/SD cycles. During the Spring 1978 refueling outage on Quad-Cities Unit 2, a dye penetrant examination was performed on the accessible areas of three nozzles, and the entire bore and inner radius of the fourth nozzle with the sparger removed. The unit had 44 SU/SD cycles since the original repair and sparger installation, and no linear indications were found. Based on the dye penetrant examination, data accumulated by General Electric for the 10 units and on CECO. data for Quad-Cities Unit 2 and Dresden Unit 2, and considering Dresden 2 will only have approximately 17 SU/SD cycles at the beginning of the refueling outage, it is our contention that no cracks, if any, are deeper than 0.2".
