Subject: Dresden Station Unit 3
Feedwater Nozzle/Sparger and
CRD Return Line Nozzle
Inspection Programs
NRC Docket No. 50-249

Subject: Quad Cities Station Unit 2
Implementation of NUREG-0619
Control Rod Drive Return
Line Nozzle Inspections
NRC Docket No. 50-265

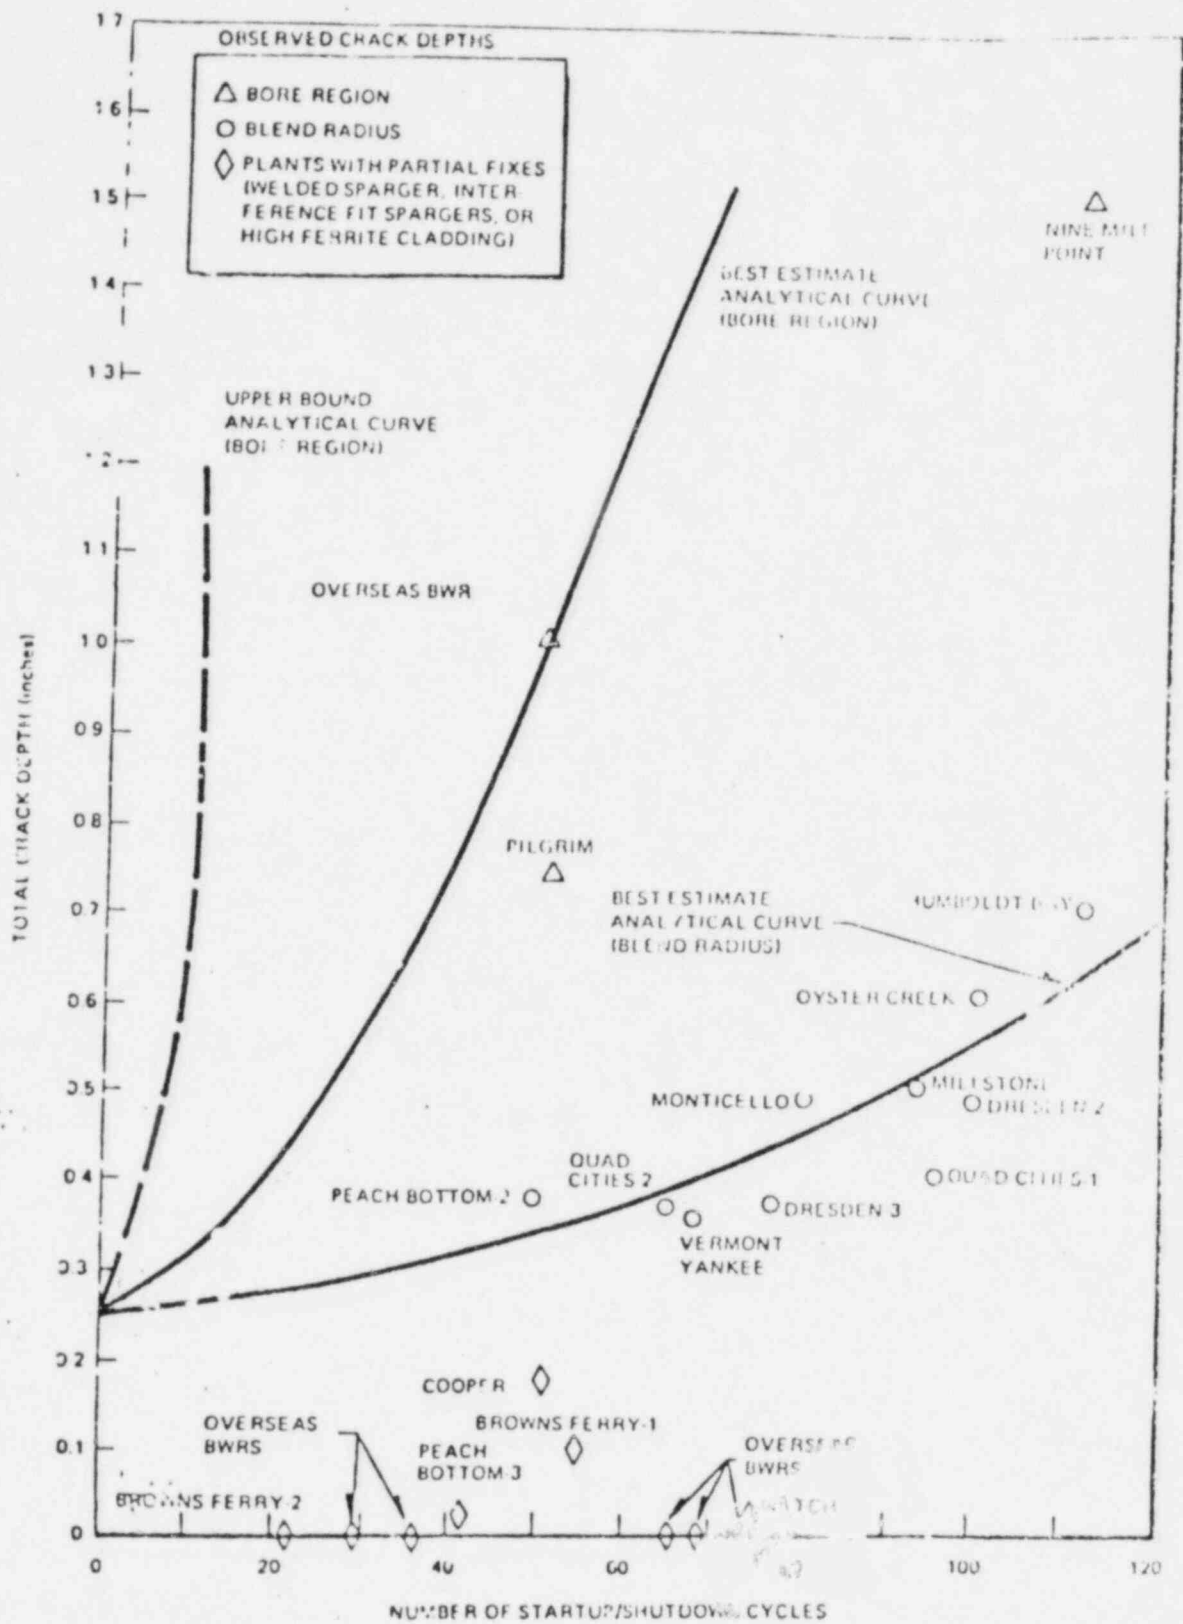
Experience accumulated with the new interference fit sparger, however, has pointed out the conservatism even in the CECo. crack growth curves. Figure 1 contains data accumulated by General Electric on crack depth for up to 75 SU/SD cycles with the interference sparger in use. A curve established using the G.E. generic SU/SD cycle is compared to this actual interference fit data. It can be seen that the worst case of the 10 units with the interference fit sparger has a maximum crack depth of 0.2", with only one other unit having a maximum crack depth of 0.1". The remaining eight units, however, had maximum crack depths that were much smaller or nonexistent. The above data points out the effectiveness of the interference fit sparger in eliminating the leakage flow which is the mechanism initiating the cracking in the feedwater nozzles.
