NEW ENGLAND POWER COMPANY  
HARRIMAN DAM IMPROVEMENT PROJECT  
FINAL REPORT  
MARCH, 1982

SUBJECT: Engineering Report for  
Harriman Dam Improvement Project

# HARRIMAN DAM IMPROVEMENT PROJECT

## ENGINEERING REPORT

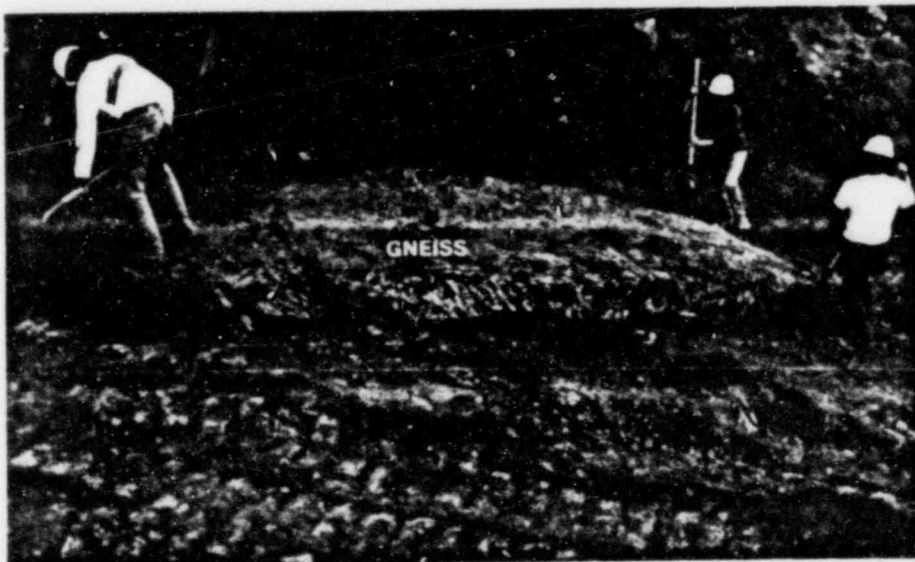
Along the left abutment between elevations 1245.0 and 1330.0, bedrock was exposed. Special care was exercised to clean the bedrock of all muck and loose or weathered rock. Photo 5 shows the results of bedrock cleaning. Bedrock cleaning involved hand work and air jetting. Before earth fill was placed on the bedrock NEPSCO/MAIN personnel inspected the abutment for complete and proper cleaning.

PHOTO 5  
LEFT ABUTMENT  
BEDROCK CLEANING  
AT EL. 1250 (9-5-81)

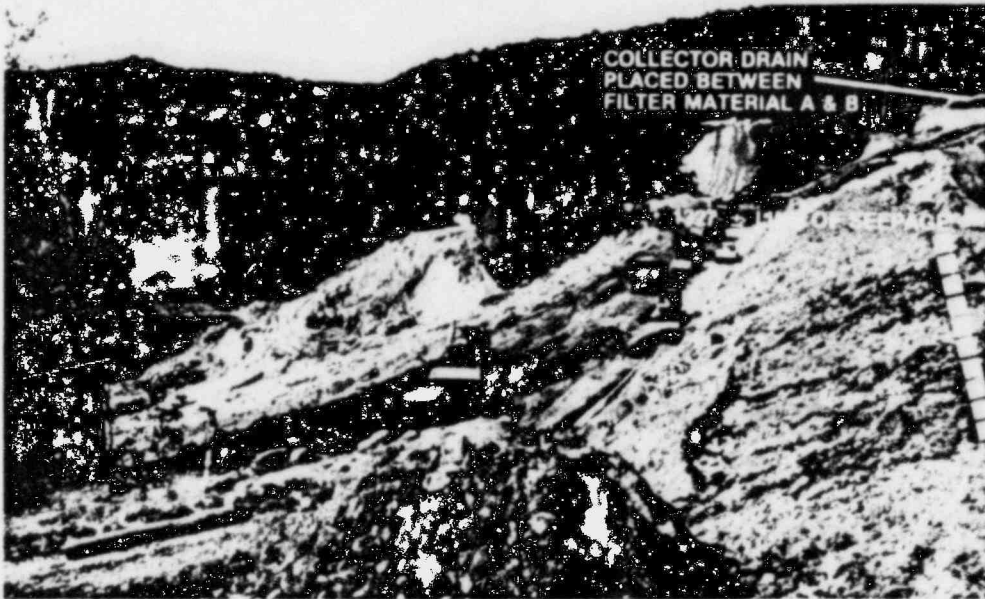
and were especially evident along the toe of the embankment between stations 3+50 and 7+00. There was one line of seepage on the embankment slope between stations 11+00 and 12+50 and elevations 1325.0 and 1328.0. Photo 7 shows the result of this line of seepage flowing down the exposed subgrade, it should be noted that the quantities are minimal. This line of seepage was recognized in 1979, when a NEPSCO/MAIN effort installed a french drain to collect a portion of this seepage for measurement.

PHOTO 7  
OVERLAY CONSTRUCTION  
AT EL. 1302 (9-30-81)

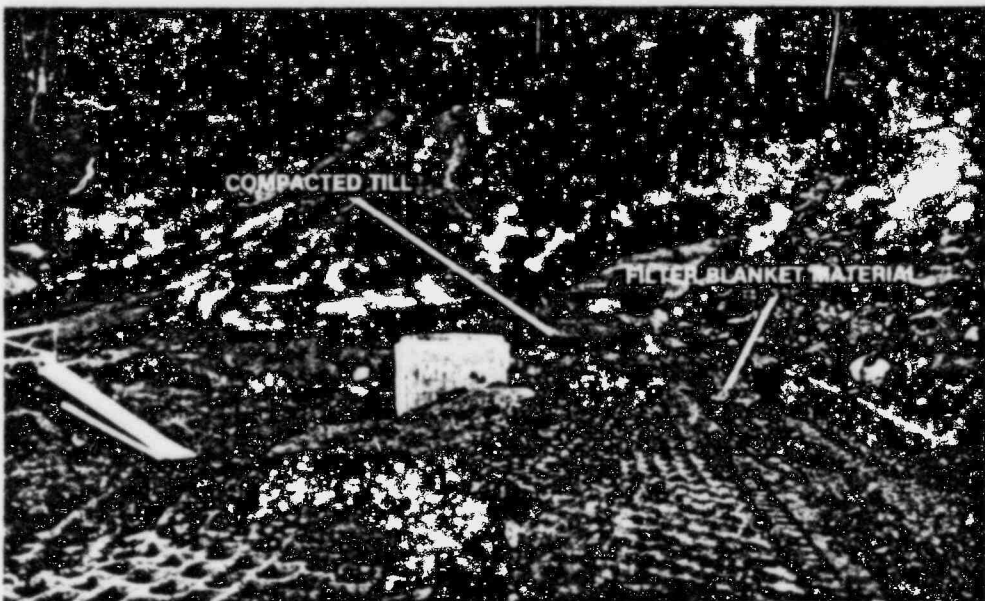
PHOTO 8  
TOE DETAIL BETWEEN  
STATIONS 6+00 AND  
3+50, EL. 1302 (10-9-81)

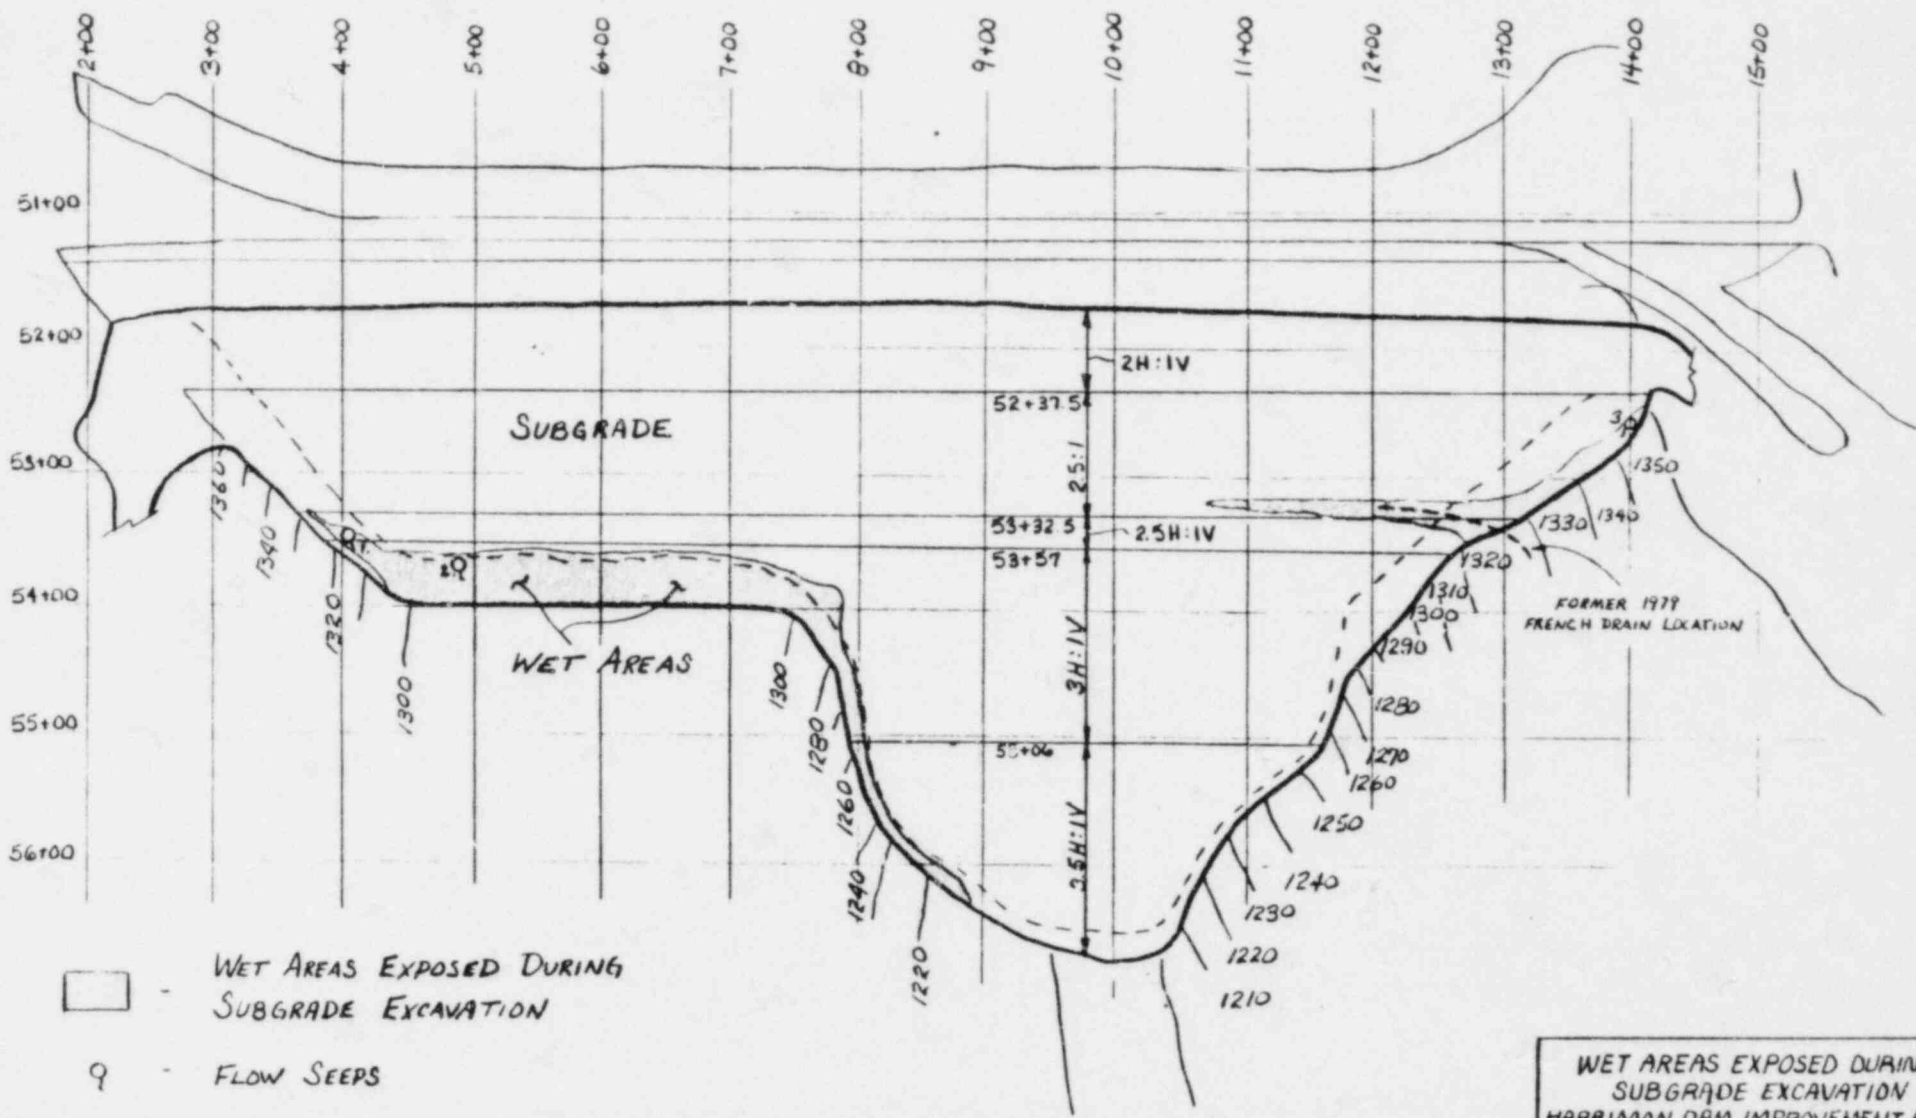
- WET AREAS EXPOSED DURING SUBGRADE EXCAVATION  
Q - FLOW SEEPS

SEEPAGE FLOW EXITING FROM "SWAMP AREA" HARRIMAN DAM IMPROVEMENT PROJECT  
 New England Power Service Company  
 DATE: January 1982  
 SHEET NO. 108 PLAIN  
 1270 7b 13
