Fourth Inspection Report  
of the  
New England Power Company  
Deerfield River Project  
Harriman and Sherman Developments  
Project No. 2323  
June 1982

Inspection and Report  
by  
CHAS. T. MAIN, INC.

SUBJECT: Fourth Inspection Report  
New England Power Company  
Deerfield River Project  
Harriman and Sherman Developments  
Project No. 2323

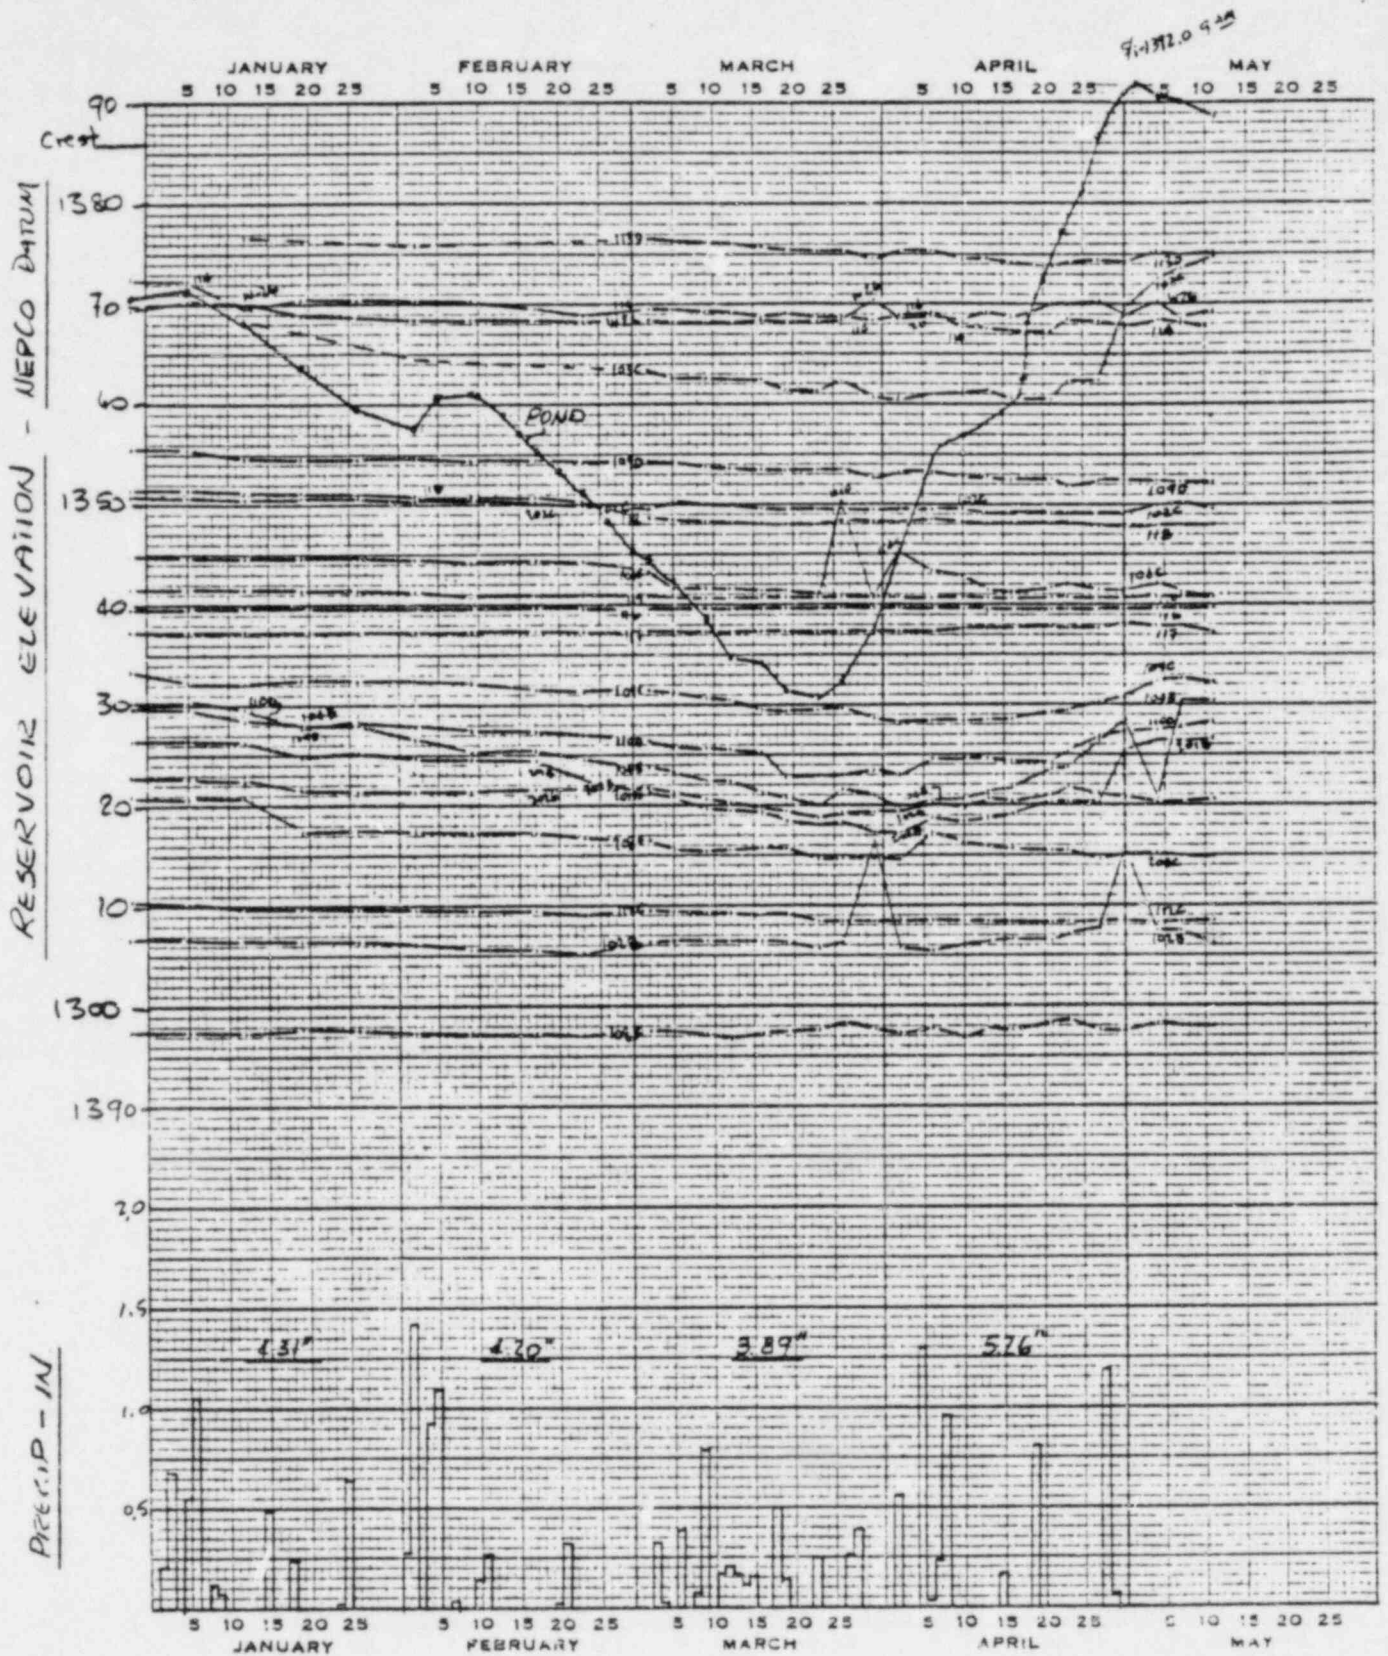
Figure 1  
Critical Piezometer Plots  
Harriman Dam - 1982

Monitoring programs with numerical pore water pressure data began with pneumatic piezometer installation at Harriman in 1979 and Sherman in 1981. Sample plots of this data appear as Figures 1 and 2, respectively.

A complete discussion of the resulting data from these monitoring units is found in the 1982 stability reports for both dams. The piezometer readings and visual observations show no seepage breakout on the downstream dam faces, no total heads above ground surface, and total heads in the dams that result in calculated static safety factors above 1.5 following the 1981 improvements to Harriman Dam.

New surveillance plots will be developed that depict "warning" values for each piezometer to aid in rapid evaluation.

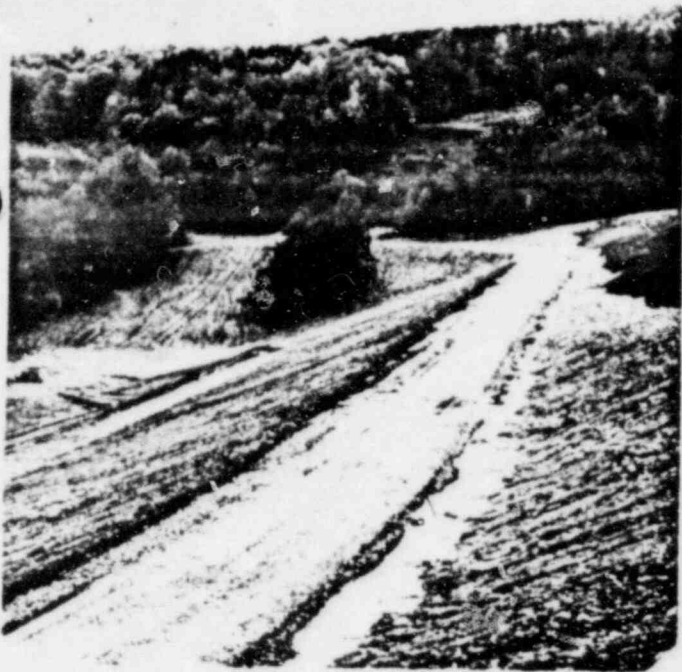
The upstream riprap generally appears in good condition, but grass and brush growth inhibit inspection in some areas. The drainage ditch on top of the new berm needs additional slope modification to permit better surface drainage.

The stability berm added to the downstream slope (along with collector drains, weirs, etc.) has improved both drainage and stability characteristics, though grass surfacing and berm crest drainage maintenance remain to be completed.

Photo No. 1  
View Across Dam at Top of Berm  
Note Minor Erosion and Ponded  
Water, Sediment Collection at Toe  
of Dam. 1981 Modification

- 1) Grading and grassing of new stability berm should be completed and maintained until grass is well established.
- 2) Regrade the drainage ditch on top of the new stability berm to provide gravity drainage.
- 3) Remove grass and brush from upstream riprap to improve visual inspection capability.
- 4) Continue to monitor new piezometers and weirs as an indication of performance.
- 5) Repair concrete spalling at the spillway.
- 6) Repoint brick intake building.
- 7) Closely examine potentially loose rock on slope south of intake and carefully remove or reinforce large blocks that could fall and damage the spillway foot bridge structure.

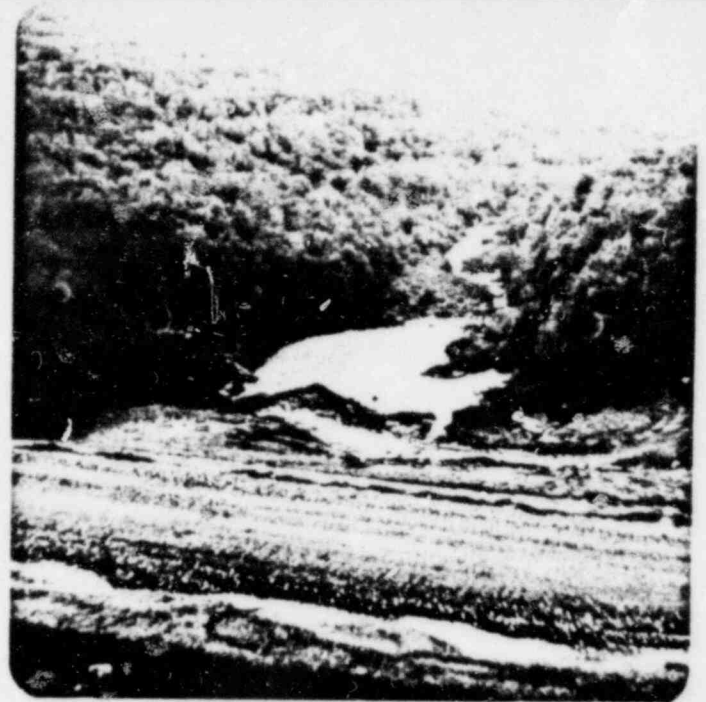
drilling program. There was no apparent crest settlement or alignment changes along the surface. Final cleanup of 1981 construction is underway and the downstream slope of the dam below elevation 1370 was being dressed for seeding and mulching. All underdrain weirs were relatively dry. Some local heavy surface erosion took place along the embankment which was due to rainfall and snow melt during the winter, but this has been redressed. No distress was seen in the overlay.

Photo No. 2  
View of Downstream Slope at Dam  
Centerline. 1981 Modification.  
Note Eroded Material and Cloudy Water  
at Toe of Dam

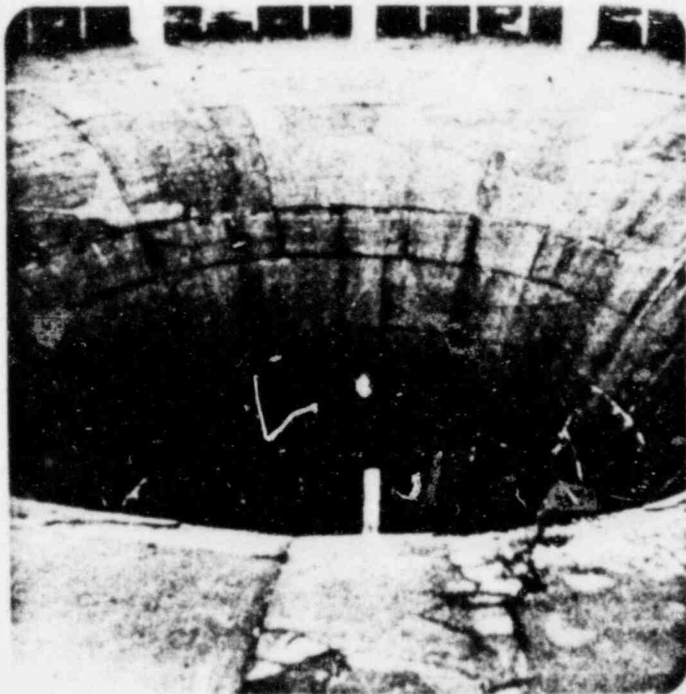
Photo No. 3  
Interior of Glory Hole Spillway  
Note Foundation/Concrete  
Lining Drain Flow

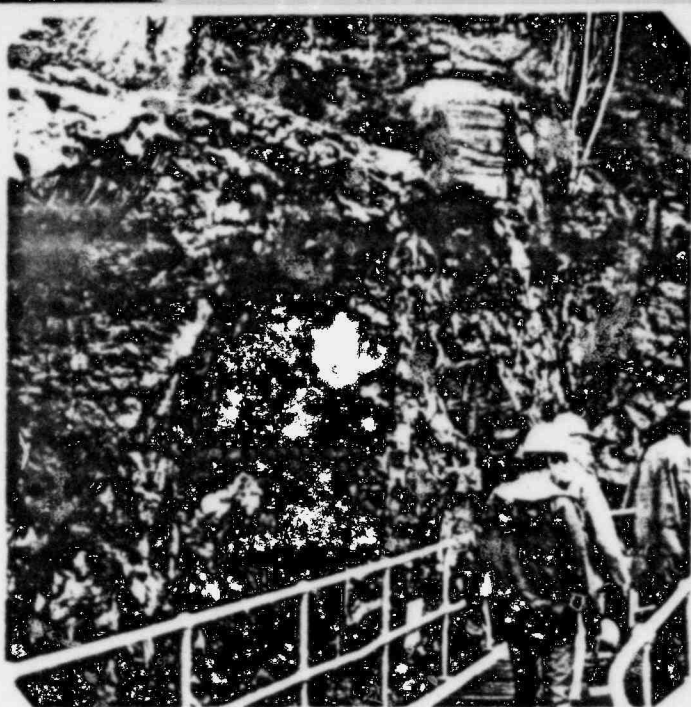
Photo No. 5  
Fractured Rock Face at Intake  
Note Overhang and Jointing

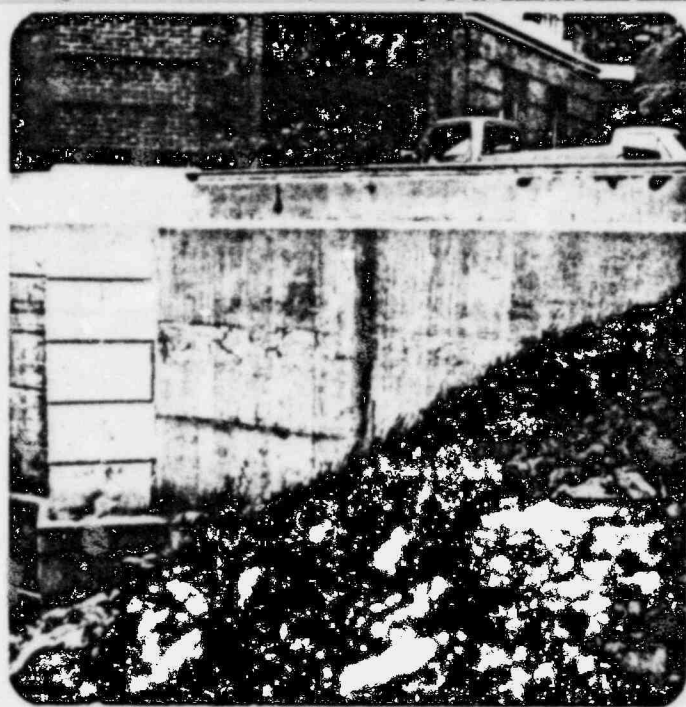
2) Yard Area - The retaining wall on the access road to the powerhouse has significant craze cracking, however, it is not related to project safety. There is some potential to affect access to the powerhouse if this wall becomes distressed. Numerous calcite deposits were seen on the wall.

Photo No. 6  
Retaining Wall Adjacent to Powerhouse  
Note Cracking and Staining

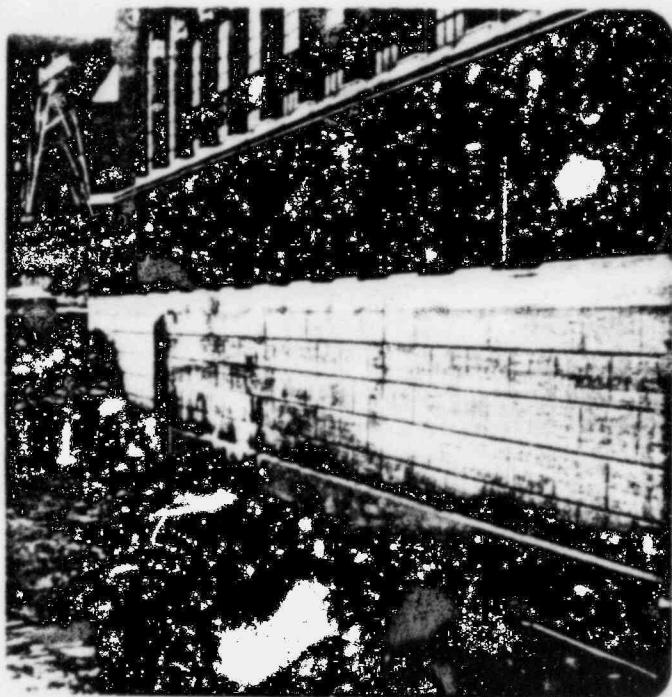
The exterior brickwork remains in excellent condition, while the left downstream lower wall (concrete) has craze cracking on its face. A calcite joint over Unit 3 tailrace shows some concrete deterioration.

Photo No. 7  
Powerhouse Wall Above Draft Tubes  
Note Seepage and Stains

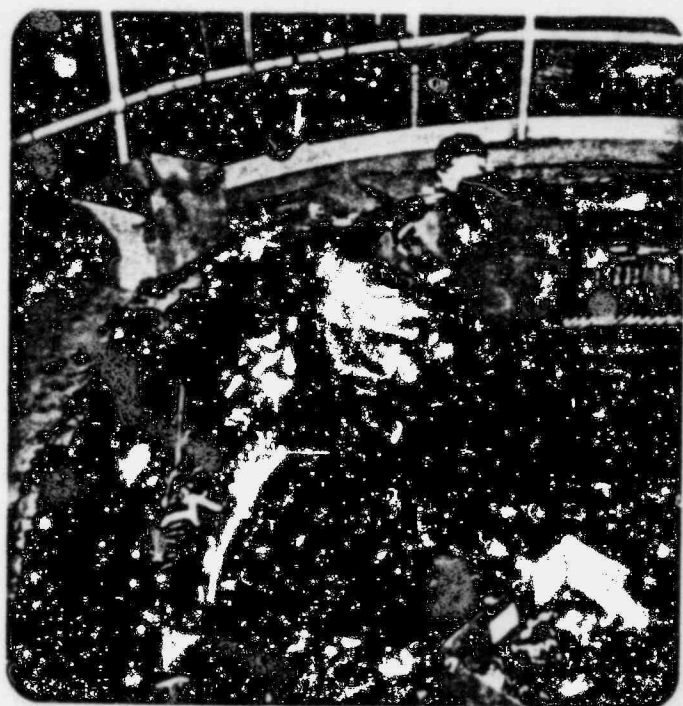
The upstream west corner shows a small amount of seepage. The upstream wall at the generator gallery level shows no cracks or seepage. Unit 1 turbine pit has a diagonal crack in the upstream corner of the barrel. Unit 1 was rewound and restored to service about May 1, 1982, but burned a stator coil in late May.

Photo No. 8  
Unit 1 Generator Stator Under Repair

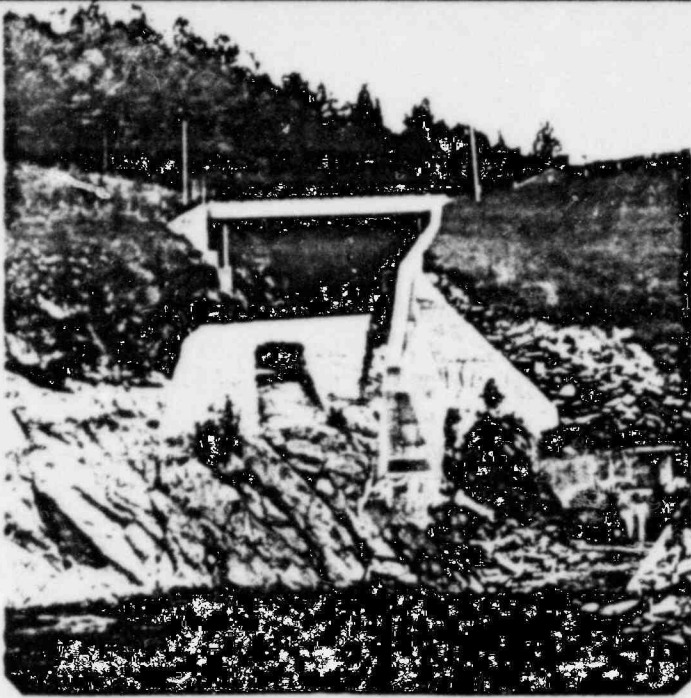
The flashboards on the spillway remain tight, while the mass concrete and lift joints appear in good condition. Rock in the spillway channel, though jointed, appears in generally good condition. Some surficial erosion of the right downstream slope has occurred, but does not present a problem.

Photo No. 1  
Lower Spillway  
Note Rock Jointing

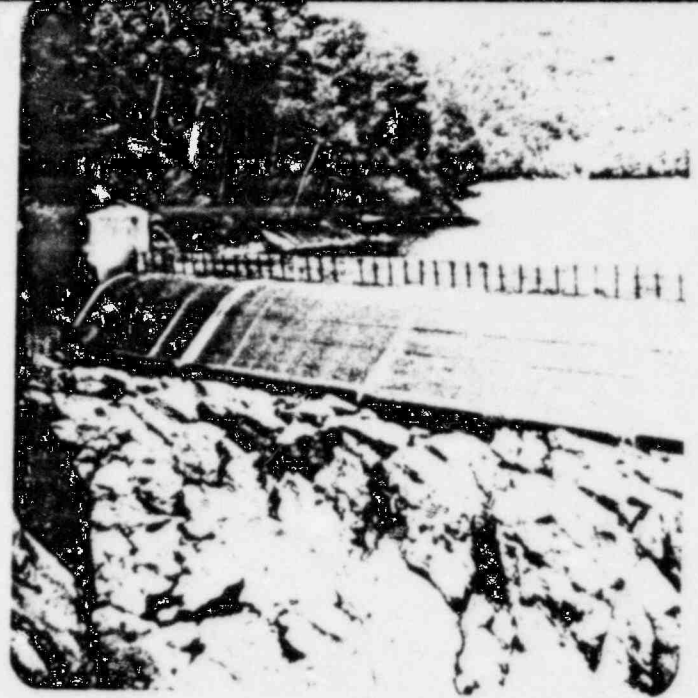
Photo No. 2  
Upper Spillway  
Note Wood Flashboards, Minor Concrete  
Spalling and Rock Jointing

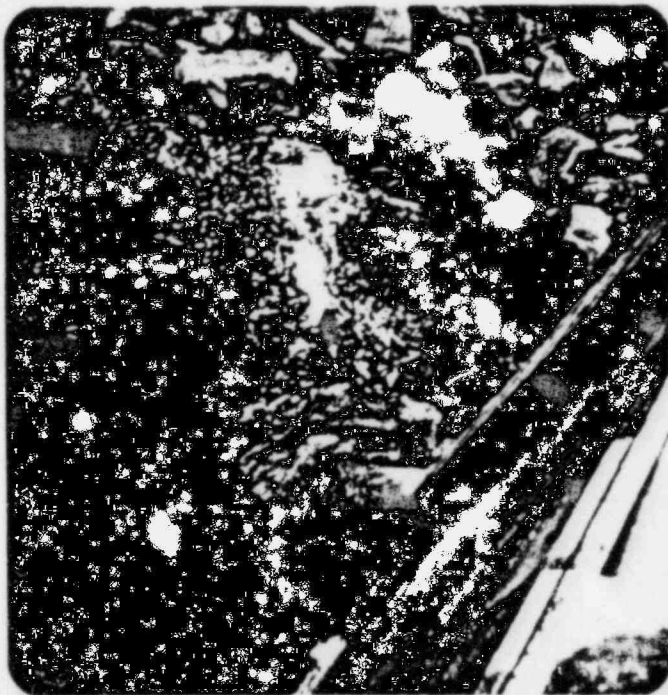
The intake racks are in good condition, and the brick intake house shows no significant deterioration. The concrete cribwall upslope of the intake house does show some deterioration. Concrete training walls below the penstock intake are spalled to a depth of 6 inches, with several rebars exposed on the right wall. Less exposed rebar is seen on the left. This training wall condition is not critical to the wall stability or the intake at this time.

A slight deterioration of the surface of the crest road and some areas of brush and grass overgrowth on the upstream riprap are evident. The concrete cribwall and upstream concrete training walls below the penstock intake show cracking and deterioration that will need attention.

Photo No. 3  
Intake Structure  
Note Deteriorated Concrete  
on Submerged Training Wall

- 1) Remove grass and brush from upstream riprap to improve visual inspection capability.
- 2) Repair deteriorated concrete cribwall and upstream training wall at penstock intake.
- 3) Repair surface of spillway bridge.
- 4) Continue to monitor new piezometers.
- 5) Continue to monitor seep at left abutment, and slope movement and seepage behind the powerhouse.
- 6) Remove a section of grillage to permit interior inspection of the bypass tunnel prior to the next 5 year inspection.

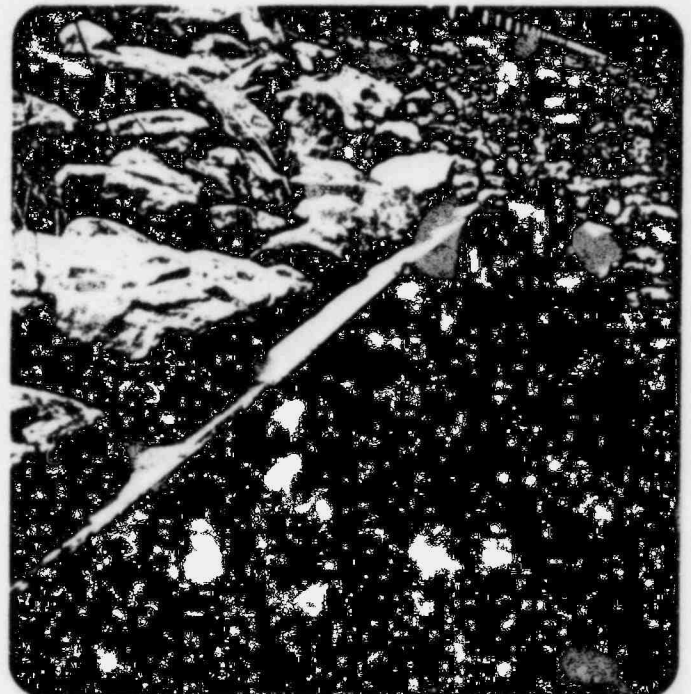
Photo No. 4  
Concrete Crib Wall  
Upslope of Intake  
Valve Chamber

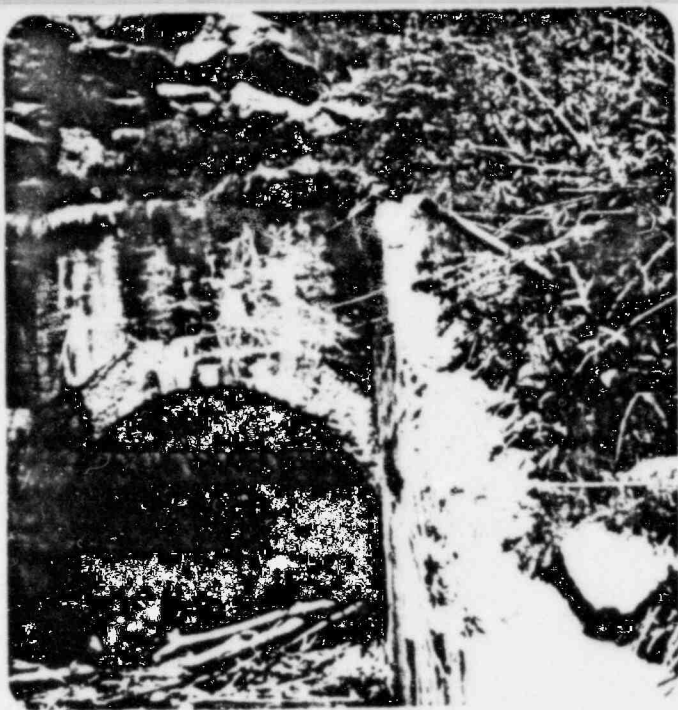
Photo No. 5  
Downstream End of Diversion Tunnel  
Note Deteriorated Concrete, Debris

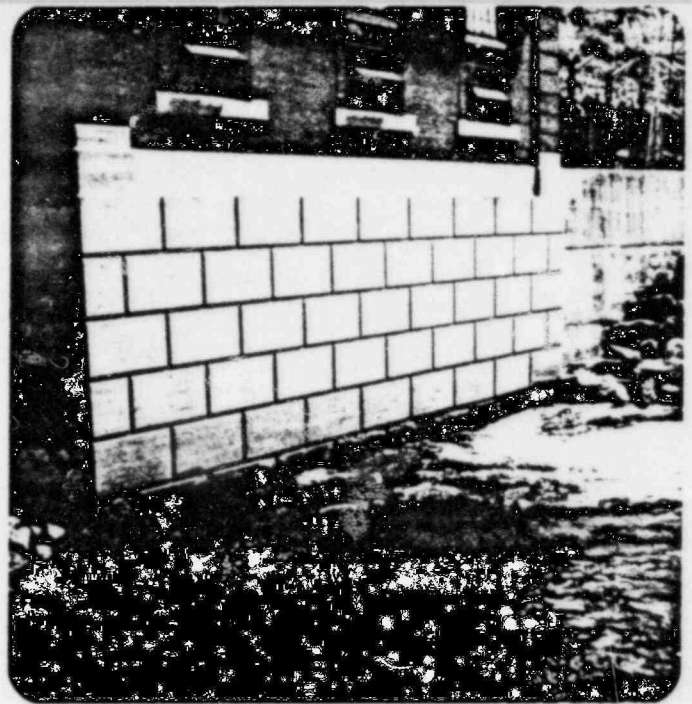
Freeze-thaw distress was observed on the concrete lower powerhouse wall at the waterline. This does not appear serious, but needs continual monitoring.

The powerhouse itself shows no serious adverse conditions. Cracks and seeps in the foundation are minor and do not suggest large differential settlement. Some concrete deterioration appears at and below the waterline above the draft tube exit, though it is not serious and does not have structural consequences.

Photo No. 6  
Face of Powerhouse Over Draft Tubes  
Note Deteriorated Concrete at Water  
Line

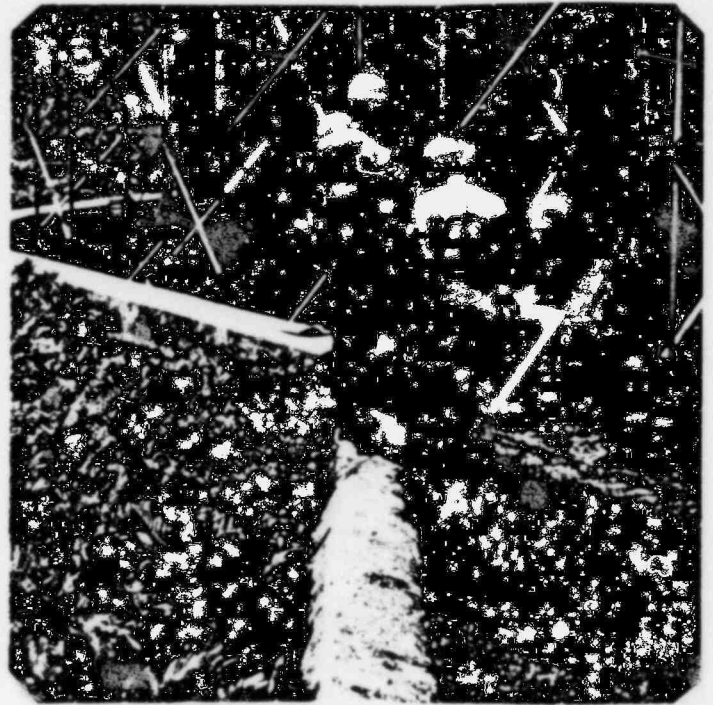
2) Yard Area - Seepage comes off the slope behind the powerhouse and collects at the base of the low retaining wall. The retaining wall shows evidence of slow movement toward the powerhouse. Improving drainage in this area would improve the overall stability of the slope and powerhouse area. The culvert behind the powerhouse continues to flow about 5 gpm (clear water). The drain just behind the powerhouse flows at much less than 1 gpm, also clear.

Seepage breakout does occur on the slope in the rear of the powerhouse and probably contributes to the slow, but continuing movements, of the low concrete retaining wall toward the powerhouse.

Photo No. 8  
View of Retaining Wall Behind Powerhouse  
Note Tilt and Deformation
