SUBJECT: FEDERAL REGISTER NOTICE: ABNORMAL OCCURRENCE - PRESSURE
 TRANSIENTS DURING SHUTDOWN AT A NUCLEAR POWER PLANT

ABNORMAL OCCURRENCE

PRESSURE TRANSIENTS DURING SHUTDOWN

AT A NUCLEAR POWER PLANT

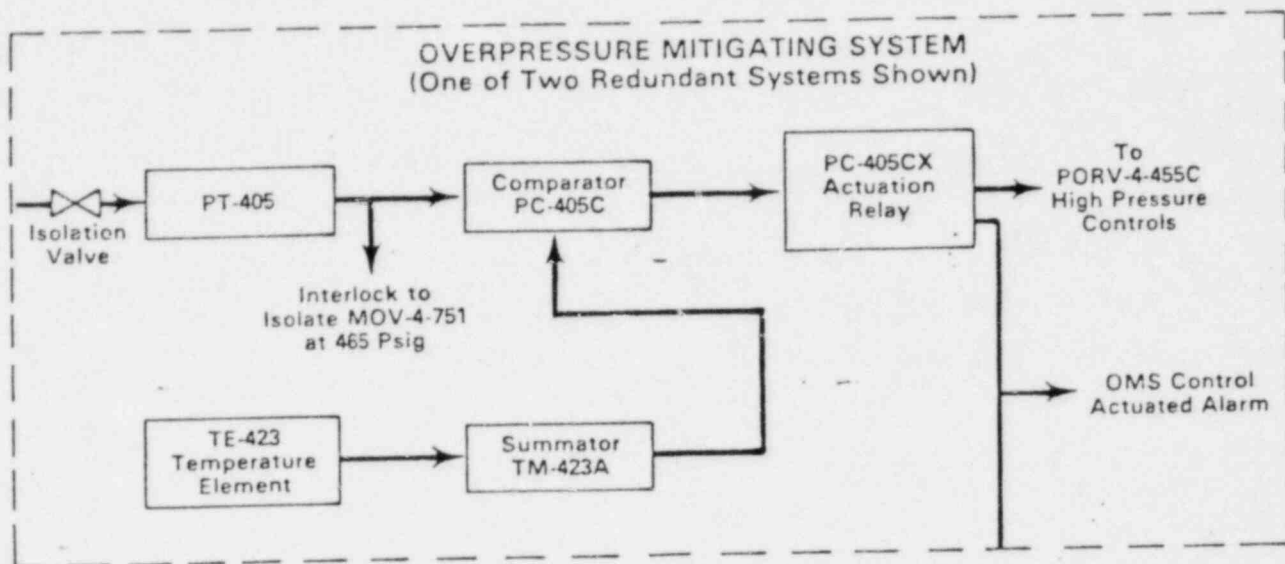
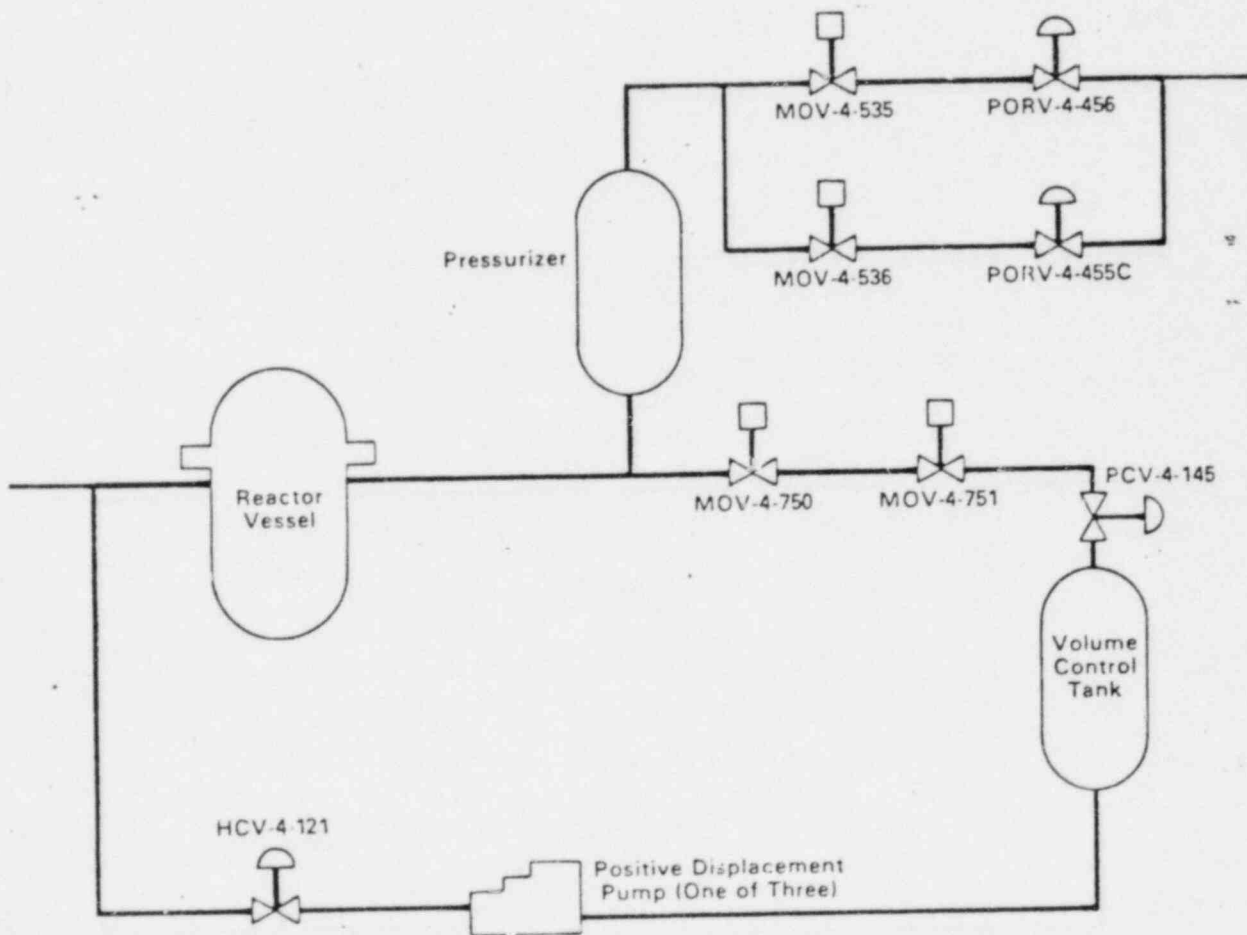
Figure 1. Turkey Point Unit 4 - Schematic of Pressure Control System

With the plant alignment described above, any flow blockage in the letdown path would cause an immediate increase in RCS pressure because the charging pump would be charging into a water solid system. Overpressure mitigating devices installed include an alarm at 400 psig warning of impending overpressure mitigating system (OMS) protective action and two independent OMS channels designed to both alarm and operate power operated relief valves (PORVs) on the pressurizer at 415 psig (at low temperature) and prevent an unacceptable pressure excursion. Figure 1 shows a schematic of the Turkey Point Unit 4 pressure control system, together with a schematic of the overpressure mitigating system.

At the time of the incidents, however, one OMS train was known to be inoperable, i.e., the PORV block valve was shut. Maintenance was being conducted on the high pressure controls for the PORV of that train. Unknown at the time, a blown fuse in the OMS comparator output rendered inoperable the alarm that signals a need for primary OMS protective action at 415 psig. Also unknown at the time, the backup OMS train was inoperable because (1) the root isolation valve for its pressure transmitter, PT-4-405, was shut which rendered the system inoperable during the first event, and (2) the temperature summator for the train had failed high rendering the train inoperable.
