UNITED STATES
NUCLEAR REGULATORY COMMISSION
WASHINGTON, D. C. 20555

AEOD/E119

JUL 22 1981

SUBJECT: LOSS OF RESIDUAL HEAT REMOVAL (RHR) CAPABILITY AT BRUNSWICK
UNITS 1 AND 2

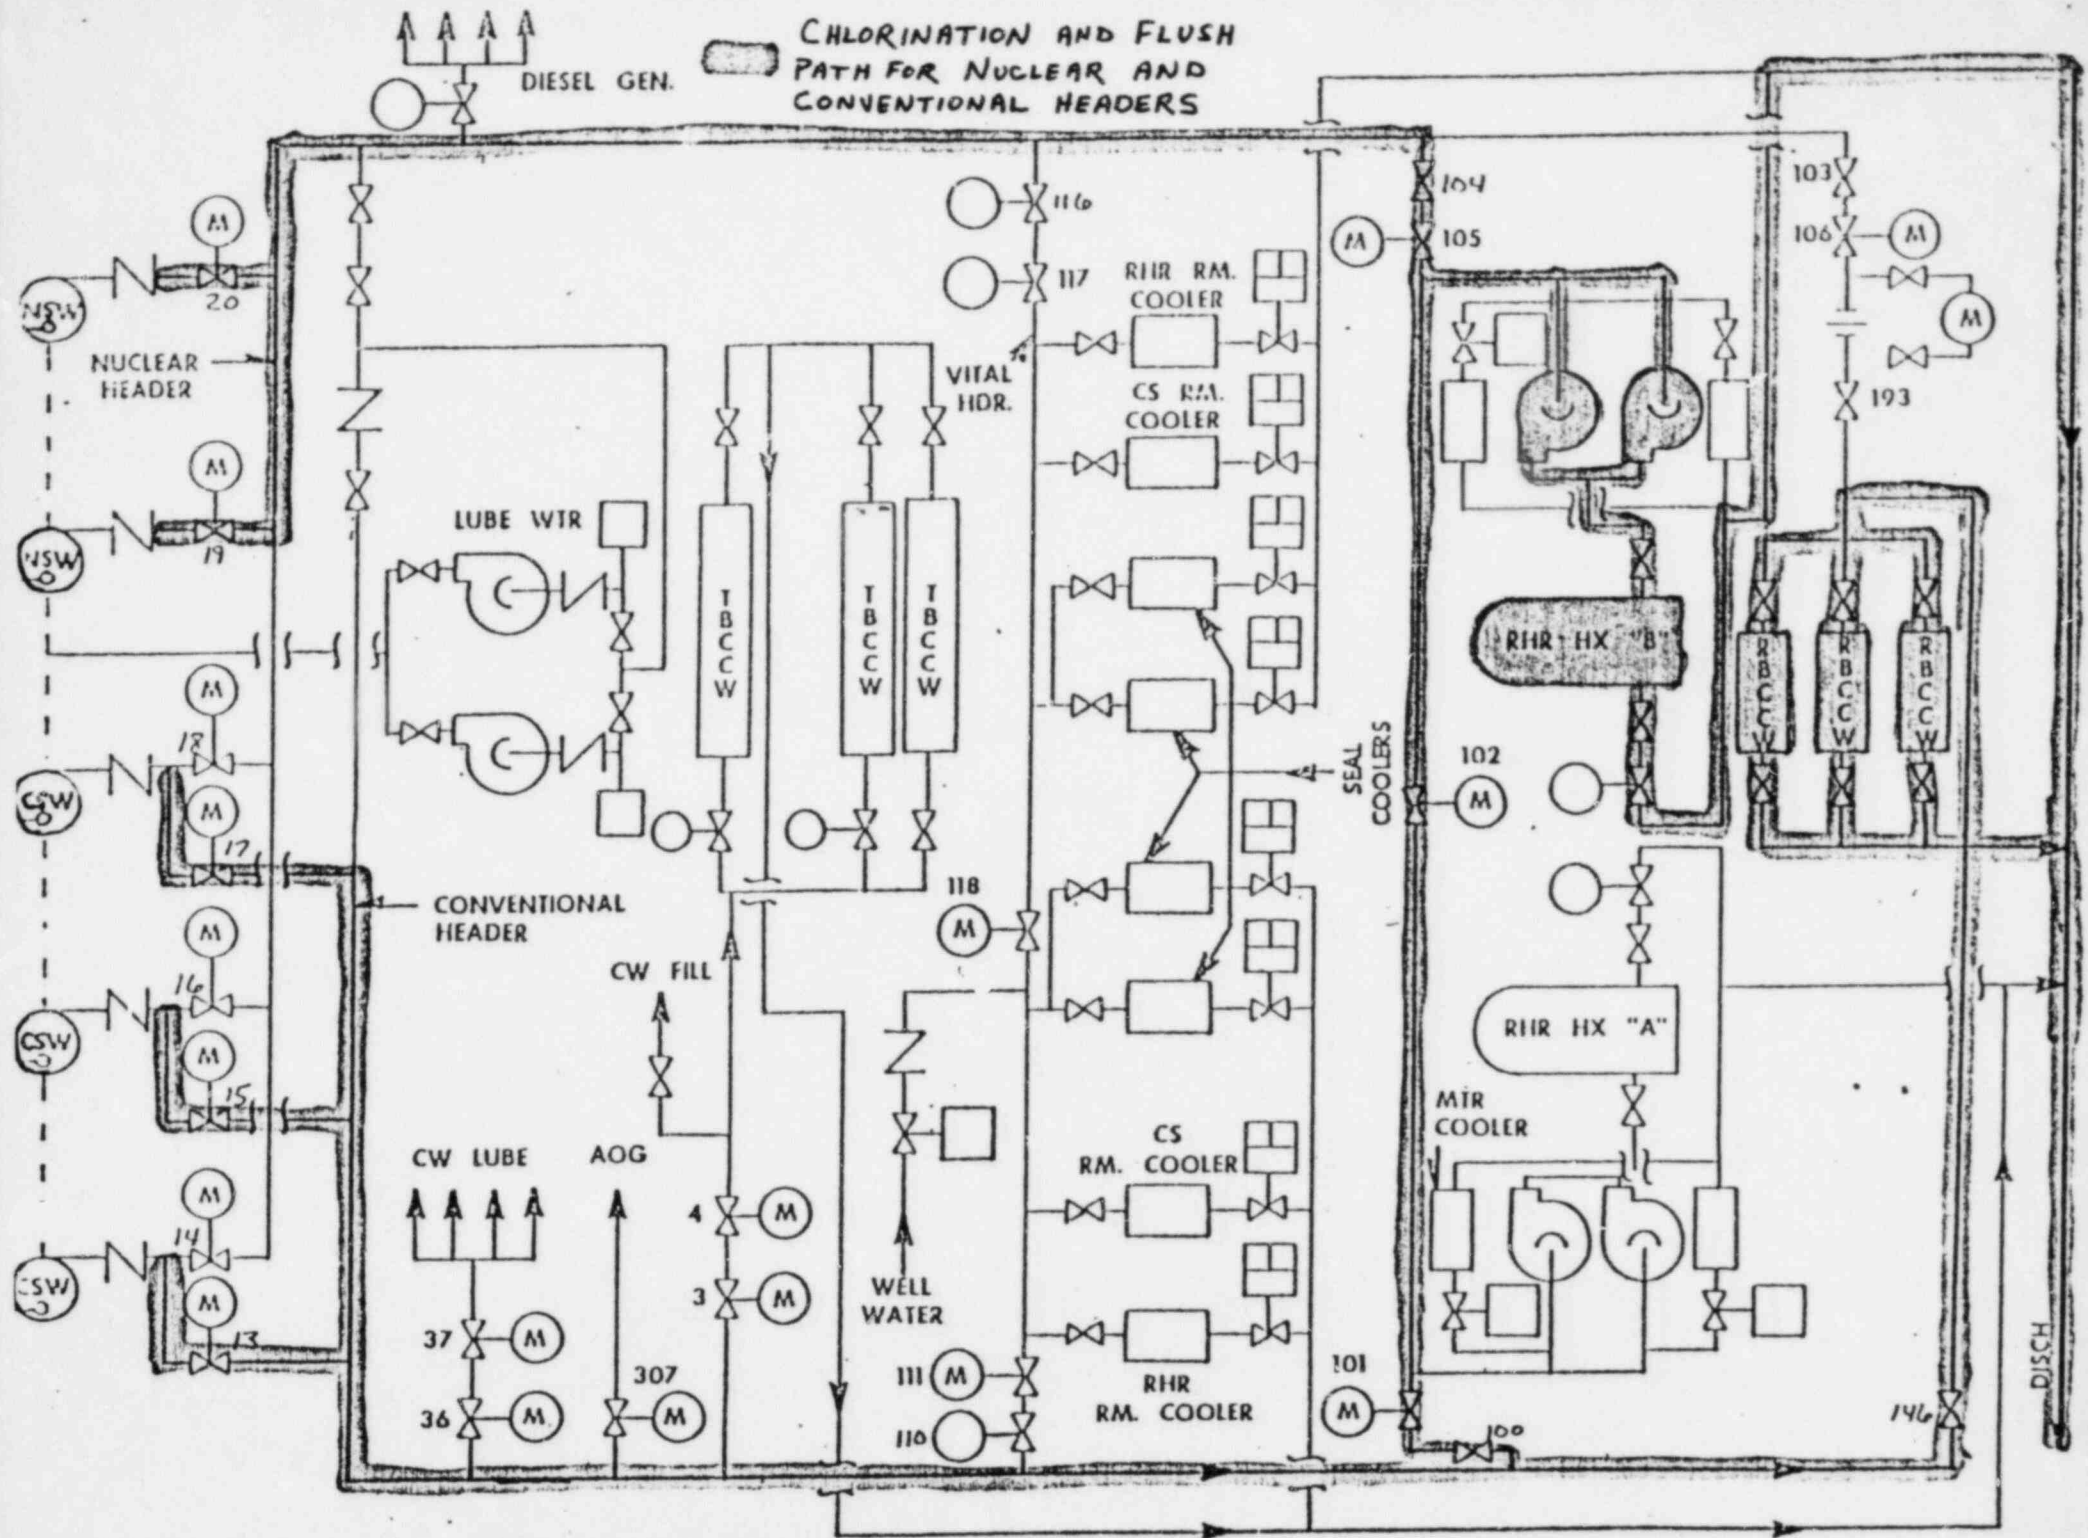
then flushed for 260 hours using the RBCCW HX water boxes as a collection point for shells. Figure 1 shows the chlorination and flush paths for the conventional and nuclear service water headers. Since shells were still found after 260 hours, the licensee concluded that cleaning the system by flushing was ineffective and resorted to mechanical cleaning.

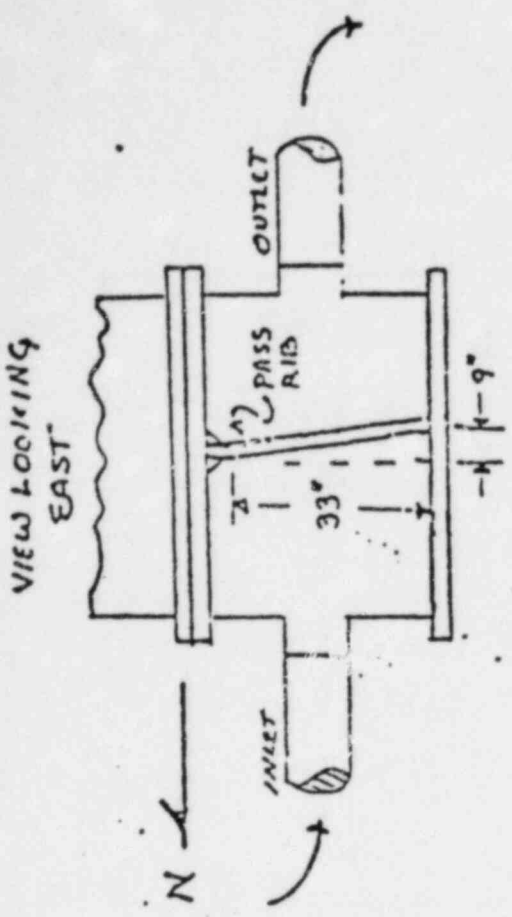
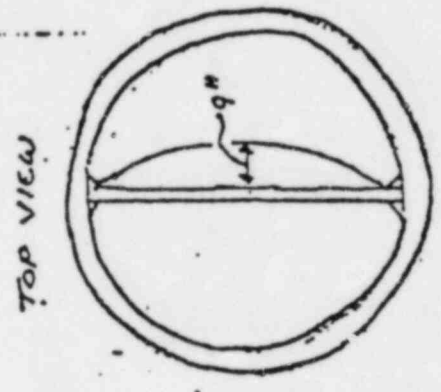
the piping, into the heat exchangers where they gradually accumulated. Eventually, the shells and shell fragments impinged on the tubesheet and were held blocking the tubes by the differential pressure between the inlet and outlet water box. As the number of tubes blocked increased, the differential pressure became greater until ultimately, the baffle plate became displaced.

HX EXHIBITING DEFORMATION (CHANNEL ASSEMBLY)

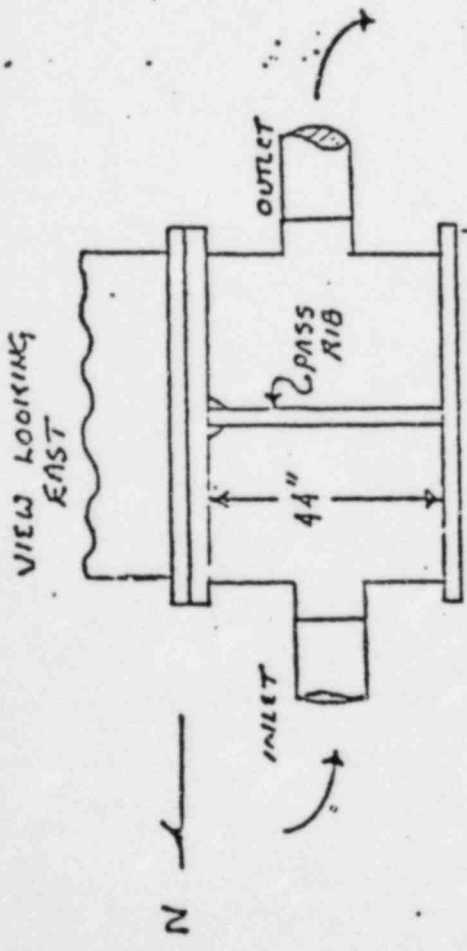
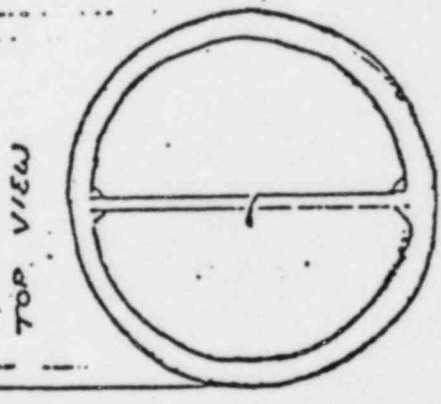
HX NORMAL OPERATION CONFIGURATION (CHANNEL ASSEMBLY)

Following the cleaning operations, the buckled RHR heat exchanger baffle plates were replaced and the heat exchangers were returned to their original design specifications (see Figure 8). Due to the Cu Ni used in these components, neither the welds nor the baffle plates themselves are as strong as in HXs in other plants with carbon steel baffles and water boxes. Figure 7 illustrates the deformation found in the heat exchangers and Table 3 summarizes the work which has been performed.
