INITIAL CONSIDERATION OF THE
POTENTIAL FOR WATER HAMMER IN THE
STEAM CONDENSING MODE OF RHR SYSTEM OPERATION
FOR BWR NUCLEAR PLANTS

Office for Analysis and Evaluation
of Operational Data

March 1981

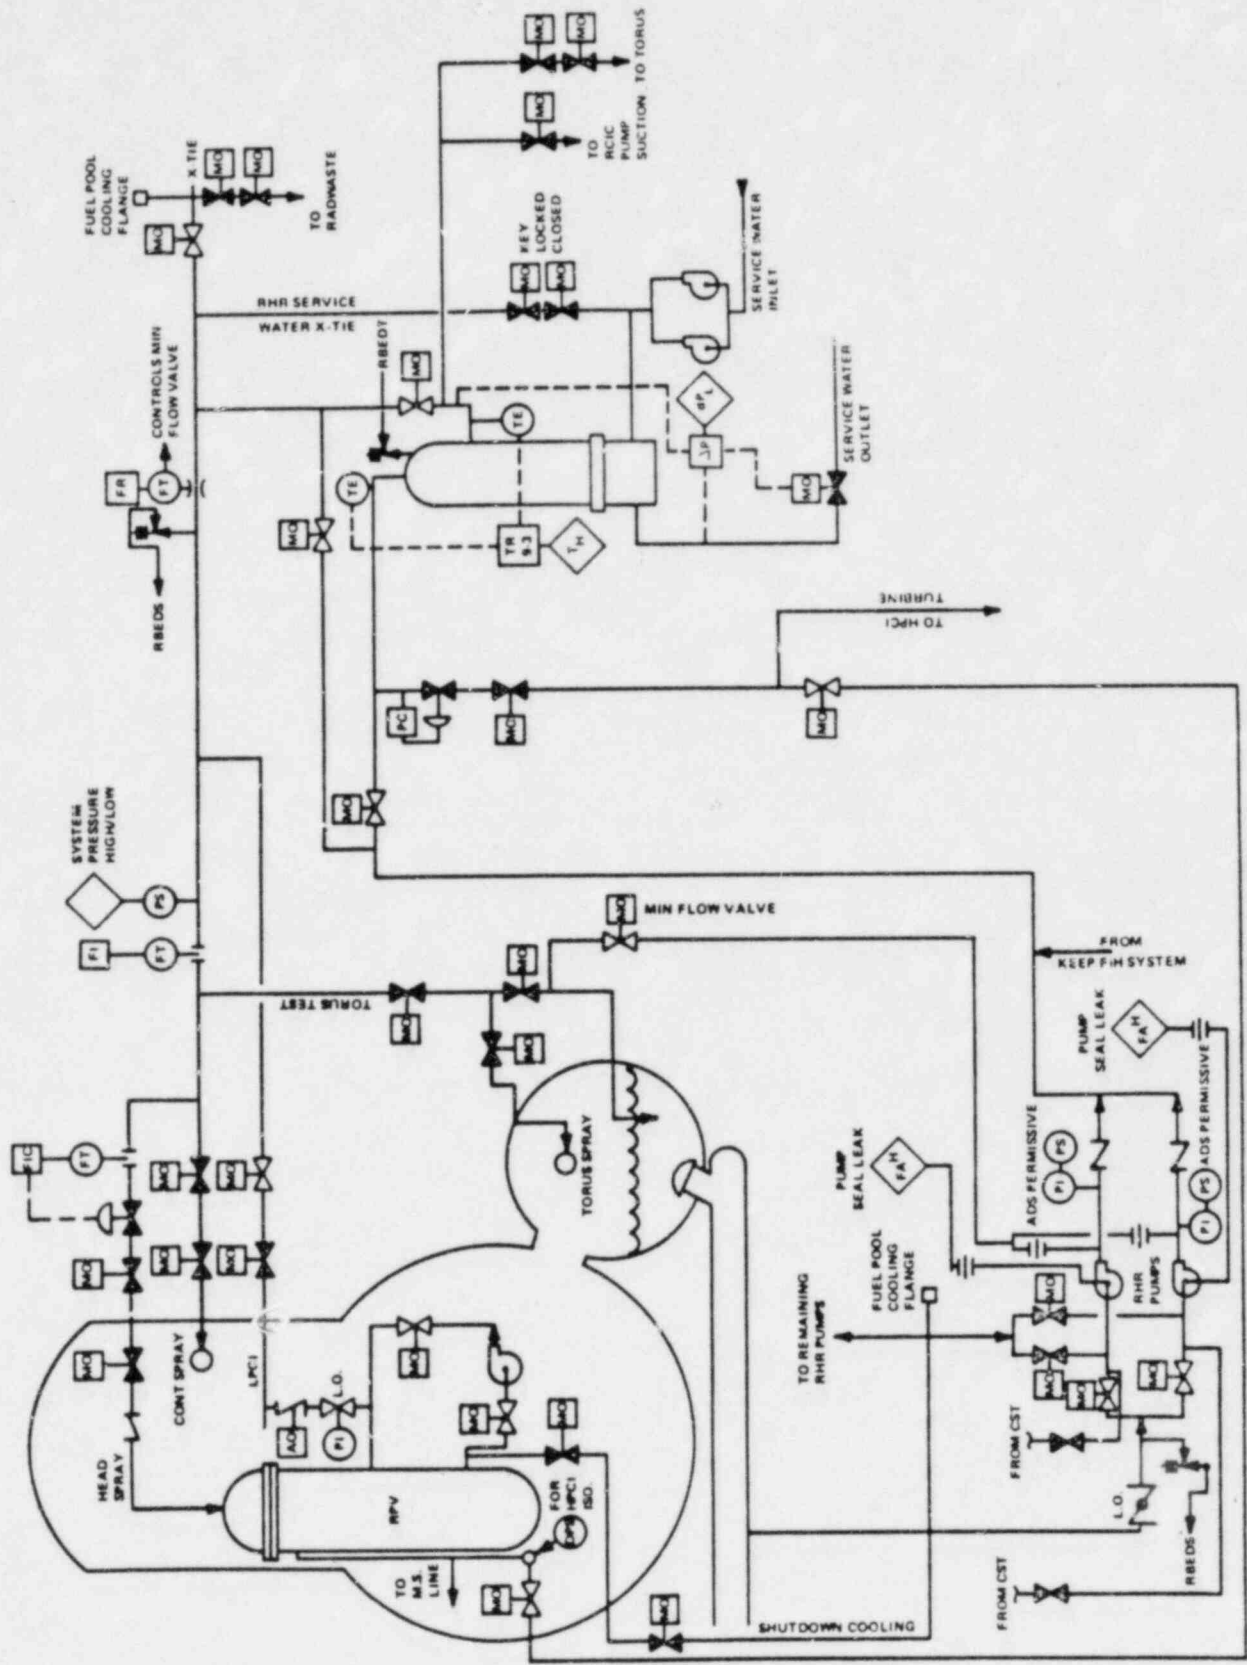
Figure 1 : RHR Functional Drawing With Steam Condensing Mode

The steam condensing mode of RHR system operation (Figure 1) must be manually started as soon as possible after isolation of the primary system from the main condenser. In the steam condensing mode, steam from the reactor is admitted into the RHR heat exchanger shell side where it is condensed by the RHR service water system. The condensate from the heat exchangers returns to the torus by gravity or to the suction of the RCIC pump where it can be returned to the reactor.

When operating the RHR heat exchangers in the steam condensing mode, steam at reactor pressure and temperature is taken from the reactor vessel via a connection from the steam supply line to the HPCI turbine and reduced to 200 psig through a throttling valve before it is admitted to the RHR heat exchanger shell side.
