NORTHERN STATES POWER COMPANY PRAIRIE ISLAND NUCLEAR GENERATING PLANT Docket No. 50-282

LER 82-016/03L-0

Event Description

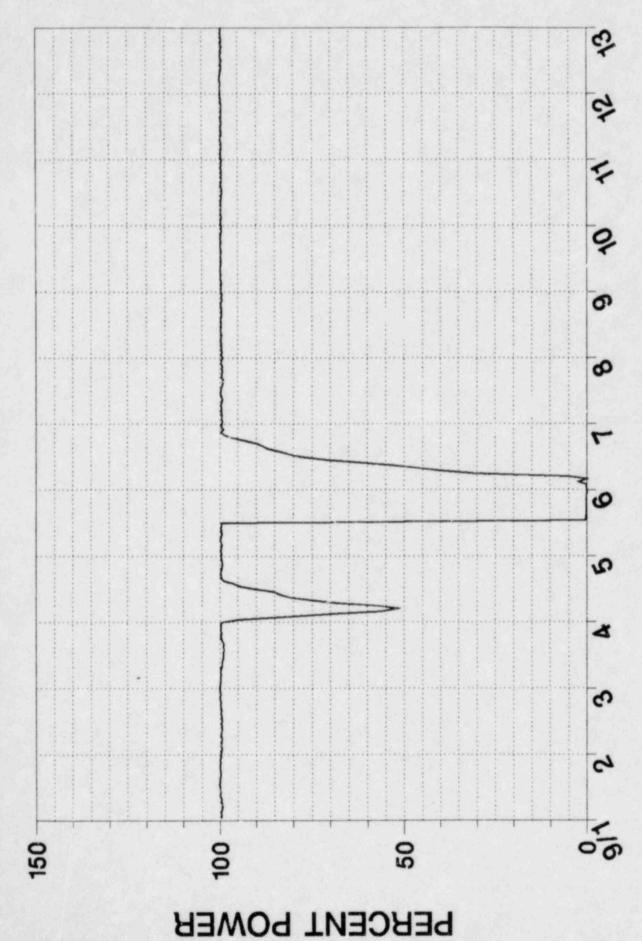
PRAIRIE ISLAND UNIT #1 POWER HISTORY

b. Reactor power history starting 48 hours prior to the first sample in which the limit was exceeded:

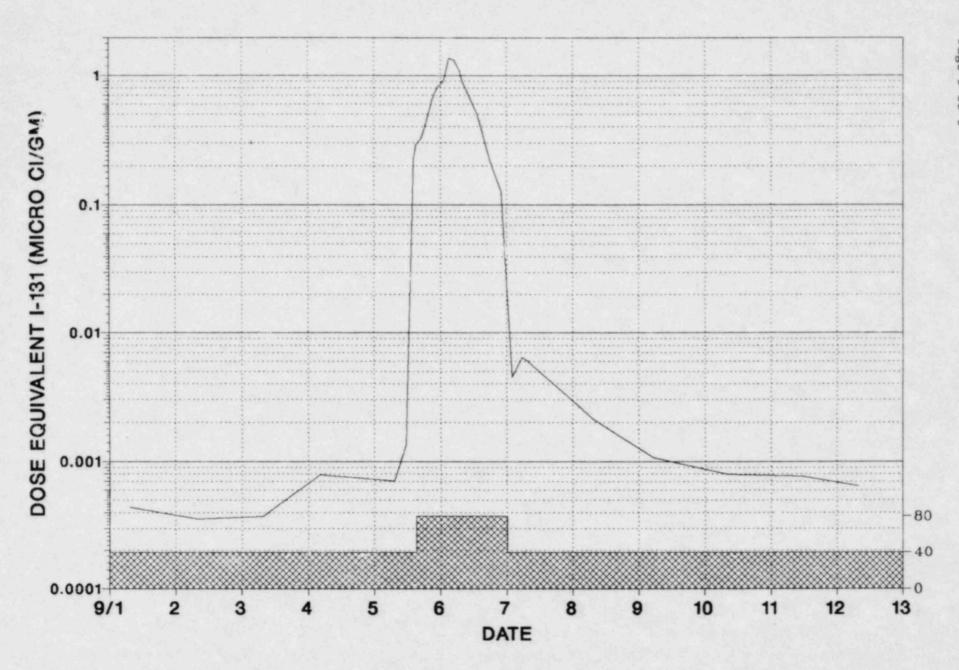
PURIFICATION GPM

d. Cleanup flow history starting 48 hours prior to the first sample in which limit was exceeded:

Cleanup flow was increased to 80 gpm until the activity had decreased below the limit.
