PHILADELPHIA ELECTRIC COMPANY

Docket No. 50-352

License No. NPF-39

SUBJECT: Limerick Generating Station, Unit 1
Plans for the Ultimate Disposition
of the Recirculation Inlet Nozzle
to Safe End Weld Indication

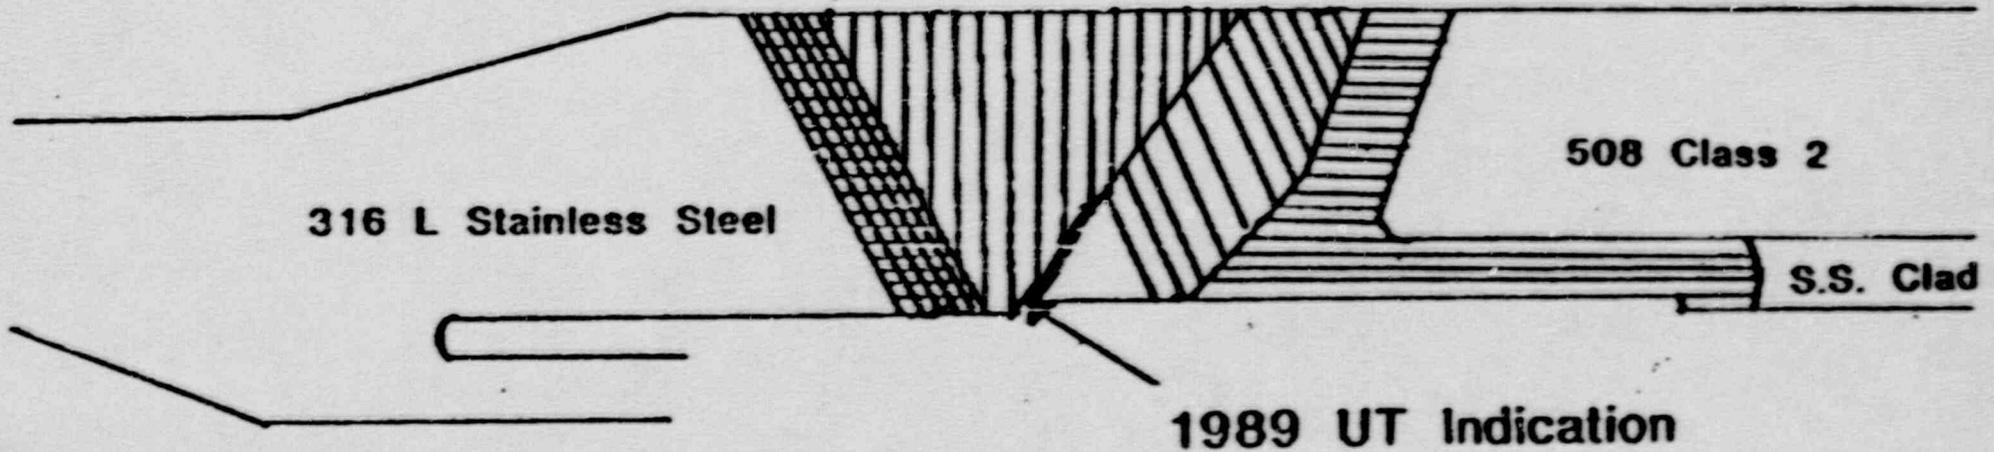
FIGURE 1

A seven inch circumferential flaw indication was found in the N2H nozzle to safe end weld as a result of UT inspection performed during the 1989 Unit 1 Refueling Outage. As shown in Figure 1, the indication is located on the nozzle side of the weld in the alloy 82 weld and/or the Inconel 600 that was left in place after the original Inconel 600 safe end was removed. With the wall thickness being 1.40 inches, the average depth of the indication is 0.25 inches (i.e., approximately 18% through wall), and a part of the indication, 0.5 inches in length, is 0.40 inches deep (i.e., approximately 29% through wall). The indication is located 31.8 inches to 38.8 inches from top dead center of the nozzle, clockwise with flow. Since actual visual inspection of the indication could not be performed, whether the indication is due to intergranular stress corrosion cracking (IGSCC) or is a pre-existing construction flaw could not be confirmed.

LGS Unit 1 Recirculation Nozzle (N2) Weld Details

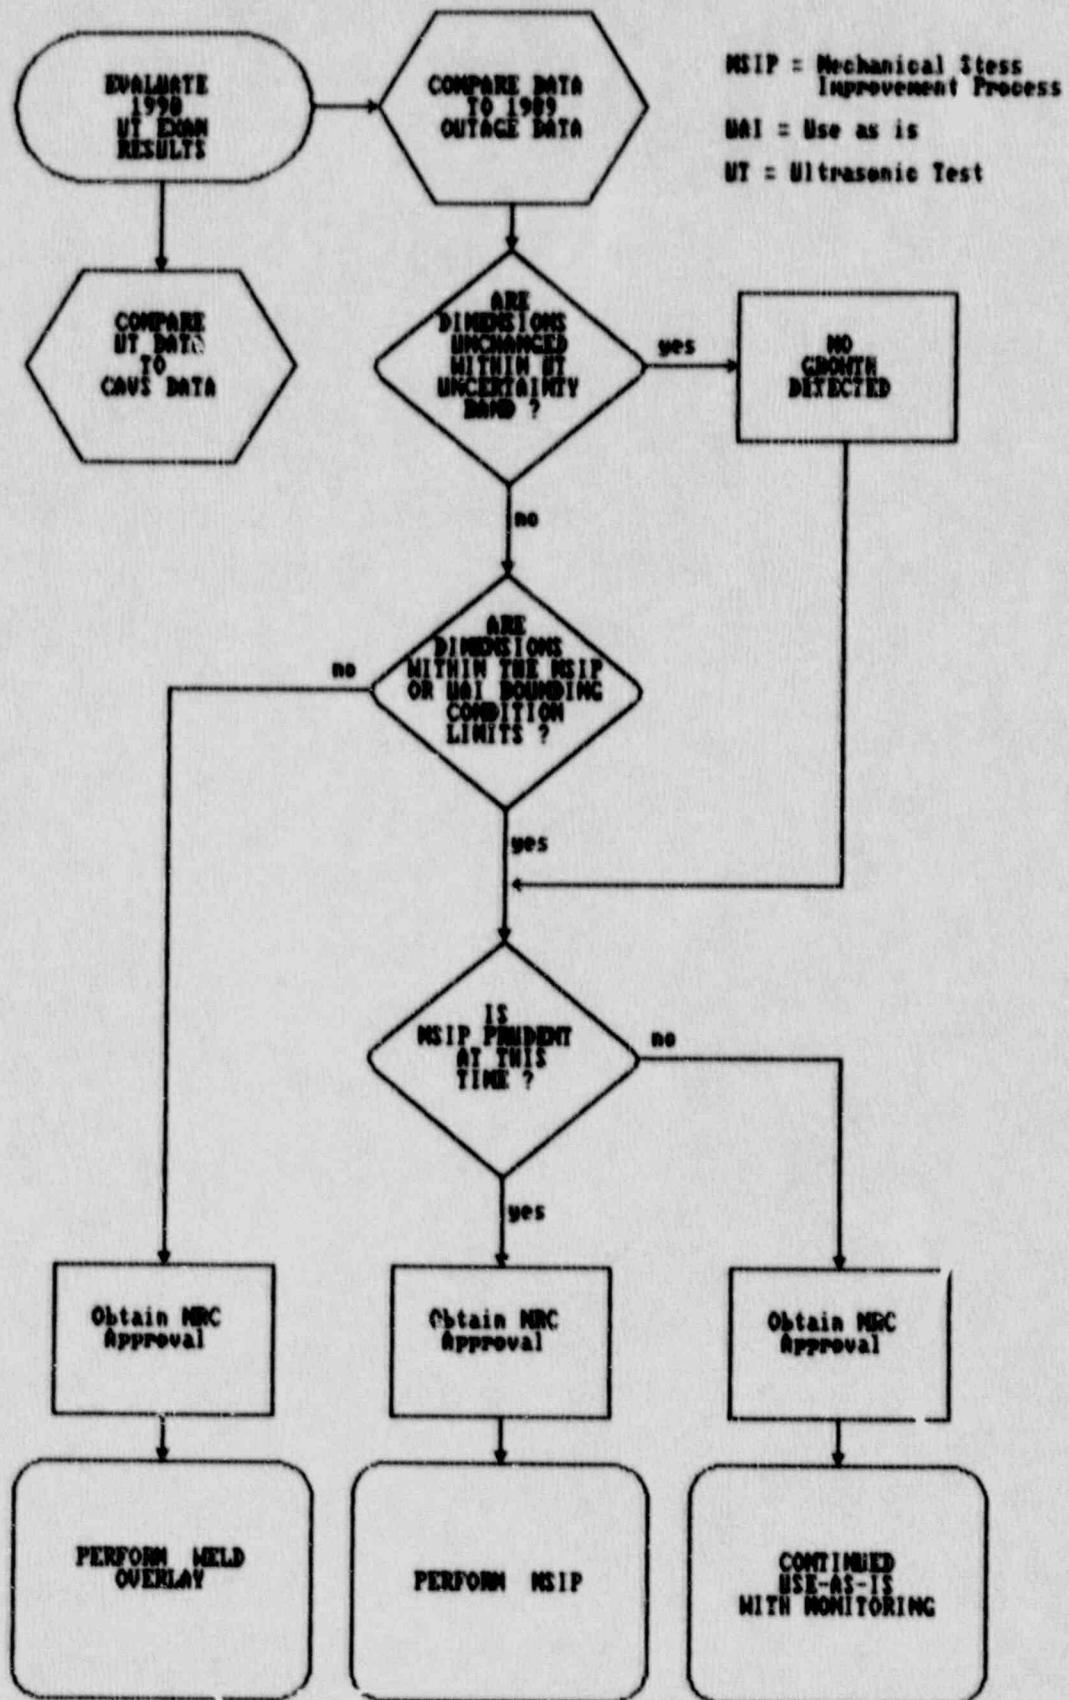
DISPOSITION ALGORITHM FOR THE N2H INDICATION

As described above, the alternative corrective actions to disposition the N2H nozzle to safe end weld indication include continued operation in the "as found" condition with CAVS monitoring, application of MSIP without continued monitoring, or repair by weld overlay without continued monitoring. The selection of the specific corrective action to be implemented will be based on the established bounding conditions, and the results of the UT inspection of the N2H nozzle to safe end weld that will be performed during the upcoming Unit 1 Refueling Outage, currently scheduled to begin on September 8, 1990. Figure 2 provides a flowchart depicting the selection process that will be followed once UT inspection results have been obtained.

1. Leave in the "as-found" condition with continued CAVS monitoring
2. Apply the Mechanical Stress Improvement Process (MSIP) with or without CAVS monitoring
3. Repair with weld overlay with or without continued CAVS monitoring
4. Replacement of the N2H nozzle safe end

If the change in the indication length and depth is consistent with a crack growth rate of 1×10^{-5} inches/hour or less, we may request NRC approval to allow Unit 1 to operate for additional cycles with the indication in the "as found" condition. If the change in the indication length and depth shows a crack growth rate of 2.5×10^{-5} inches/hour or less, we may request NRC approval to allow Unit 1 to operate for only the next cycle with the indication in the "as found" condition since the size of the indication at the end of next (i.e., fourth) cycle would not exceed the ASME Code allowable flaw size.

If the UT inspection results show no growth of the indication, as explained above, or if the indication size has increased but is within the bounding conditions for the application of the MSIP, we may request NRC approval

to apply the MSIP to the N2H nozzle to safe end weld. If the change in the length and depth of the indication is greater than the established conditions for "use as is," or the bounding conditions for the application of the MSIP, we would request NRC approval to repair the N2H nozzle to safe end weld using weld overlay.
