SUBJECT: ENFORCEMENT CONFERENCE SUMMARY

BRUNSWICK NUCLEAR PROJECT
ENFORCEMENT CONFERENCE RELATED TO
UNPLANNED PERSONNEL RADIATION EXPOSURE

AUGUST 6, 1990

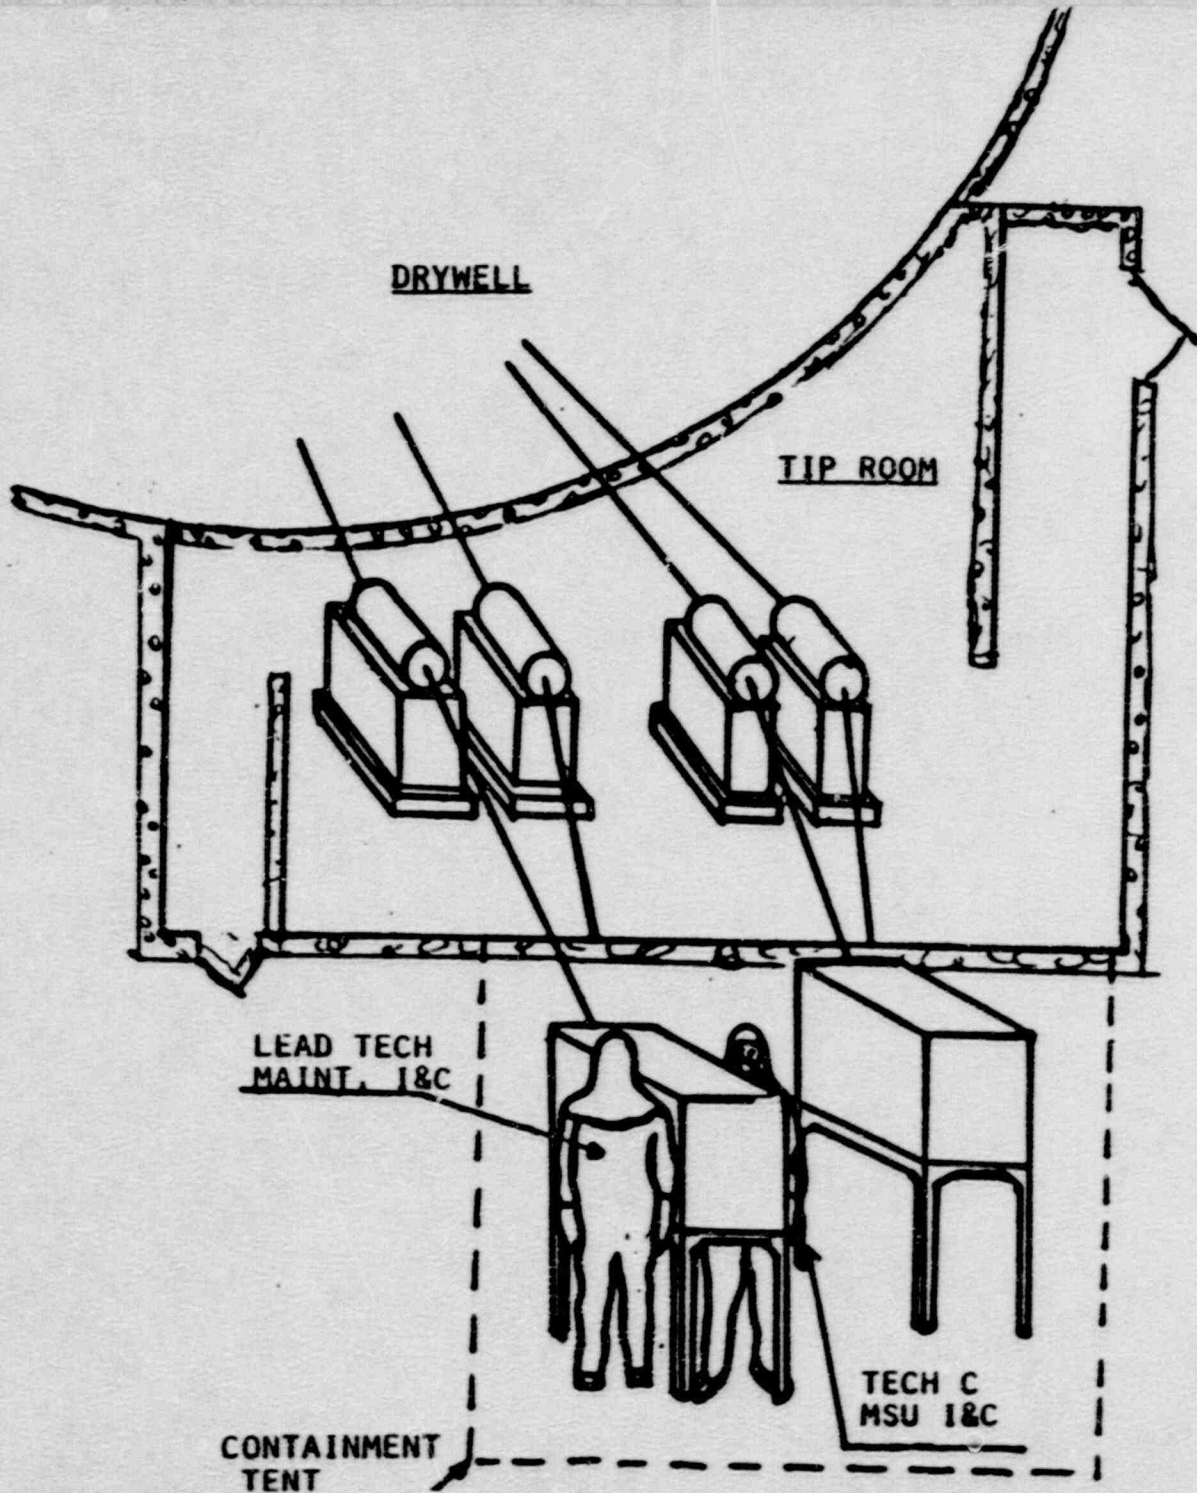
- COMMUNICATIONS MAINTAINED BETWEEN I&C TECHNICIANS AT DRIVE UNIT AND IN CONTROL ROOM.
- DETECTOR MANUALLY INSERTED TO CORE TOP IN FIRST GUIDE TUBE AND CORE TOP LIMIT ADJUSTED.
- CLUTCH BINDING PROBLEM NOTED DURING INSERTION.
- DETECTOR MANUALLY RETRACTED FROM CORE TOP.
- DETECTOR INADVERTENTLY RETRACTED INTO DRIVE UNIT.
- PERSONAL DOSIMETRY AND AREA RADIATION MONITOR ALARMED.
- DETECTOR IMMEDIATELY REINSERTED.
- TECHNICIANS CHECKED PERSONAL DOSIMETRY, NOTIFIED ENGINEERS, EXITED AREA AND REPORTED TO HEALTH PHYSICS.

DRYWELL

TIP ROOM

LEAD TECH
MAINT. I&C

TECH C
MSU I&C

CONTAINMENT
TENT

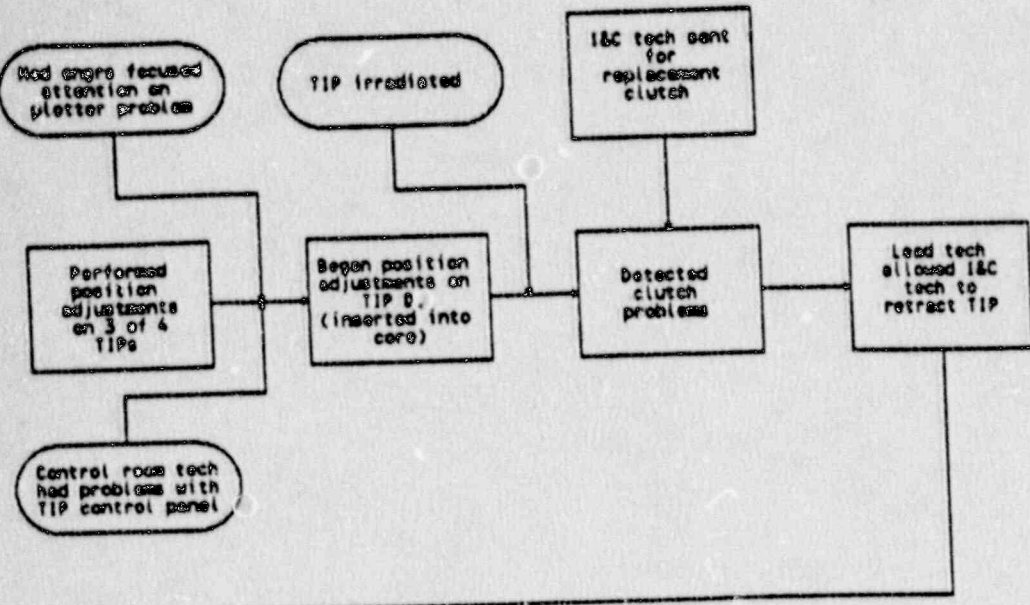
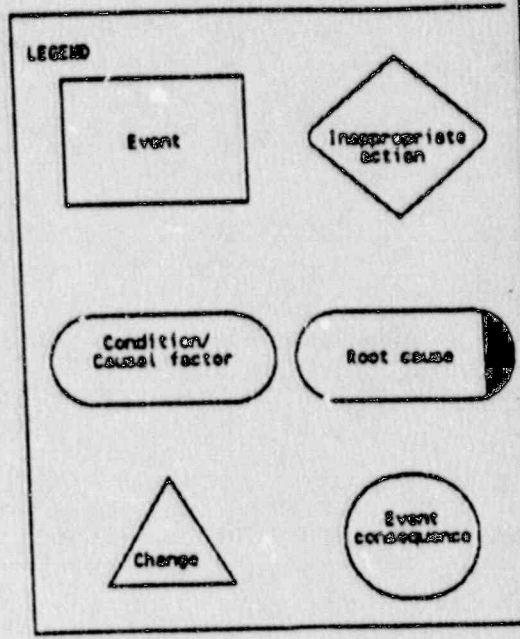
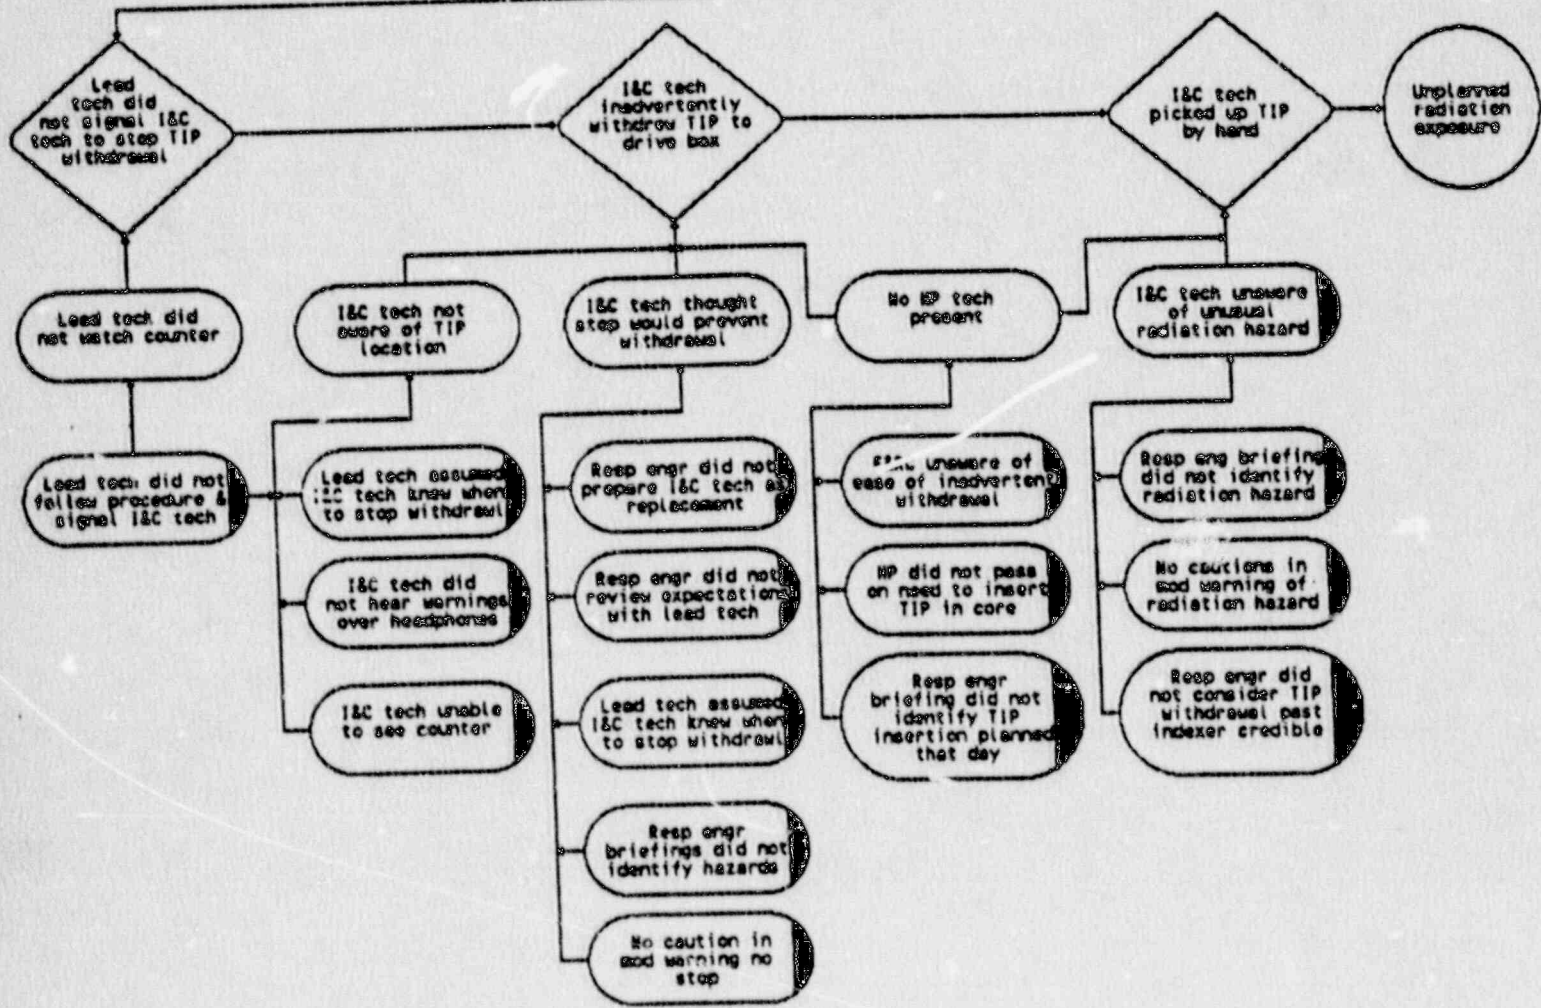
Some TIP 'D' Retracted to Drive Box
Simplified Event and Causal Factor Chart

I. LEAD I&C TECHNICIAN DID NOT SIGNAL I&C TECHNICIAN ON HAND-CRANK TO STOP TIP DETECTOR WITHDRAWAL.

II. I&C TECHNICIAN INADVERTENTLY WITHDREW TIP DETECTOR PAST INDEXER AND INTO THE DRIVE UNIT.

III. I&C TECHNICIAN PICKED UP IRRADIATED TIP DETECTOR CABLE WITH HIS HAND AND REINSERTED IT INTO THE DRIVE TUBE.
