U.S. NUCLEAR REGULATORY COMMISSION

Report No. 40-3392/90004

Licensee: Allied-Signal, Inc.
P.O. Box 430
Metropolis, IL 62960

Facility Name: Metropolis Works

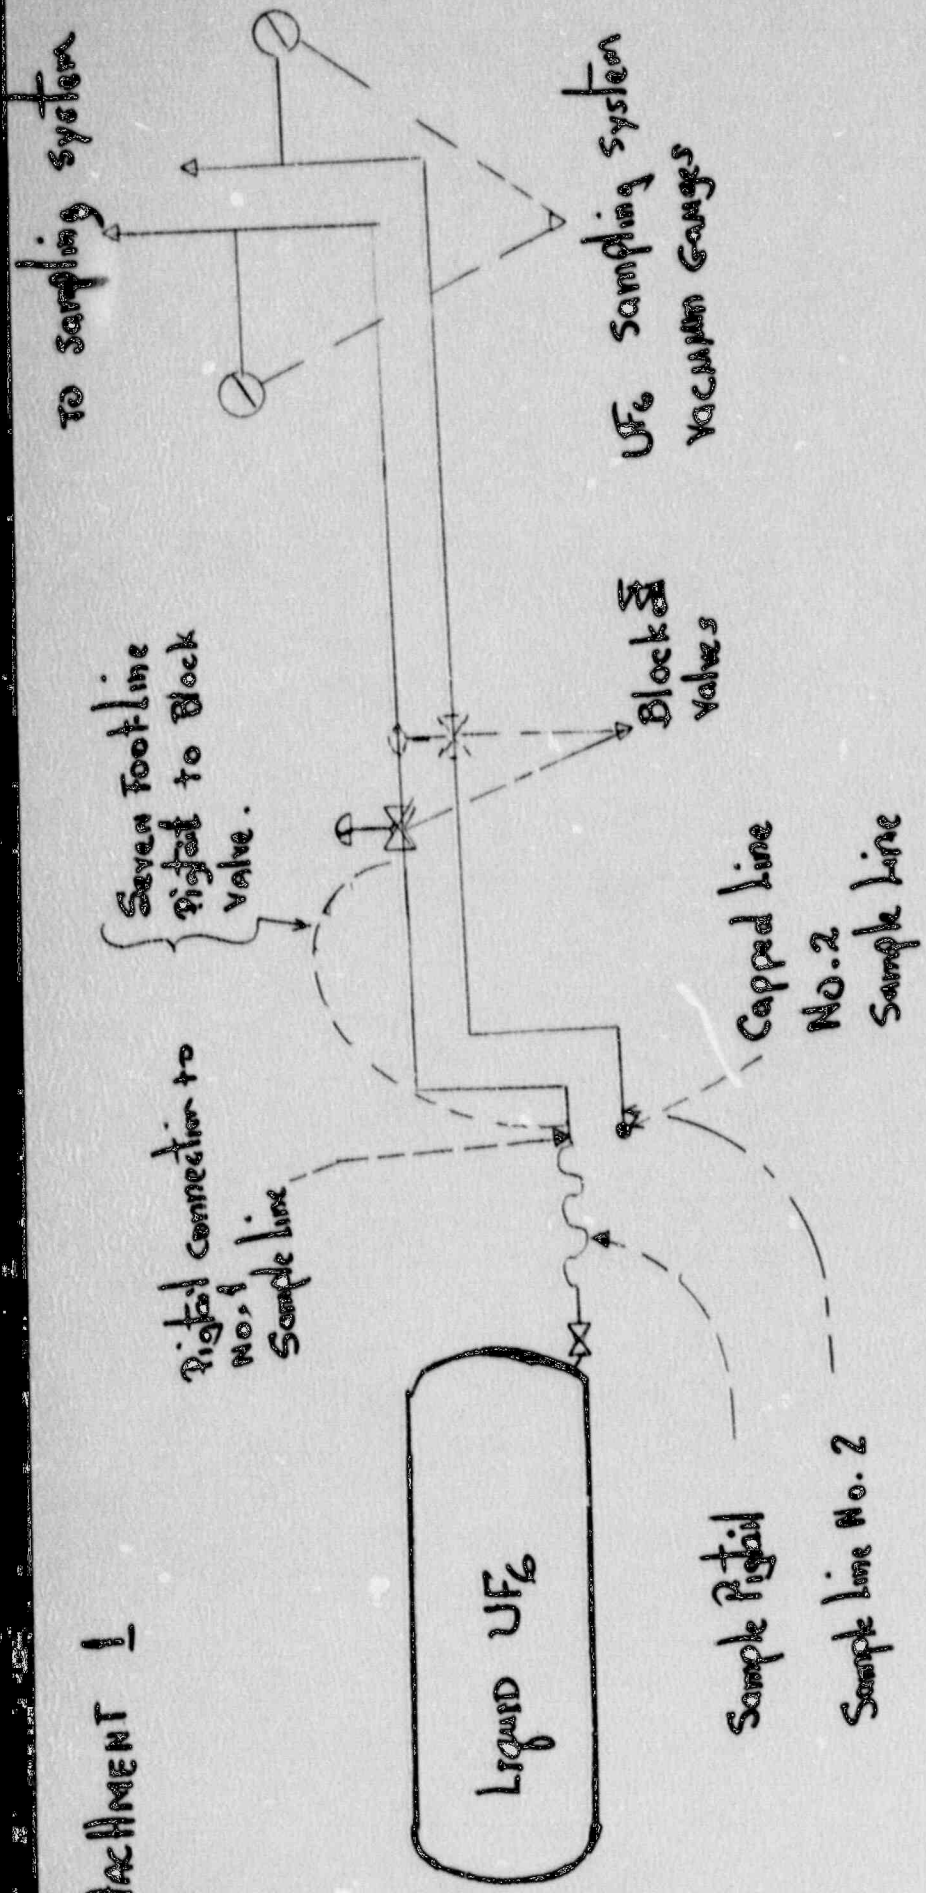
Figure 1., UF₆ CYLINDER SAMPLING SYSTEM;
SHOWING NO. 1 + NO. 2 SAMPLE LINES

There are four product cylinder fill-stations. Each station is equipped with a steam chest and two identical sample lines (No. 1 and No. 2). A product cylinder filled at anyone of the four fill-stations can be sampled for purity by connecting a transfer line (pigtail) from the cylinder to either of the sample lines. Both sample lines are independently traversed from the fill-stations to the sampling unit. Similar to the product fill-line each sample line is heat traced with ethylene glycol. A vacuum gauge located at the sampling unit is used to determine if the sample line is under a vacuum through to the cylinder. The licensee noted that the chemical/physical properties of UF_6 are such that either moist air and/or a cold spot (temperature less than $147^\circ F$) could cause hydrolysis of the UF_6 to form UO_2F_2 -HF and solidify within the line. Either condition (UO_2F_2 or solid UF_6) could cause a blockage in the line and give an indication on the vacuum gauge that the line is evacuated from the sampling unit to the cylinder. Under normal conditions the system is purged with nitrogen to test for leaks. Afterwards the system is evacuated prior to transferring UF_6 from the cylinder to the sampling unit.

The release of UF_6 to the surrounding environment occurred while the operators were trying to dislodge solidified UF_6/UO_2F_2 from the No. 1 sample line. The blockage in the line probably occurred from the reaction of air and moisture with UF_6 and or perhaps a cold spot in the sample line. The inspector was unable to discern a precise cause of the blockage. However, the following conditions discovered when the licensee was cleaning out the sampling system probably contributed to the release:

- The No. 1 sample line at the No. 1 product fill-station had not been used in 6 weeks. Residual UF_6 probably coated the line between the sample line block valve and the pigtail connection (7 foot line). This is plausible since the block valve was found to be leaking. A redundant seal in the valve (by design) prevented the leakage of UF_6 to the atmosphere. When liquid UF_6 is admitted to the sample line from a cylinder located in either one of the four product filling stations, it is possible that liquid UF_6 makes contact with the four block valves located in the No. 1 sample line. Under these conditions UF_6 seepage could occur between a leaking valve and the capped end of the line (7 foot length of line where the pigtail is connected). If cold spots were present some freeze out of UF_6 in the line would also occur.

- e. Review the possibility of shortening the distance between the block valve and the capped end of the sample line; install a vacuum gauge for this portion of the system.
