Maine Yankee

Subject: Maine Yankee Licensee Event Report 90-002-01 - Inadvertent SIAS While Swapping Vital AC Busses

LICENSEE EVENT REPORT (LER)

Title(4)
Inadvertent SIAS While Swapping Vital AC Busses

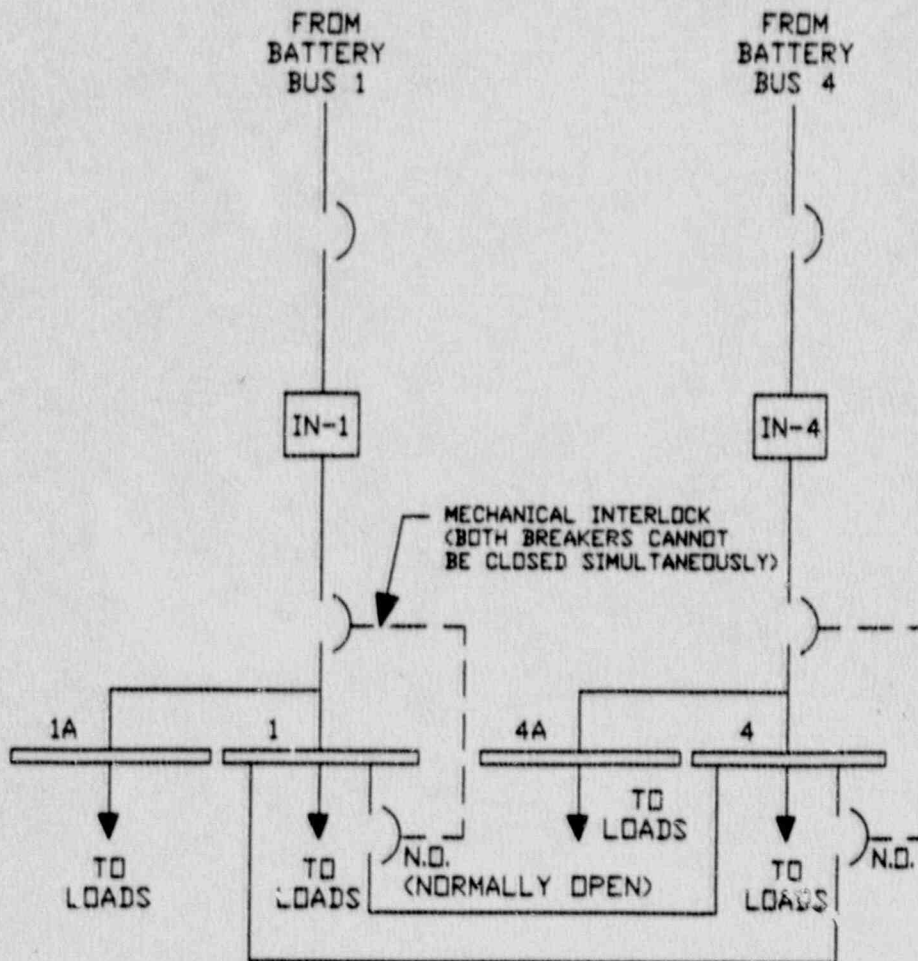
LOW VOLTAGE ELECTRICAL SYSTEM
(PARTIAL FIGURE)

At 2307 on April 14, 1990, while in a refueling shutdown condition, an inadvertent actuation of safeguard systems occurred. The 120 volt AC vital (EF) busses (BU) #1 and #4 were being powered from inverter #1 (INVT) to allow maintenance on inverter #4. See attached diagram. While returning the #4 inverter to service, a licensed operator incorrectly opened the normal supply breaker (BKR) for bus 1. This action simultaneously de-energized both vital AC busses #1 and #4. Both trains of Safety Injection (JE) actuated at the instant both vital busses were de-energized. There were no significant adverse effects on plant operation since the plant was in a refueling shutdown condition with the affected safety systems secured. Inverter #1 was returned to service and the safeguard systems were reset.

It was immediately determined that the wrong breaker had been opened and was the cause of the inadvertent safeguard actuation. As the diagram indicates, AC vital busses #1 and #4 can be cross-tied to either inverter #1 or #4. The cross-tie is accomplished by a set of mechanically interlocked breakers that require disconnecting the vital bus from one source before connecting to the new source. Power for bus #4 was being supplied through the normally open feeder breaker from inverter #1. The procedure directed the opening of the alternate feeder breaker on bus #4 to intentionally de-energize it prior to closing in its normal feeder breaker from inverter #4. The licensed operator incorrectly opened the normal feeder breaker from inverter #1, simultaneously de-energizing both vital bus #1 and #4.

Due to the fail-safe design of the Engineered Safeguard Feature logic, the loss of power to busses #1 and #4 caused two of the four pressurizer (PZR) pressure channels to de-energize and automatically unblock the associated Safety Injection channels. This satisfied the logic for actuation of Safety Injection Actuation Signal (SIAS) on low pressurizer pressure.

An initial review of the procedures and conditions associated with the inappropriate action identified a weakness in the labeling scheme utilized on the vital bus transfer panels. As an immediate corrective action, the labeling was changed to aid operator identification and indicate the purpose of each breaker on the vital bus transfer panels. Maine Yankee is currently implementing a program to upgrade the labeling on plant components and will provide permanent human factored labeling on the affected transfer panels. Additionally, a root cause evaluation is being performed by the Operations Department.
