UNITED STATES
NUCLEAR REGULATORY COMMISSION
REGION II
101 MARIETTA STREET, N.W.
ATLANTA, GEORGIA 30323

Report No. 50-325/90-29 and 50-324/90-29

Facility Name: Brunswick 1 and 2

Inspection Conducted: August 1 - September 7, 1990

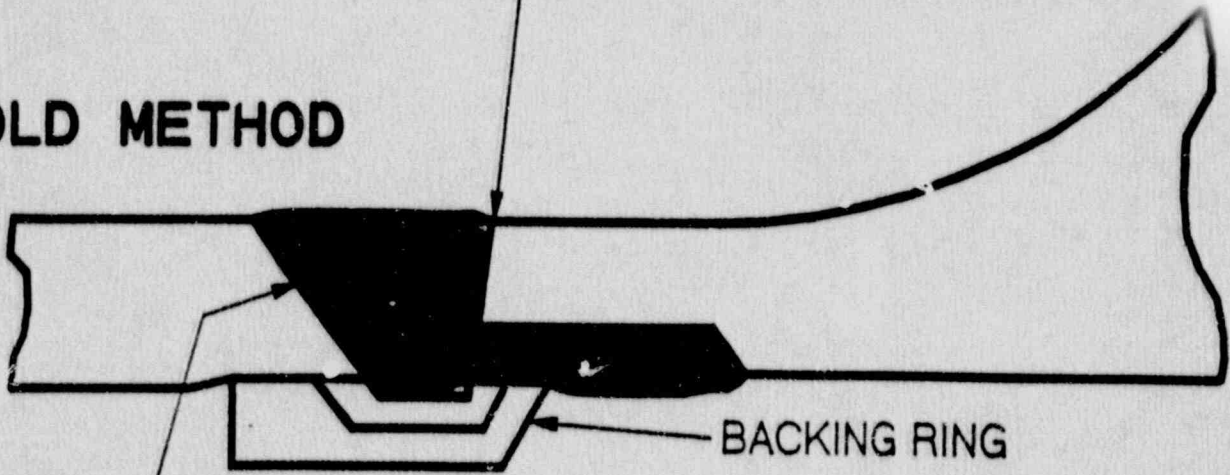
OLD METHOD EMPLOYED
7 1/2° NOZZLE PREP ANGLE.
DIFFICULT WELD ANGLE

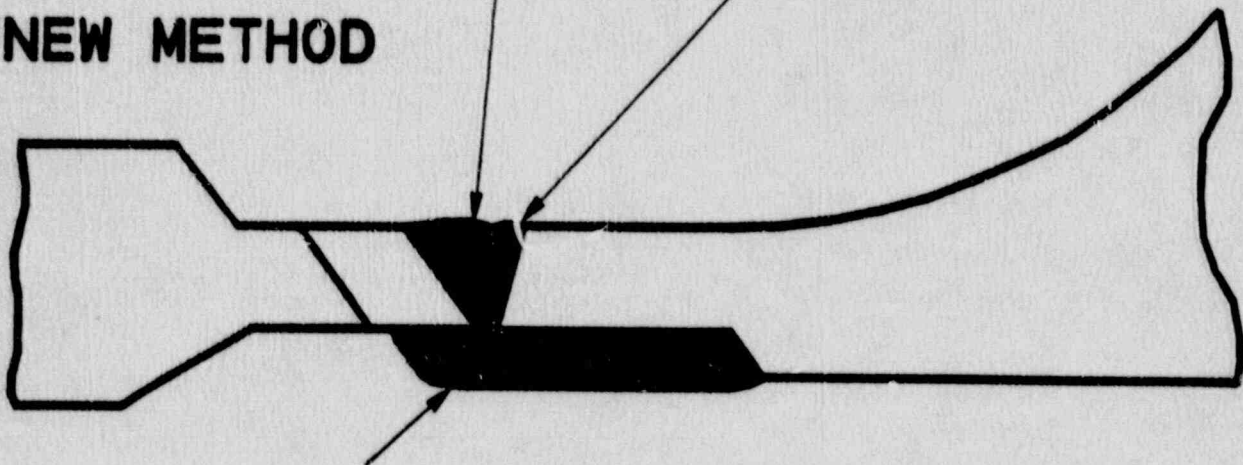
VOLUME OF WELD METAL
TO BE DEPOSITED IN FIELD
HAS BEEN CONSIDERABLY
REDUCED BY NEW METHOD

NEW METHOD EMPLOYS
15° NOZZLE PREP ANGLE.
MUCH EASIER WELD ANGLE

ABSENCE OF BACKING RING IN NEW METHOD
WILL ALLOW A MORE INTERPRETABLE
RADIOGRAPH OF THE BUTTER TO BE PERFORMED
PRIOR TO COMPLETING PWHT
