In Reply Refer To:  
Docket: STN 50-482/90-08

Subject: Docket No. 50-482: Response to Inspection Report 90-08

**Response to Inspection Report 90-08**

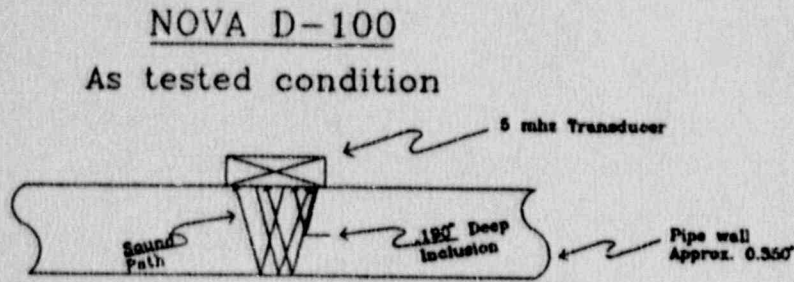
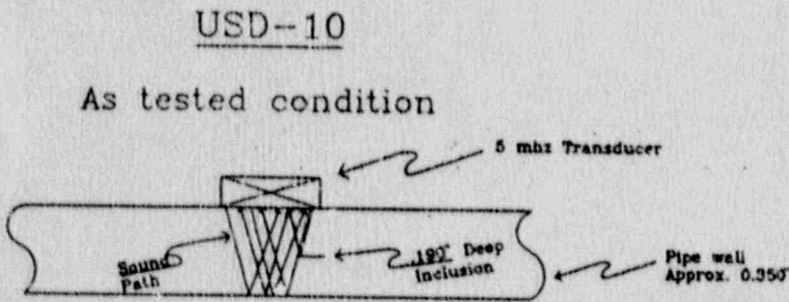
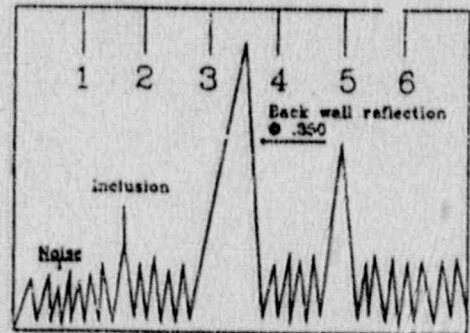
The USD-10 is a state-of-the-art, versatile flaw detection instrument utilized to evaluate and size small anomalies found during erosion-corrosion and Inservice inspection examinations. The signal from the I.D. surface as well as volumetric anomalies will be detected and displayed on the screen which allows evaluation of the signal. Figure 1 illustrates the D100 and the USD-10 displays.

WCNOG performed an examination of the isolated areas that appeared to have anomalies with the DMX-1 instrument and identified the same anomalies as the NRC had identified. A follow-up examination using the USD-10 was performed. The areas were examined and no relevant I.D. flaws or significant volumetric flaws were identified. This is based on an evaluation of the USD-10 signal that displayed a back wall reflection at the nominal wall value (0.350"). The signal from the anomaly was the same amplitude as that contained in the noise level of the scope indicating that the signal recorded by the Nova D100 was the result of a small material anomaly (such as an inclusion).

"First" signal back  
displayed as wall  
thickness

Back wall @ .350"  
Inclusion indication  
noted in noise level
