U. S. NUCLEAR REGULATORY COMMISSION
REGION I

Docket/Report No. 50-289/90-13
50-320/90-06

Facility: Three Mile Island Nuclear Station, Units 1 and 2

Inspection Summary for Combined for Inspection Report Nos. 50-289/13 and 50-320/06

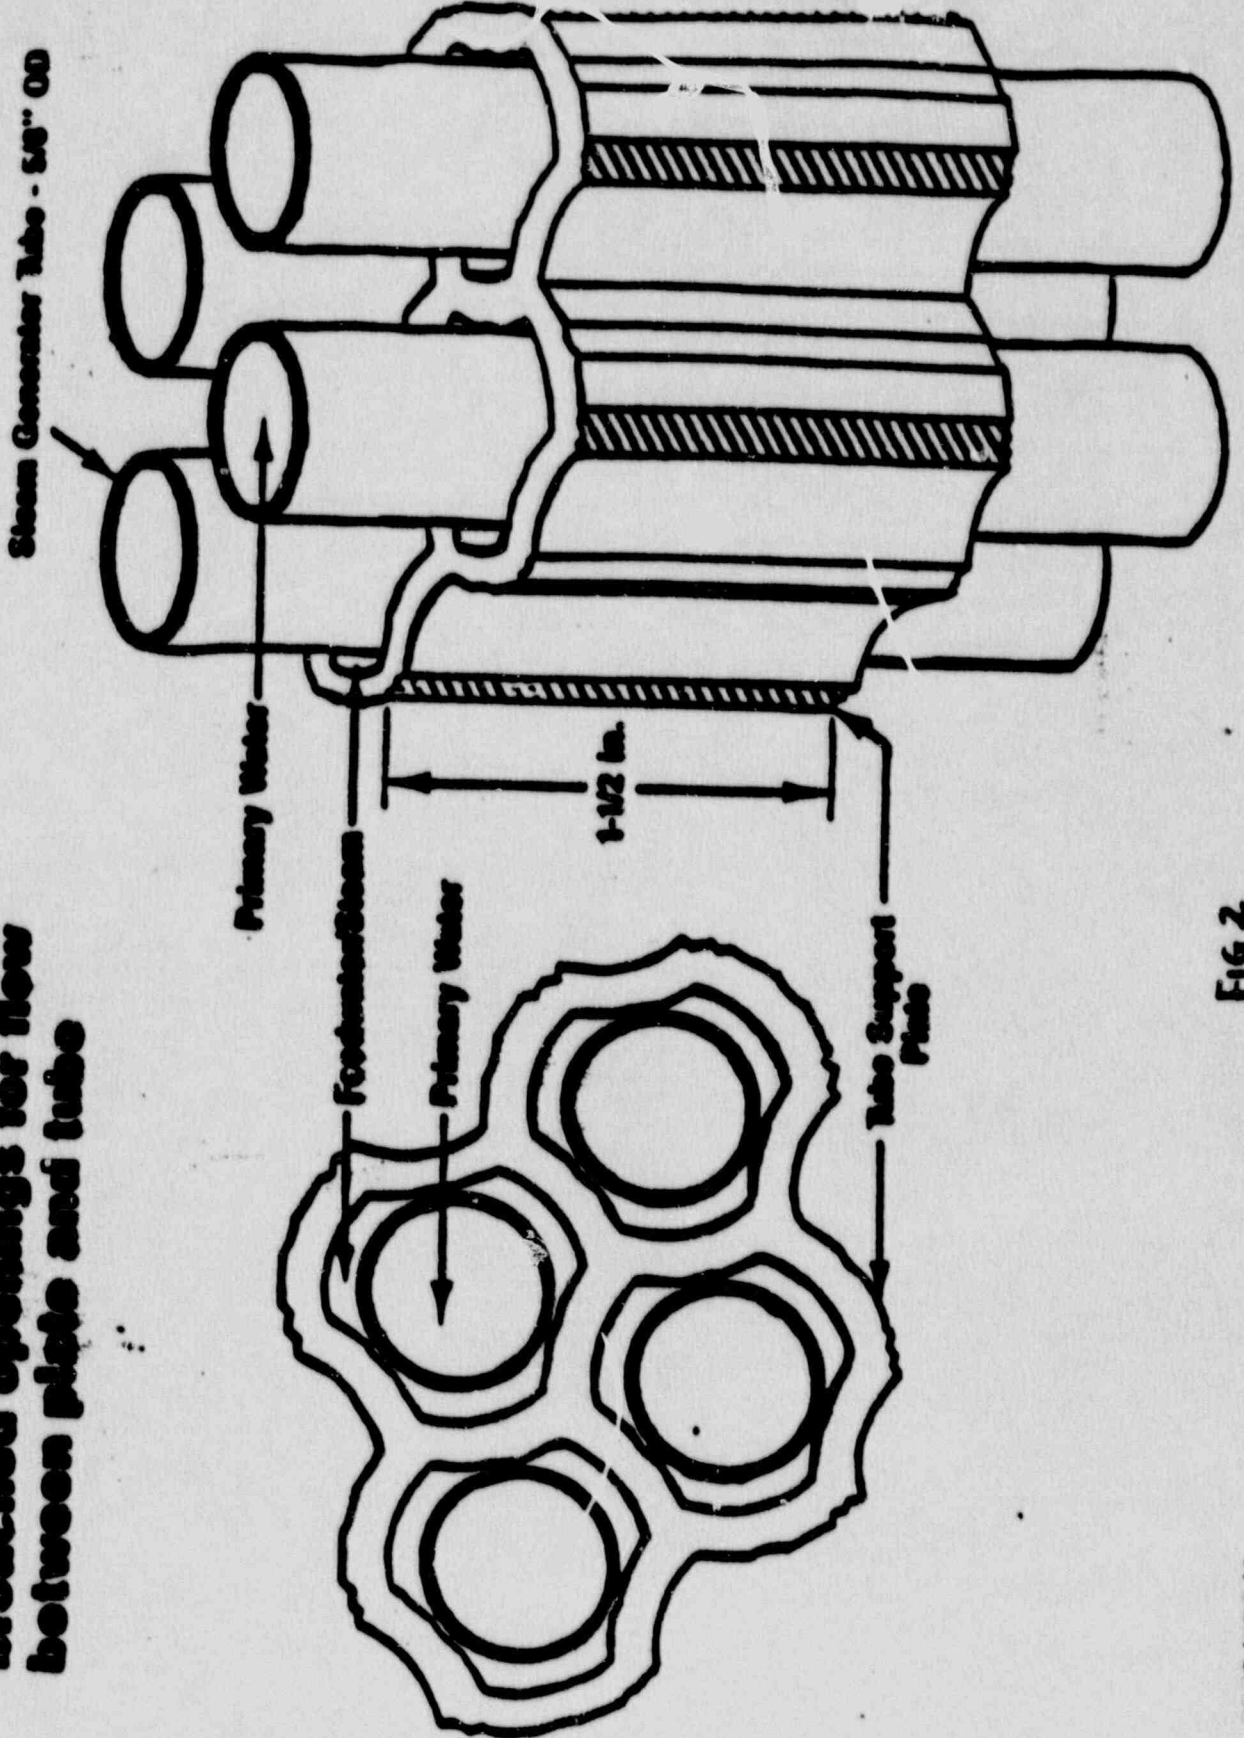
FIG 2

**OTSG Tube Support Plates,
brached openings for flow
between plate and tube**

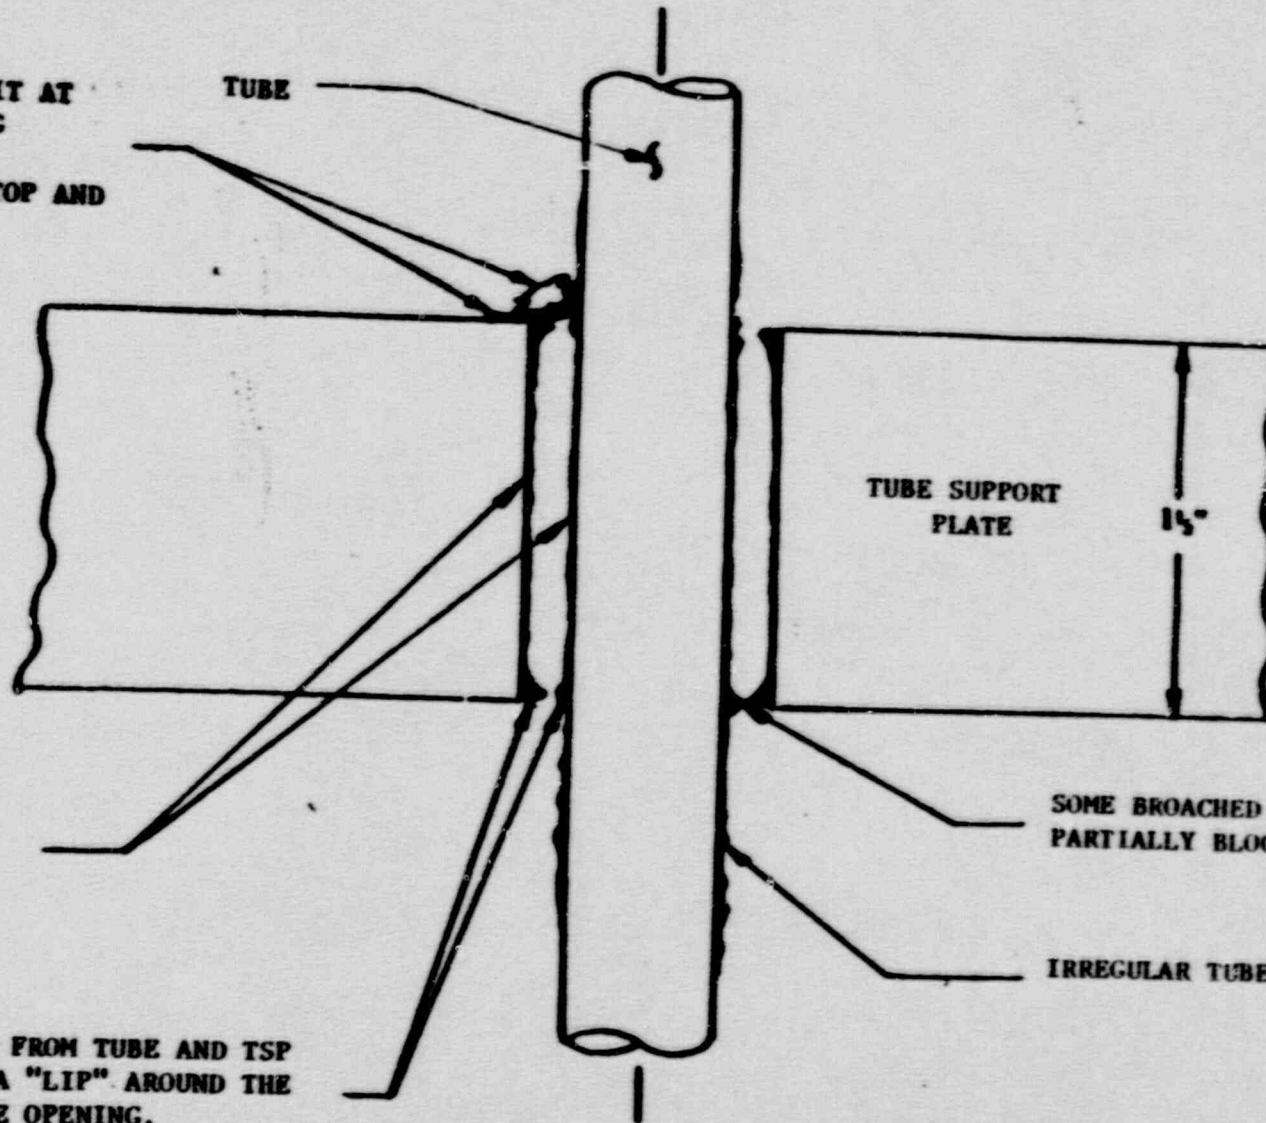
FLAKES OF DEPOSIT AT
BROACHED OPENING
LOCATIONS
- CAN OCCUR AT TOP AND
BOTTOM OF TSP

DEPOSIT ON TUBE
AND TSP SURFACES
INSIDE BROACH

SOME BROACHED OPENINGS
PARTIALLY BLOCKED.
