October 1, 1990
MP-90-1068

Reference: Facility Operating License No. NPF-49
Docket No. 50-423
Licensee Event Report 90-023-01

LICENSEE EVENT REPORT (LER)

FACILITY NAME (1) Millstone Nuclear Power Station Unit 3										DOCKET NUMBER (2) 0 5 0 0 0 4 2 3						PAGE (3) 1 OF 0 5	
TITLE (4) Both Trains of Containment Recirculation Pump Area Coolers Inoperable Due to an Inadequate Surveillance Procedure																	
EVENT DATE (5)			LER NUMBER (6)				REPORT DATE (7)			OTHER FACILITIES INVOLVED (8)							
MONTH	DAY	YEAR	YEAR	SEQUENTIAL NUMBER	REVISION NUMBER	MONTH	DAY	YEAR	FACILITY NAMES								
0 6 1 5 9 0	9 0	-	0 2 3	-	0 1	1 0	0 1	9 0									
OPERATING MODE (9)		THIS REPORT IS BEING SUBMITTED PURSUANT TO THE REQUIREMENTS OF 10 CFR § (Check one or more of the following) (11)															
POWER LEVEL (10)		20.402(b)		20.402(c)		50.73(a)(2)(iv)		73.71(b)									
1 0 0		20.405(a)(1)(i)		50.36(c)(1)		<input checked="" type="checkbox"/> 50.73(a)(2)(v)		73.71(c)

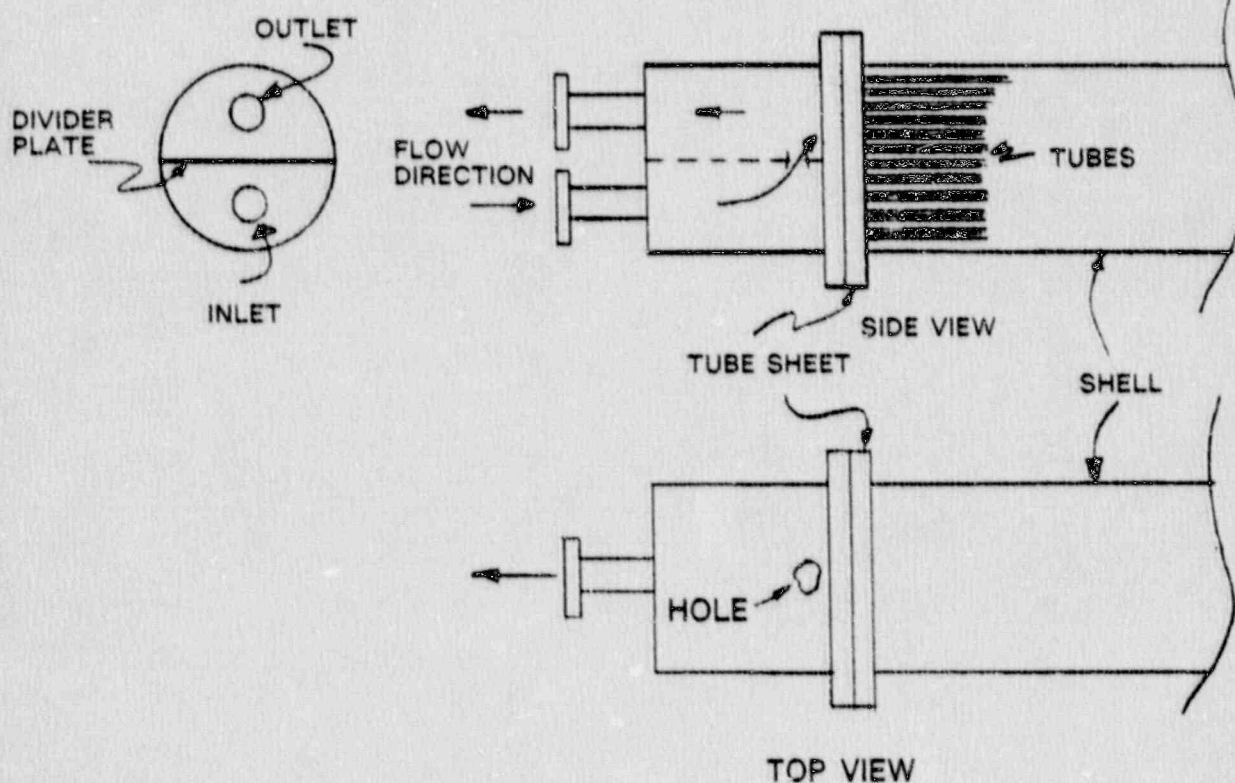
SCHEMATIC OF HVQ HEAT EXCHANGERS

While cleaning each of the two Containment Recirculation Pump Area Coolers, damage to the divider plate between the combined inlet and outlet head of the heat exchangers was found (see attached figure). The divider plates developed holes (app. 1" diameter in 3HVQ*ACUS2A and app. 1 3/8" by 1 3/4" in 3HVQ*ACUS2B). The holes developed from a 1/4" drainage hole provided by the vendor. The 3HVQ*ACUS2B unit was completely fouled in the return head with Tubularia Hydroids. A detailed engineering evaluation of the operability of the heat exchangers was initiated. The engineering evaluation was completed on July 5, 1990. The conclusion was that the each of the heat exchangers were inoperable as a result of the eroded drainage hole and fouling.

A contributing cause was the hole in the divider plate which was part of the design of the heat exchangers. Fouling of the heat exchanger forced additional flow through the 1/4" drainage hole in the inlet/outlet head divider plate. As the velocity increased, the copper nickel material of the divider plate eroded away increasing the size of the hole. The process occurred at a rate which prevented a high differential pressure from being detected by the surveillance program.

Neither of the Containment Recirculation Pump and Area Coolers had exhibited any sign of high differential pressure, which is the parameter measured in the surveillance program. This was due to flow bypassing the heat exchanger tubes through the hole in the divider plate.

The divider plates on 3HVQ*ACUS2A and 2B units were repaired using a monel patch. A 1/4" diameter drain hole was drilled in the patch to maintain consistency with the original design. By utilizing monel for the repair, the galvanic impact of a different material was minimized. Monel is not susceptible to the same flow erosion as the original copper nickel material.
