U.S. NUCLEAR REGULATORY COMMISSION
REGION IV

NRC Inspection Report: 50-445/90-33
50-446/90-33

Facility Name: Comanche Peak Steam Electric Station (CPSES)

Inspection Conducted: September 24-28, 1990

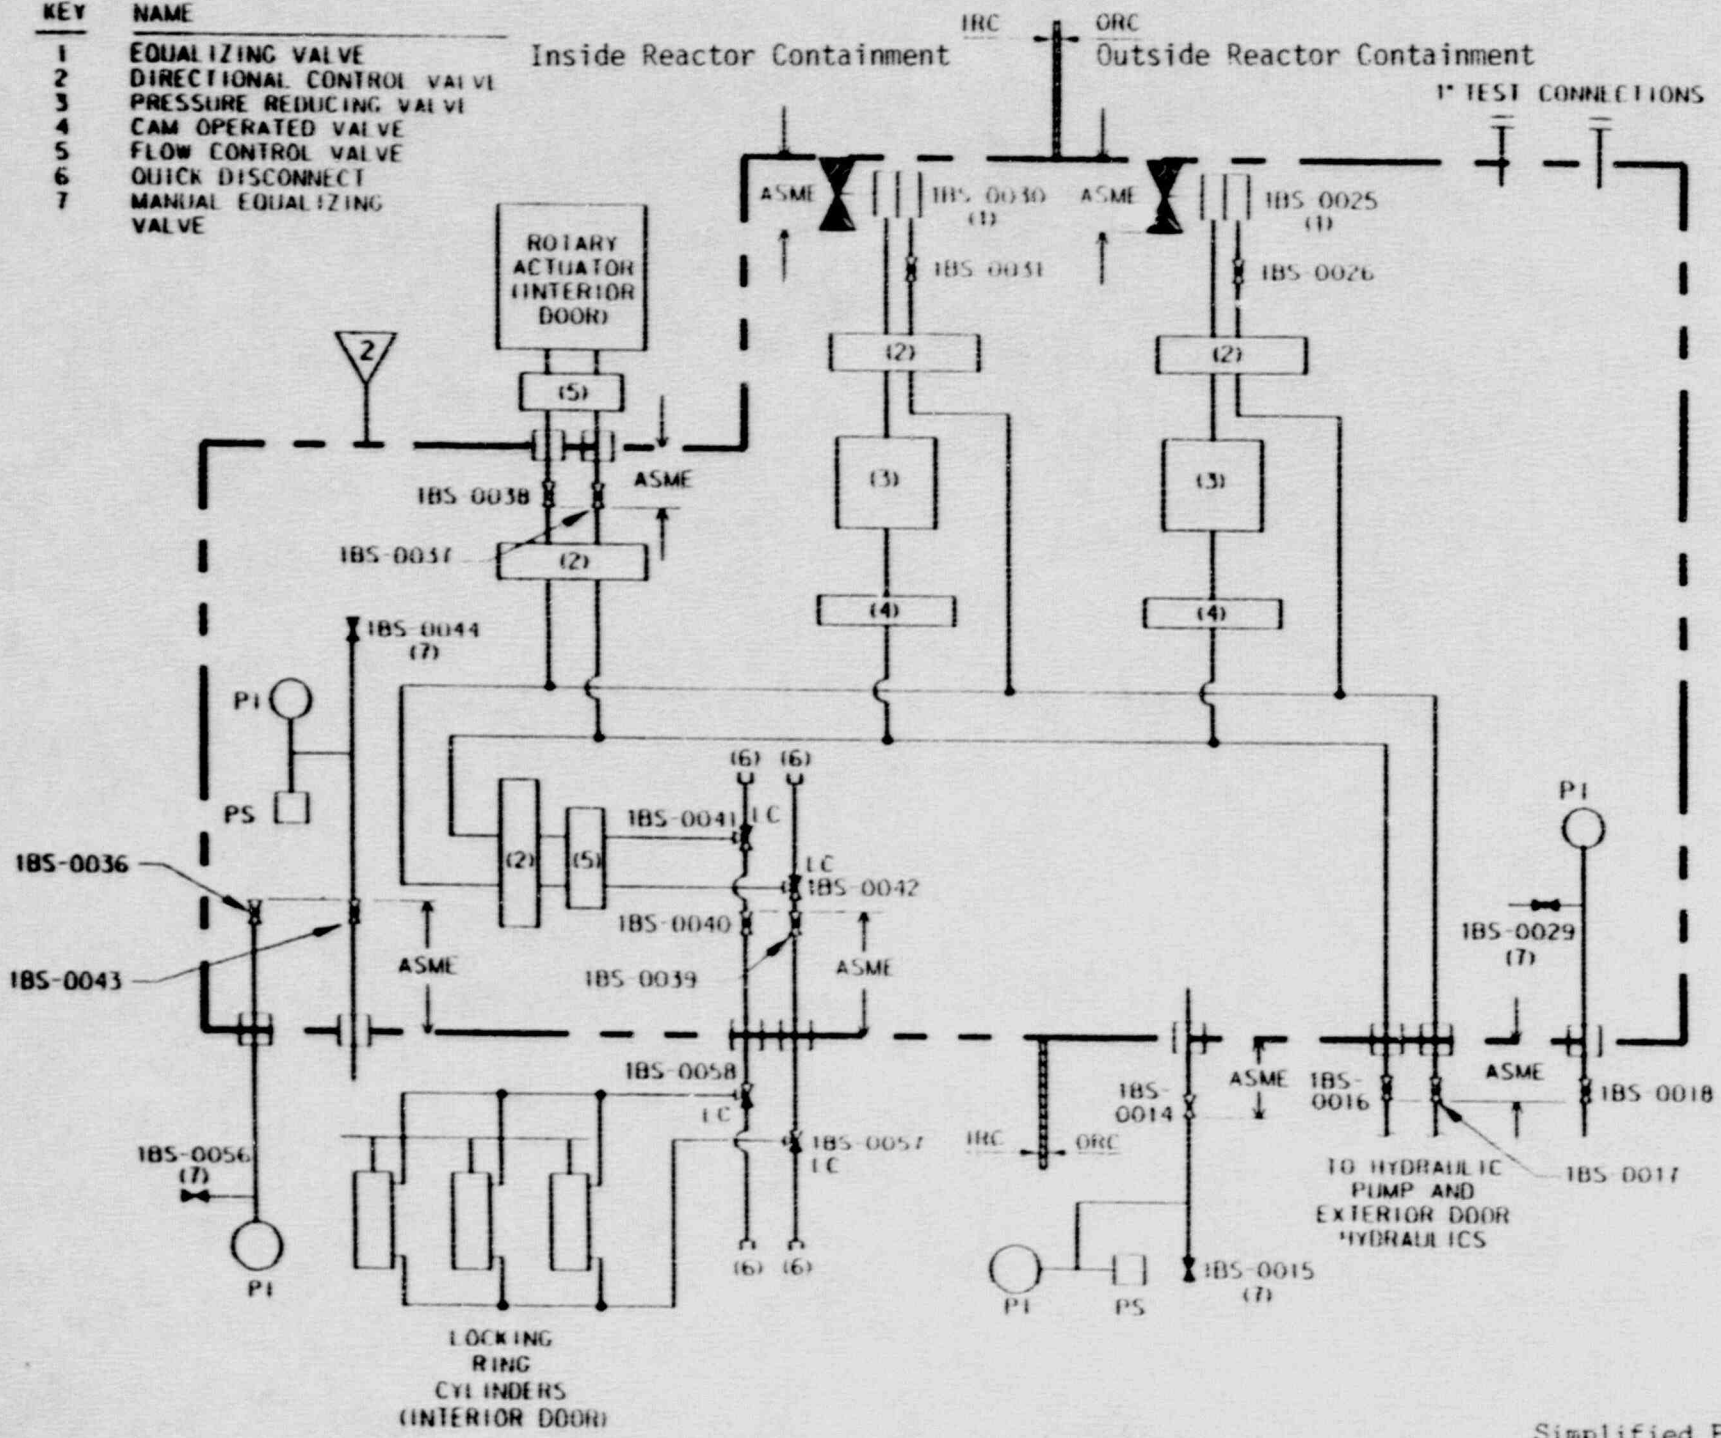
Simplified Personnel Airlock
 Hydraulic System Diagram

When making an entry into the containment on September 26, 1990, at approximately 8 p.m., the licensee found the personnel airlock inner door interior 3/4 inch equalizing valve 1BS-0044 open. With this valve open, the isolation function of the inner door was essentially breached. Through discussions with the licensee, the inspectors determined that the last containment entry, prior to the one on September 26, 1990, occurred on September 24, 1990, at approximately midnight. The personnel airlock is operated using Standard Operation Procedure SOP-907A, Revision 3, dated September 19, 1990, which requires that if the equalizing valves are used to equalize pressure, the valves are required to be shut after use. Failure to shut Valve 1BS-0044 after use, as required by Procedure SOP-907A, resulted in a valve line-up that placed the interior of the airlock in continuous communication with the containment atmosphere regardless of whether containment transit activities were in progress. Furthermore, with the valve open, whenever the outer door or the outer equalizing valve was opened a direct pathway existed between the containment and the safeguards building. A conservative estimate was that the valve was in the open position for approximately 44 hours (from September 24, 1990, 12 p.m. to September 26, 1990, 8 p.m.). This is an apparent violation of Technical Specification 3.6.1.3, which requires the airlock to be operable in Modes 1, 2, 3, and 4. (445/9033-01)

The leakage path was determined to be the hydraulic fluid return line to the pump reservoir from inside the airlock. The hydraulic pump and reservoir, used to actuate the airlock door locking ring, are located outside the airlock in the safeguards building. Upon discovery of this leakage path the return isolation valve (1BS-0017) in the safeguards building was shut and the leakage was stopped. The licensee determined that a locked closed three-way hydraulic diverter valve (1BS-0041) inside the airlock had failed allowing the air to leak from inside the airlock through the hydraulic system to the safeguards building. Inspection of the valve internals by the licensee revealed that the valve was badly worn.

The three-way diverter valve is fitted with a "quick disconnect" device and is used to attach a hand operated hydraulic pump if the normal pump fails. There are three sets of these diverter valves (one suction and one discharge) for hand pump attachment. One set is located inside containment, one set is located inside the personnel airlock and one set is located in the safeguards building. By procedure, these valves are locked closed (i.e., the hand pump ports are shut and the valves lined up for normal pump operation). This was the lineup during the conduct of the Type B leakage test on August 22, 1990, and is also the normal lineup during power operation.

The inspectors concluded that, as designed, the personnel airlock hydraulic system had the potential to allow a direct pathway from the containment to the safeguards building. The consequences of this are similar to that of the apparent violation described in paragraph 2.1. At the time the inspection was completed, the licensee was continuing its engineering analysis and compiling final documentation. This item is considered an unresolved item pending further NRC review. (445/9033-02)

A temporary modification was made to the personnel airlock hydraulic system to prevent the leakage described above. This was accomplished by adding two manual isolation valves between the "quick disconnect" fitting and the three-way diverter valves (1BS-0041 and 1BS-0042). This temporary modification stopped the air in leakage from the airlock into the hydraulic system and allowed successful completion of the Type B test with the hydraulic system lined up in its normal configuration. The licensee subsequently determined that the temporary modification should be made a permanent plant modification. It was during this process that the licensee discovered that there was inadequate documentation to verify that portions of the hydraulic system and instruments, instrument tubing, and associated valves supplied with the personnel airlock were in accordance with ASME Section III of the Boiler and Pressure Vessel Code, and the seismic Category I Criteria for the CPSES site. The licensee instituted a search within its own records and requested that the supplier of the personnel airlock, Chicago Bridge and Iron (CBI), also search for the supporting documentation. The licensee also started an engineering analysis of the airlock. At the time this inspection was concluded, additional seismic analysis and documentation was being prepared. The inadequate documentation discovery is considered an unresolved item pending NRC review of the licensee's followup actions on this matter. (445/9033-03)

As an interim measure, the licensee has performed leak tests on six manual isolation valves that are qualified. These six valves then were locked in the closed position, which effectively isolated the airlock hydraulic system from the containment and the safeguards building. The details for this change in hydraulic system line-up and the licensee's basis for considering the personnel airlock to be operable are contained in the licensee's Technical Evaluation TE No. PE-90-2603. This evaluation was provided to the inspectors at the time of the exit meeting and was subsequently reviewed by them in the Region IV office.
