U.S. NUCLEAR REGULATORY COMMISSION
REGION I

Docket/
Report No. 50-213/93-22

Facility: Haddam Neck Plant

HADDAM NECK PLANT INSPECTION 50-213/93-22

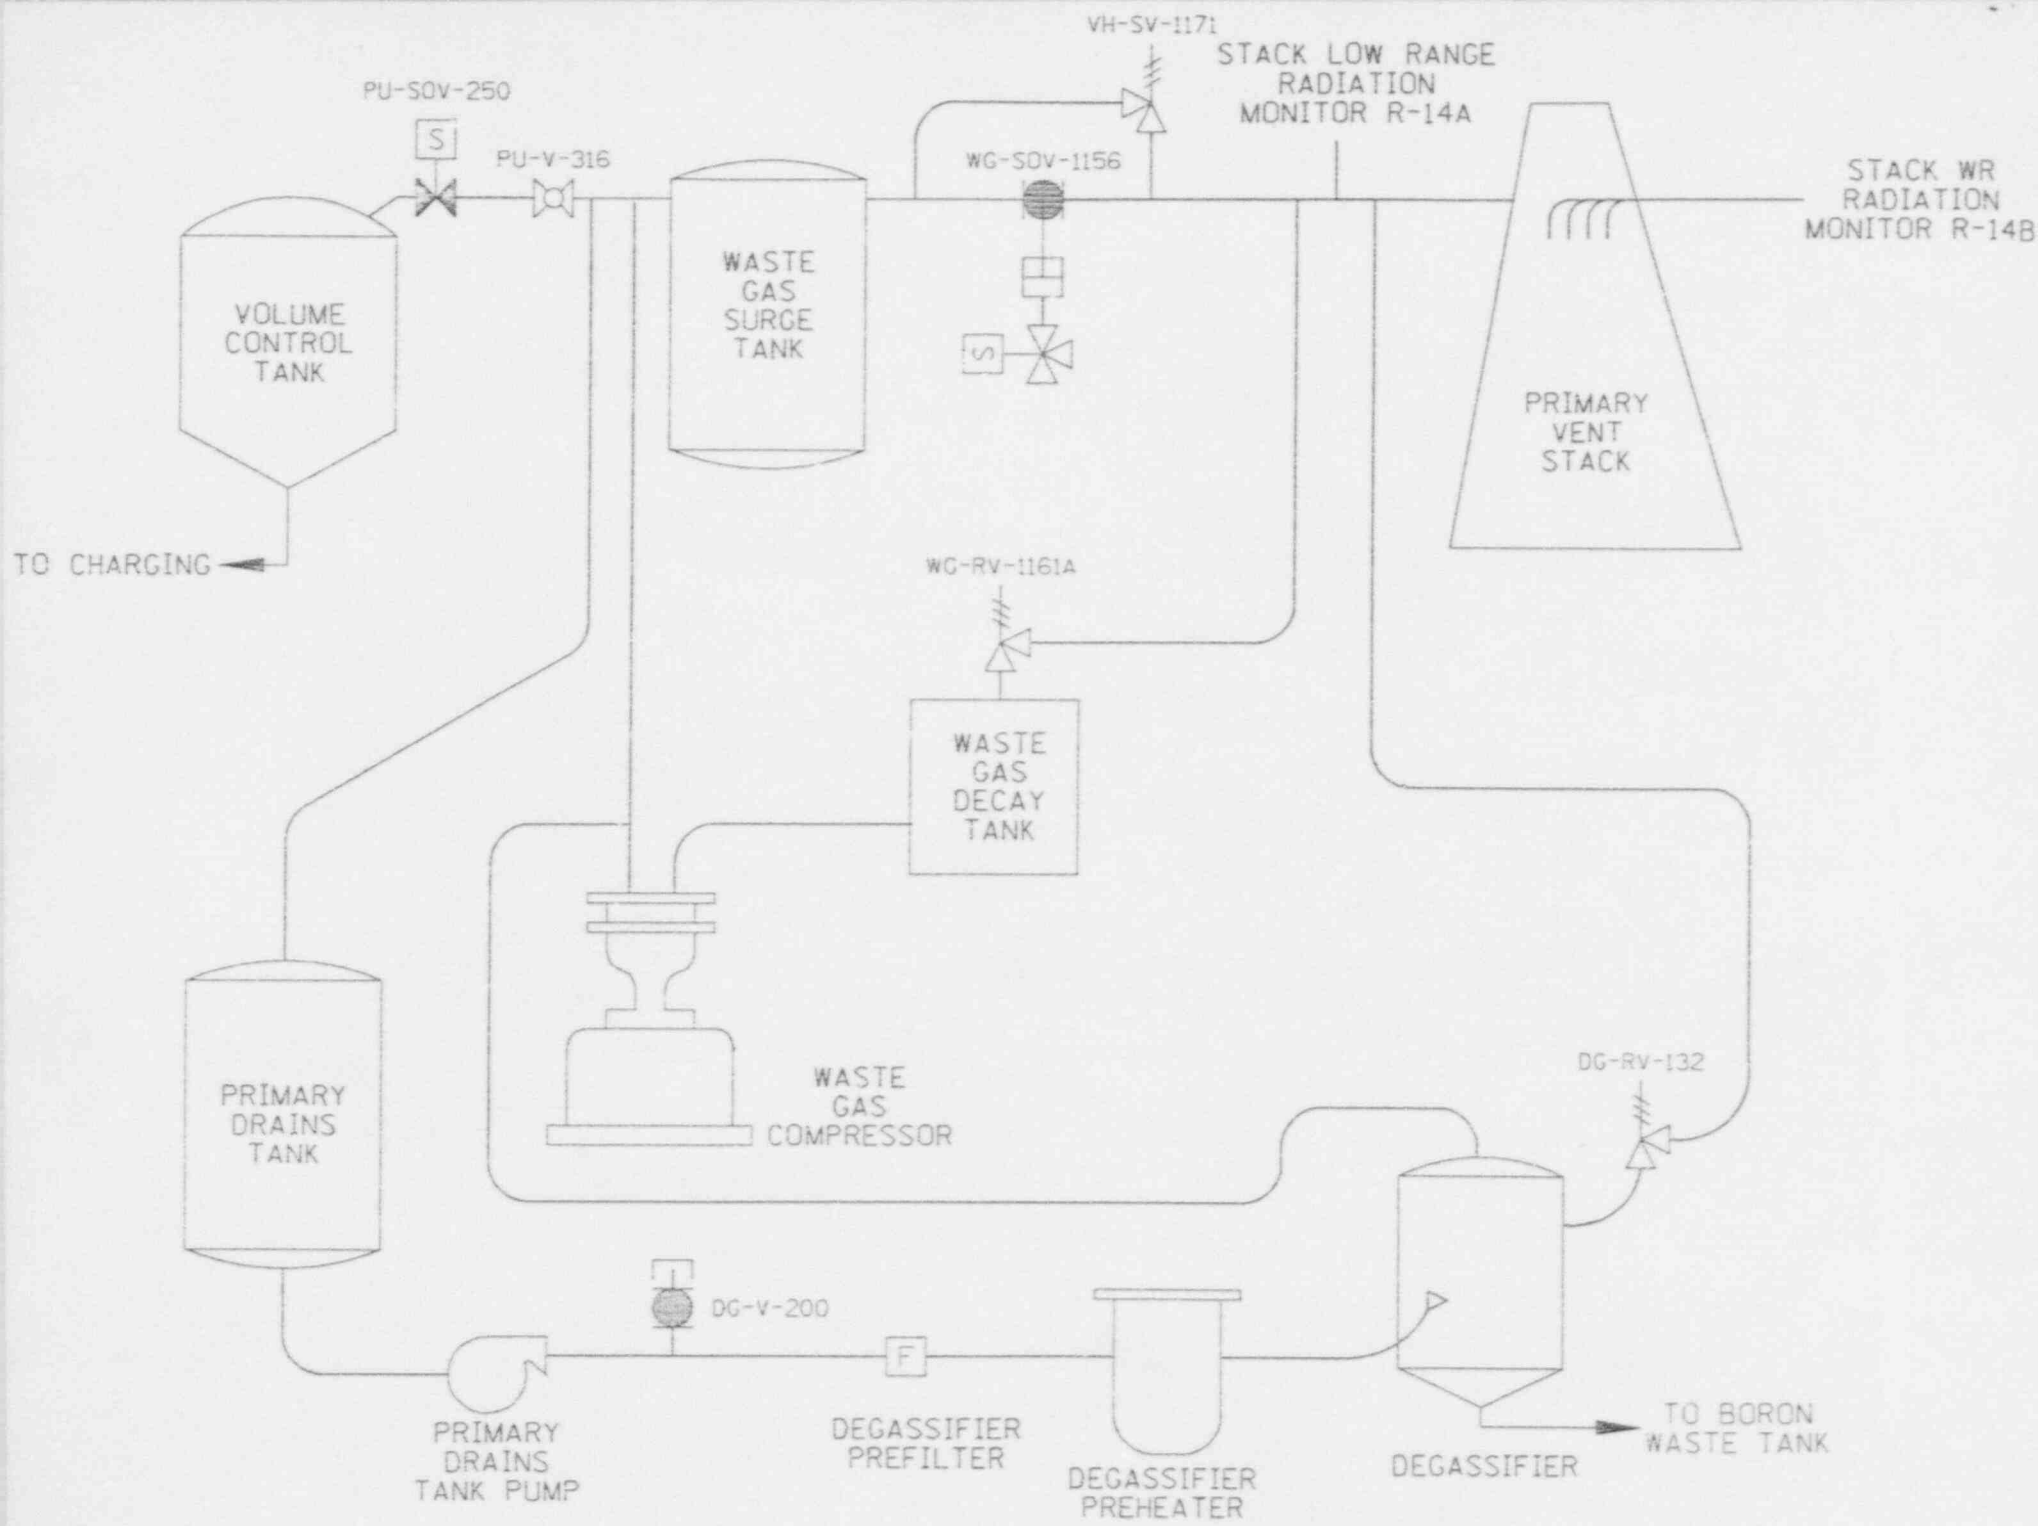
FIGURE 1. WASTE GAS SYSTEM

The licensee performed an immediate investigation of the event to determine how the release occurred and its causes. The inspector observed the licensee activities and independently confirmed the event sequence and causes. The release occurred as the VCT was being vented. The release path was from the VCT to the waste gas vent header to the waste gas surge tank to the waste gas relief line to the primary vent stack (see Figure 1). The licensee concluded that the relief valve on the waste gas vent header of the waste gas surge tank had lifted prematurely.

Although PU-SOV-250 was left open longer than intended during the venting operation, this action alone did not cause the unplanned gas release. The waste gas system is designed to operate assuming an open path from the VCT to the waste gas system. VCT valve PU-V-316 is throttled to limit the flow rate from the VCT into the waste gas vent header. The licensee's followup investigation confirmed that PU-V-316 was one turn open, as required. Waste gas compressors C-13-1A and 1B start automatically when the pressure in the waste gas header reaches 1.5 psi and 2.0 psi, respectively. Both compressors operated as expected during the event. The setpoints on the relief valves located both on the suction and discharge sides of the compressors are set to allow sufficient margin to the normal operating pressure in the header, as follows: VH-SV-1171 is set at 20 psig; WG-SOV-1156 is set at 14.5 psig; DG-RV-132 is set at 65 psig; and, WG-RV-1161A-D are set at 225 psig. However, the pressure in the waste gas header and the waste gas surge tank only reached about 4 psig during the release. The licensee concluded that one of the relief valves had misoperated and lifted prematurely. The initial investigation focused on valves WG-SOV-1156 and VH-SV-1171.

- The solenoid operator for waste gas surge tank relief valve WG-SOV-1156 was tested and found to operate satisfactorily at the prescribed lift setpoint of 14.5 psig. Thus the mechanical relief valve (VH-SV-1171) on the waste gas surge tank was the likely malfunction causing the release. The licensee plans to test this valve, but deferred that action until system conditions allow isolation of the tank.
