The inspector, while performing visual examinations of cable tray hanger welds, found deficient welds on structural steel supporting the hangers. As a result of this finding a sample area was inspected for welding quality, erection as per drawing, fabrication to applicable specification requirements, and material availability.

WM. H. ZIMMER NUCLEAR POWER STATION, UNIT 1
FINAL SAFETY ANALYSIS REPORT

W8 X 17's - Elevation 546 Auxiliary Building
Switchgear Room

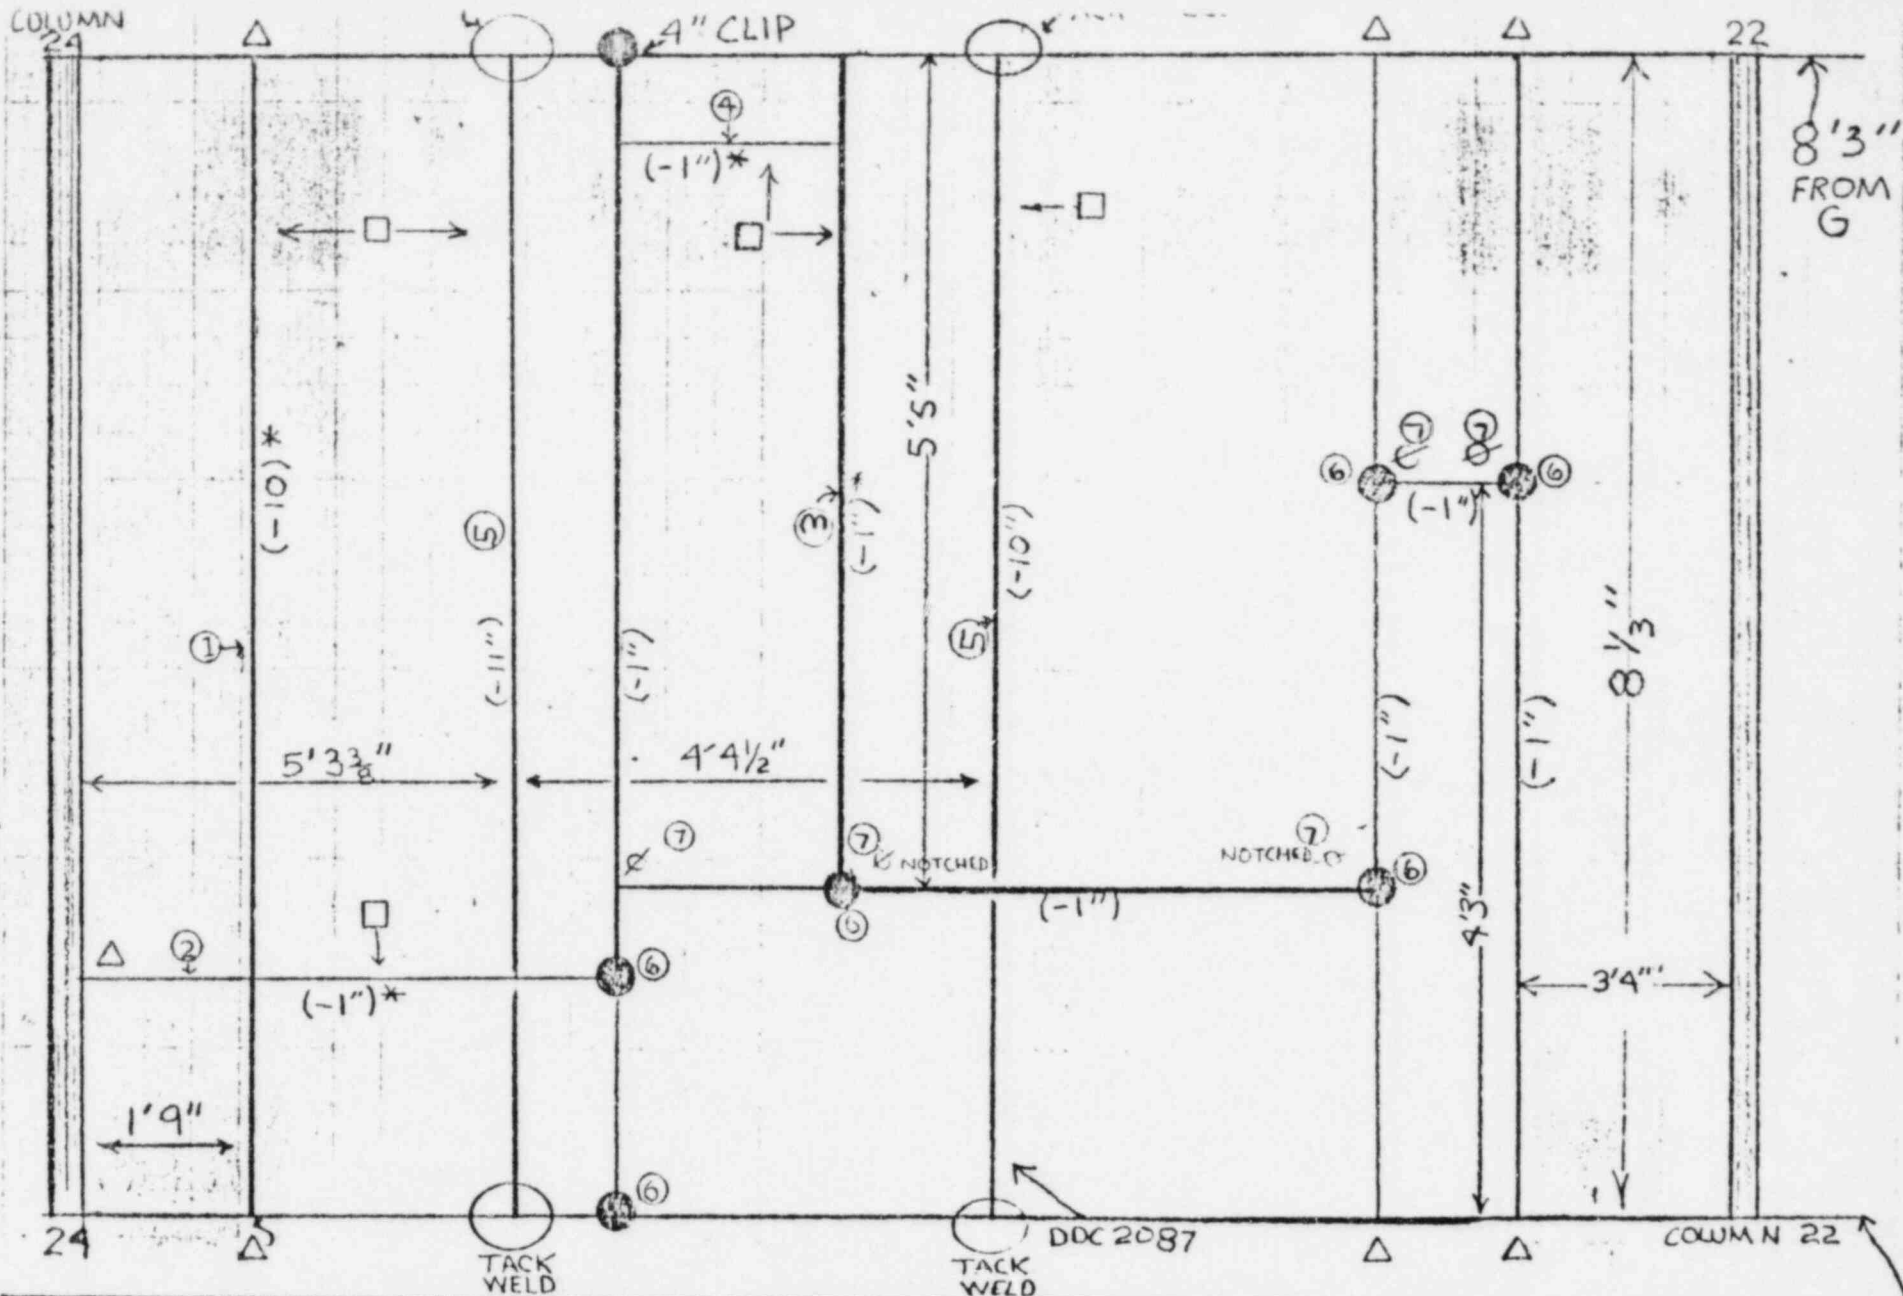
The area ~~selected~~ ^{observed} was in the 1-11. Aux. building blue switchgear rooms at the 546 elevation level. The area inspected was 8'3" west of G and 16'6" east of H; between columns 22 and 24 of S+L drawing: # S-546 rev. AB.

- ② W8x17 beam 6'3" in length positioned north to south 13'8" west of G, -1" from elevation 546; same discrepancy as ① and defective.

⑦ In addition to the above, the following defects of the fabricated beams was noted: Re-entrant corners of several W8x17's in this area were observed to have notches and no radius as required by AISC seventh edition ('69) page 4.113 ($\frac{1}{2}$ " radius required) see Attachment A for locations.

① Defective erection welds; ^(AISC-D.1.1) several fabricated
beams have no radius and are notched

- * --- Not shown on S&L DWG. #S-546, Rev. AB or DDC's listed.
- --- Re-entrant corners not coped.
- △ --- Welds or connections covered with fire proofing unable to evaluate.
- --- No identification on W8X17's or records to support tracibility of material.
- --- Defective welds.

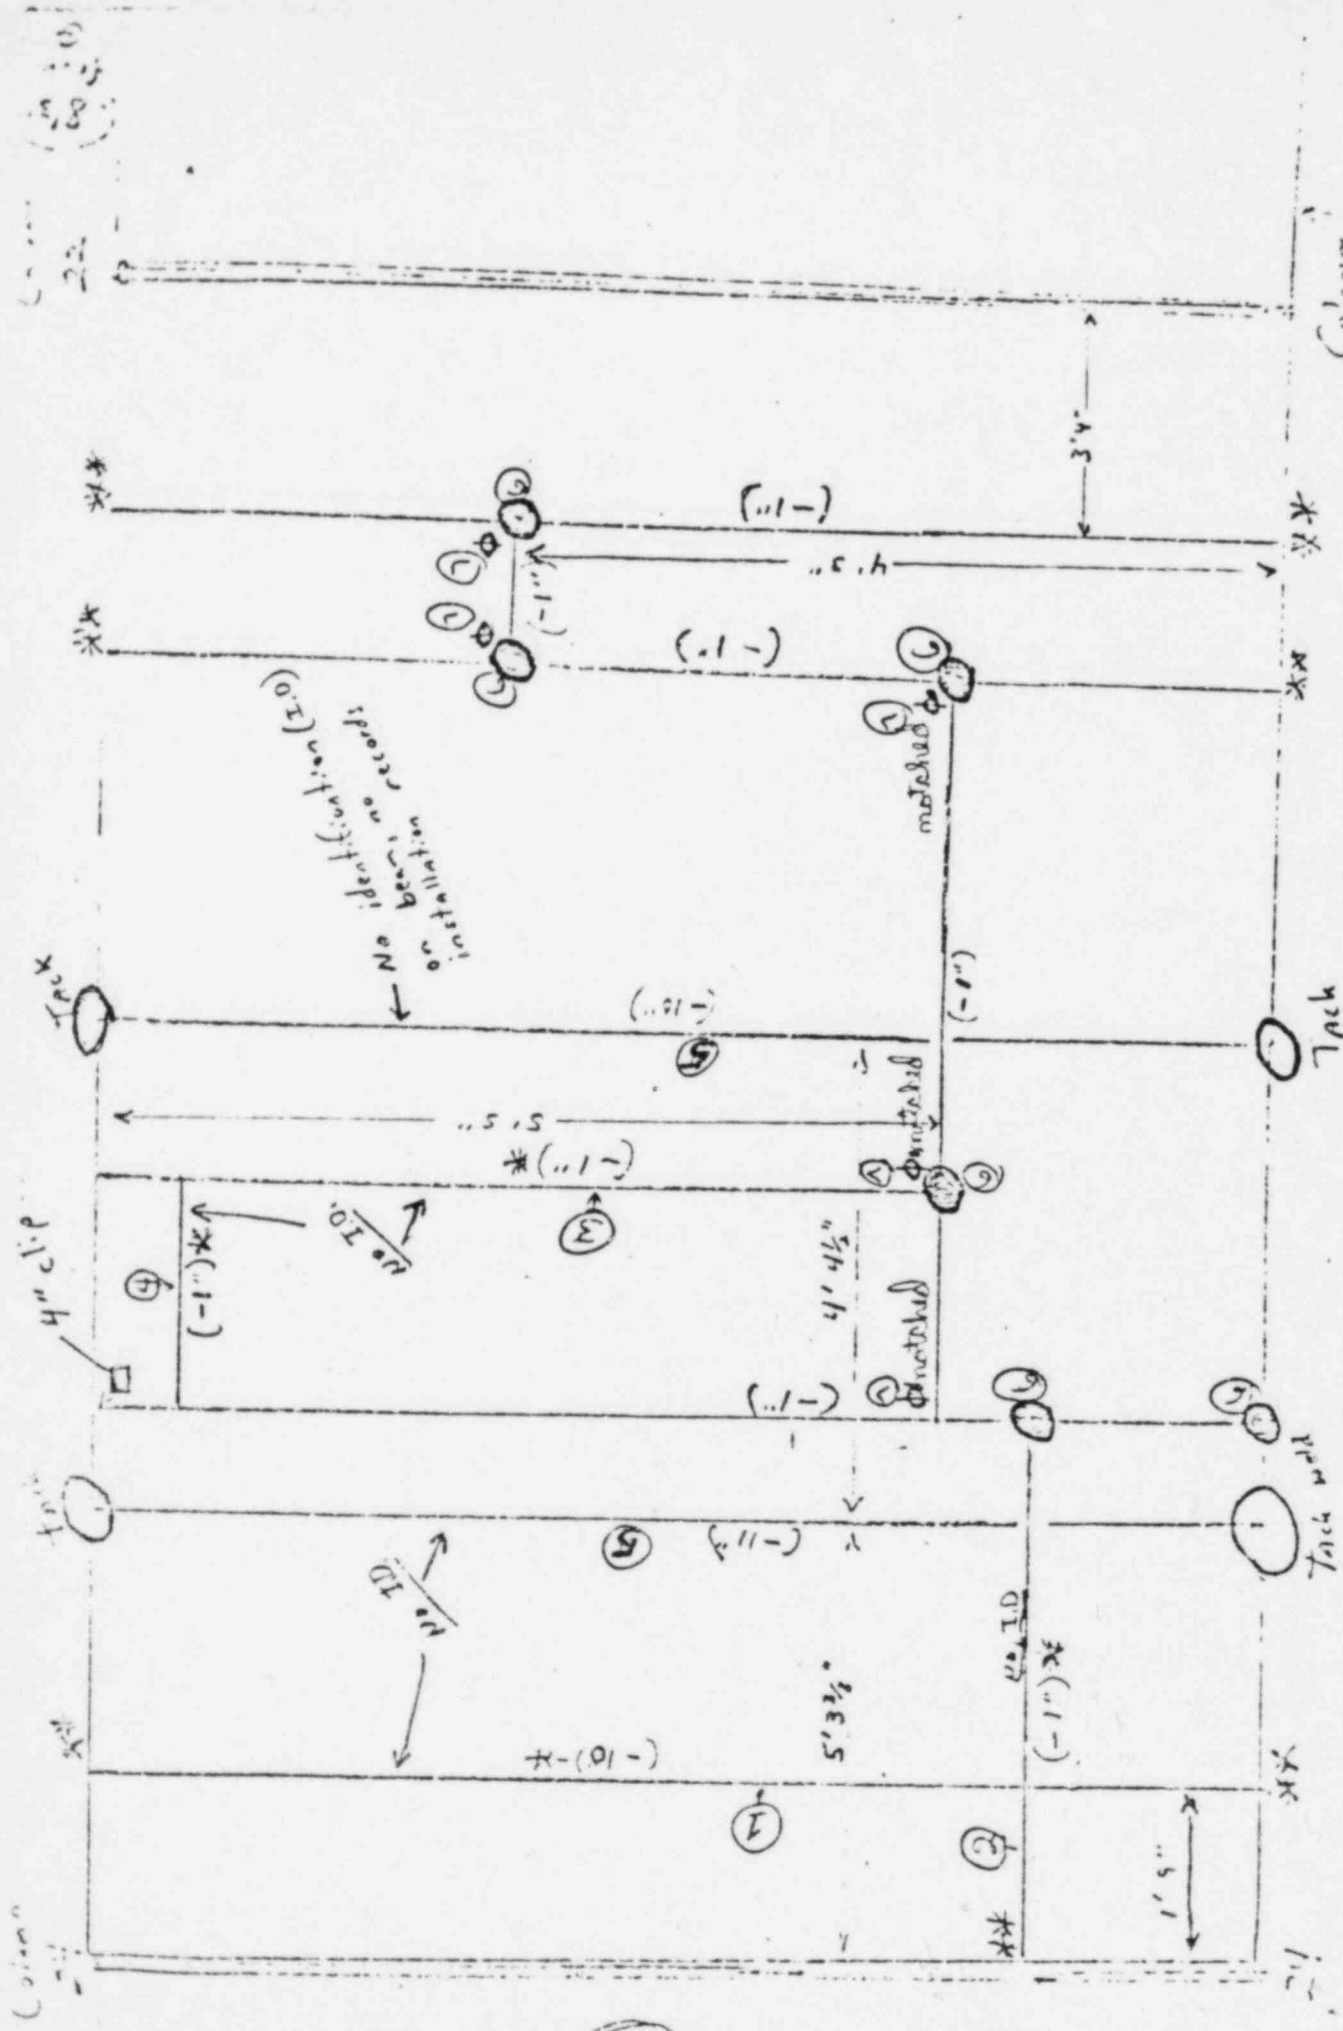
17 x 17's - Elevation 546 Aux. Building Blue switchgear room
 * Not shown on S&L Dwg. #5-546 Row AB or DDC's listed defective welds
 * permanent covers not copied

on bases no identification (I.D.)
 install with records

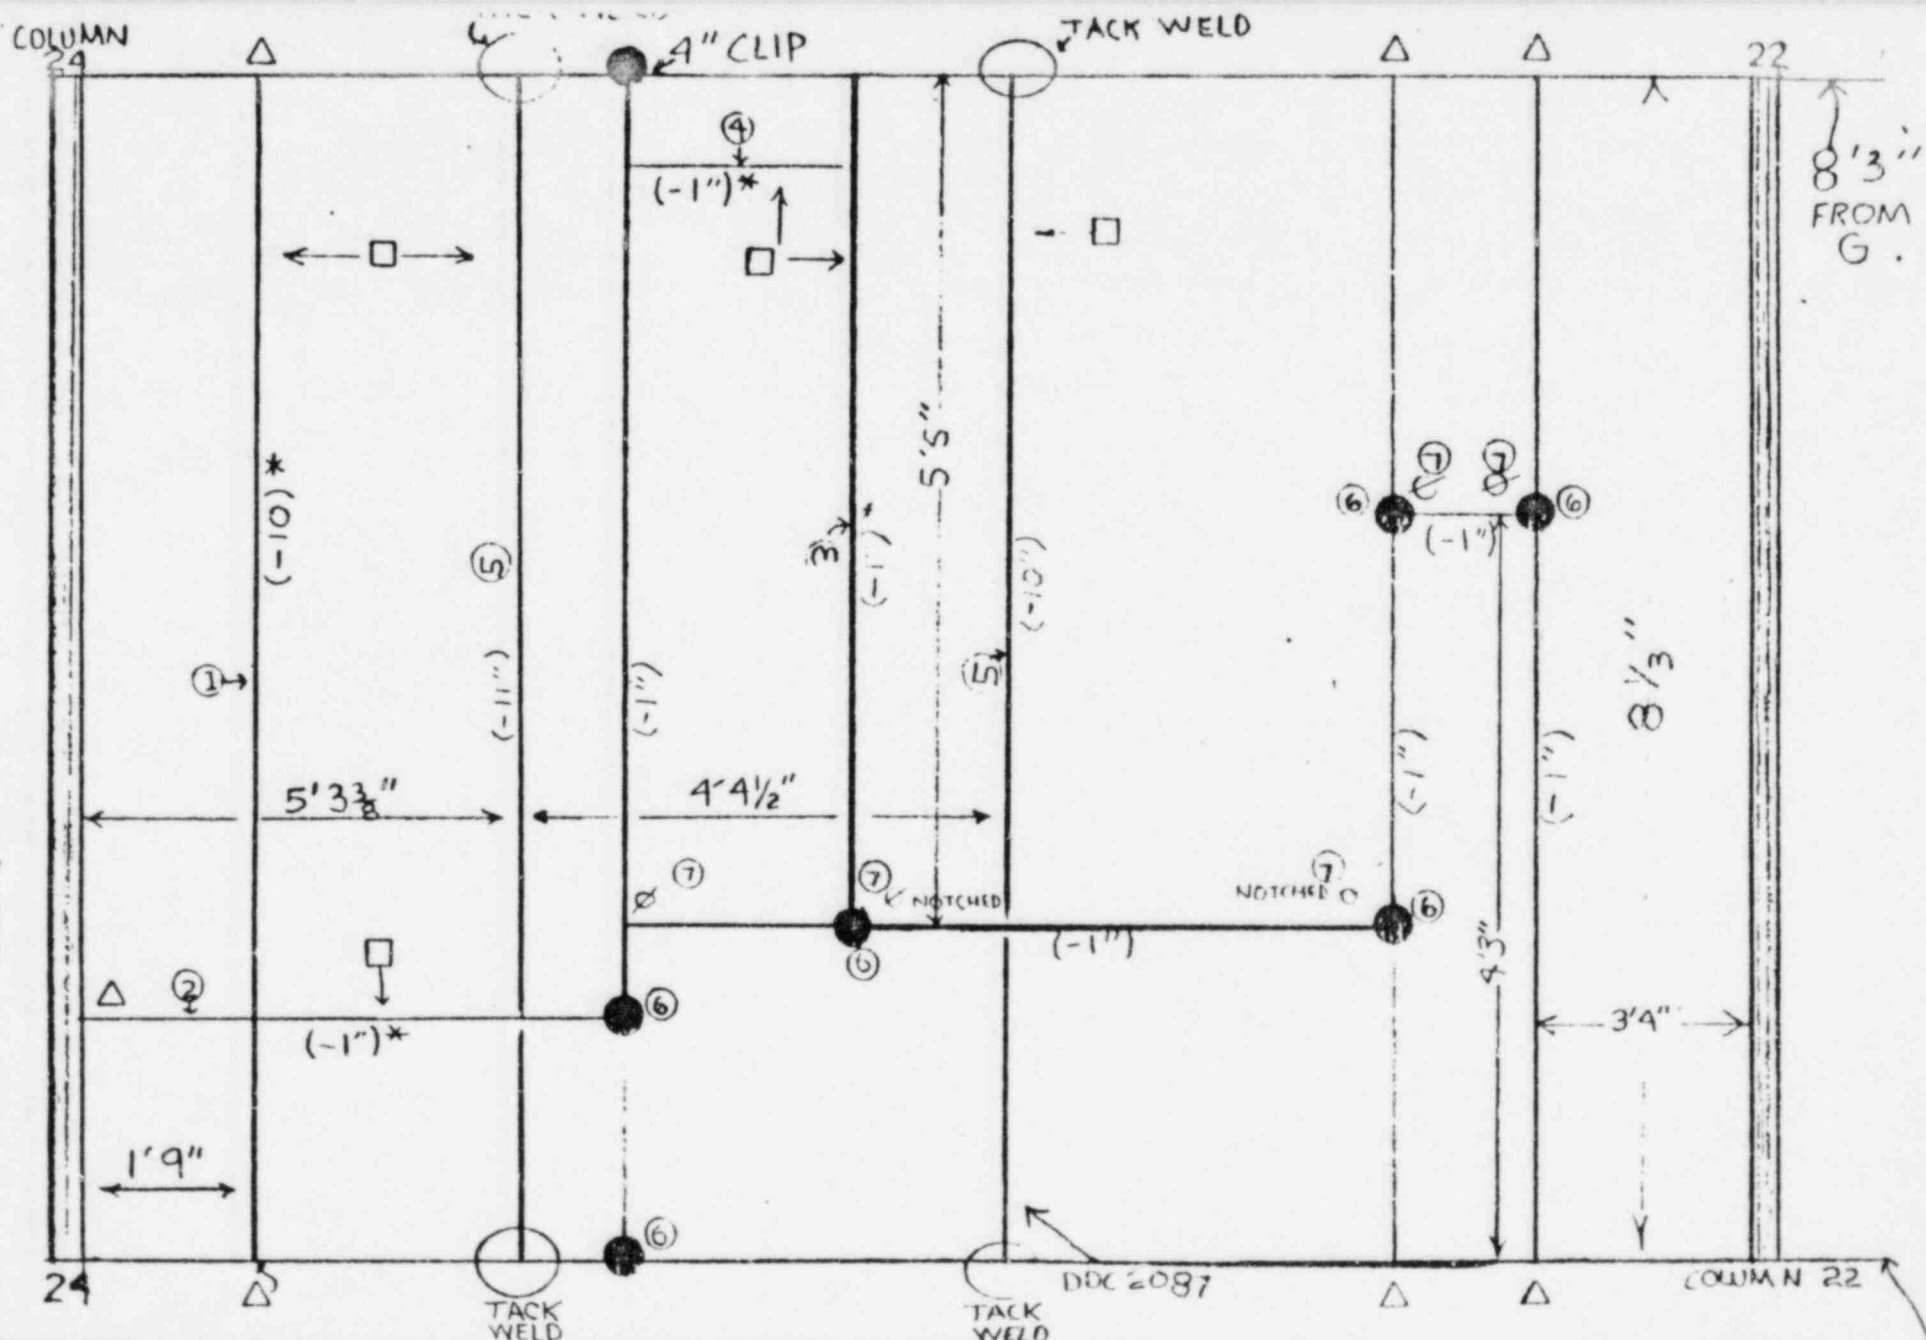
ATTACHMENT A
 W8 X 17's - Elevation 546 Auxiliary Building
 Switchgear Room

- * --- Not shown on S&L DWG. #S-546, Rev. AB or DUC's listed.
- --- Re-entrant corners not coped.
- △ --- Welds or connections covered with fire proofing unable to evaluate.
- --- No identification on WRX17's or records to support tracibility of material.
