UNITED STATES
NUCLEAR REGULATORY COMMISSION
REGION V

Docket Nos. 50-133
50-275
50-323

UL FIRE TEST

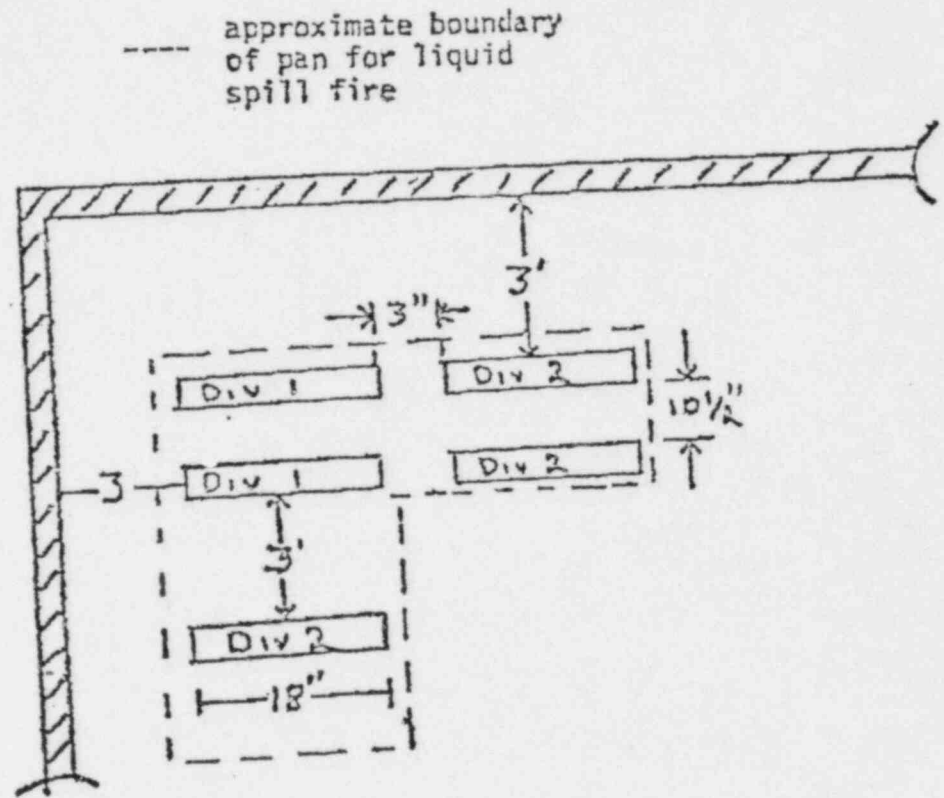
Figure 1

Vertical Tray Corner Test
