UNITED STATES  
NUCLEAR REGULATORY COMMISSION  
REGION III  
799 ROOSEVELT ROAD  
GLEN ELLYN, ILLINOIS 60137

IE Circular No. 78-18  
November 6, 1978

UL FIRE TEST

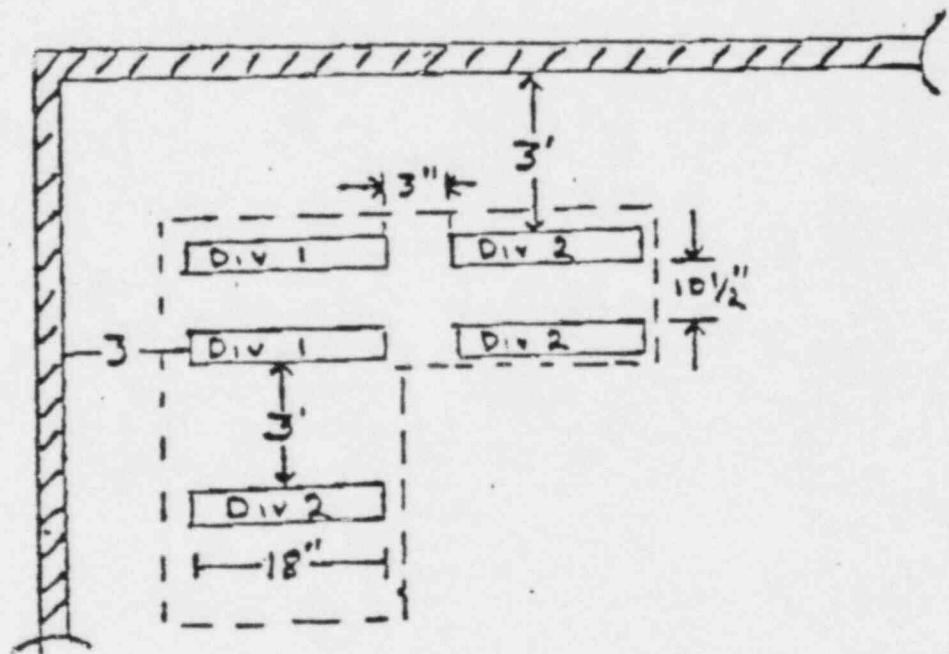
Figure 1

The configuration of the fire test was selected to simulate a section of a plant area with vertical cable trays containing redundant safety divisions arranged such that the redundant divisions could be simultaneously exposed to a potential fire resulting from an inadvertent spill of flammable liquid in the area. The arrangement of the cable trays and the designation of the redundant tray divisions is shown in Figure 1. Figure 2 shows the location of the fire detectors and the three groups of sprinklers. Each of the five cable trays contained cable insulated with polyvinyl chloride and was enclosed in a separated ceramic fiber blanket fire barrier from floor to ceiling in accordance with the manufacturer's recommendations. The sprinkler and detector arrangement was as permitted by NFPA Code. However, no water was actually used at any time during this test due to the failure of some sprinkler heads to actuate, as explained below.

Preliminary information indicates that the flammable liquid or flames penetrated the protective barriers at the bottom of the vertical trays and caused fire damage to the polyvinyl chloride insulation on cables in four of the five trays.

The most probable cause of the fire damage in certain cable trays appears to be related to the absorption or seepage of heptane under the ceramic fiber blanket at the juncture with the floor. Once the heptane entered the interior regions of the cable tray, then ignition apparently occurred via the small opening at the floor or through a vapor/air path within the joints. There is some indication that some cable damage was caused by absorption of heptane on the inside of the barrier (wicking effect) and its ignition which heated a cable tray ladder rung, causing damage to a cable in contact with the rung. The ingress of the heptane into the ceramic fiber needs to be further evaluated since this appears to be the most significant failure mode.

Vertical Tray Corner Test

1. To protect against spills of flammable liquids, barriers or curbs may be needed to prevent entry of the flammable liquid behind fire barriers. A wick effect may also need to be considered in the design of fire barriers.
2. Some small fires may not actuate sprinkler heads. To reduce this possibility in sprinkler systems to be installed, fast response sprinkler heads should be considered (less than approximately 3 minutes in the UL Standard 199 "Automatic Sprinklers for Fire Protection Service").
3. The location of the fire detection devices and the sprinkler heads relative to the fire and components being protected is of great importance. The path of the air movement in the area influences the actuation of such devices and should be considered in the system layout.
