UNITED STATES  
NUCLEAR REGULATORY COMMISSION  
REGION III  
799 ROOSEVELT ROAD  
GLEN ELLYN, ILLINOIS 60137

IE Circular No. 78-18  
November 6, 1978

UL FIRE TEST

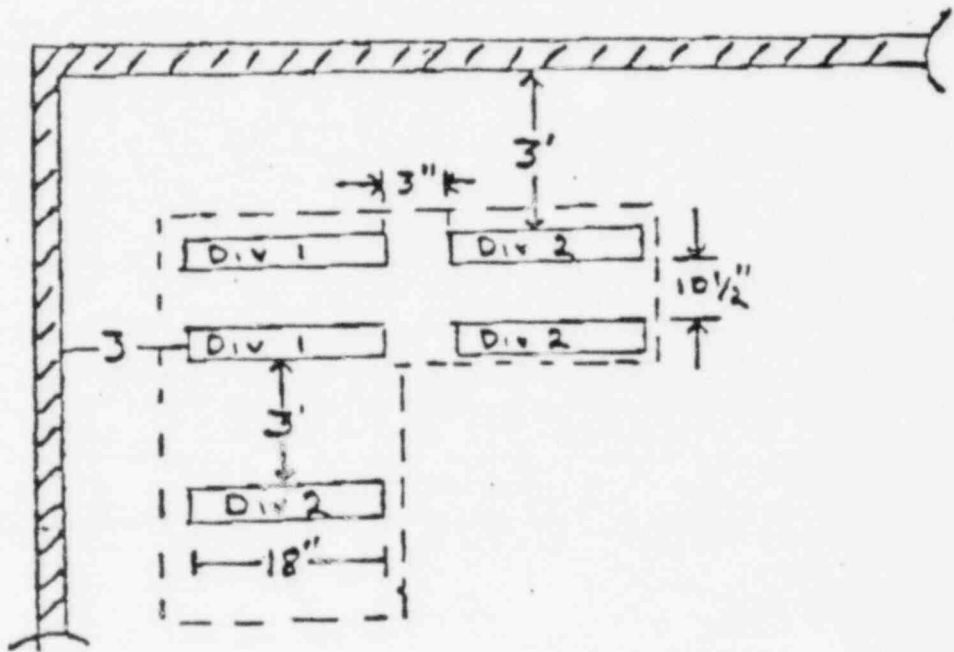
Figure 1

--- approximate boundary  
of pan for liquid  
spill fire

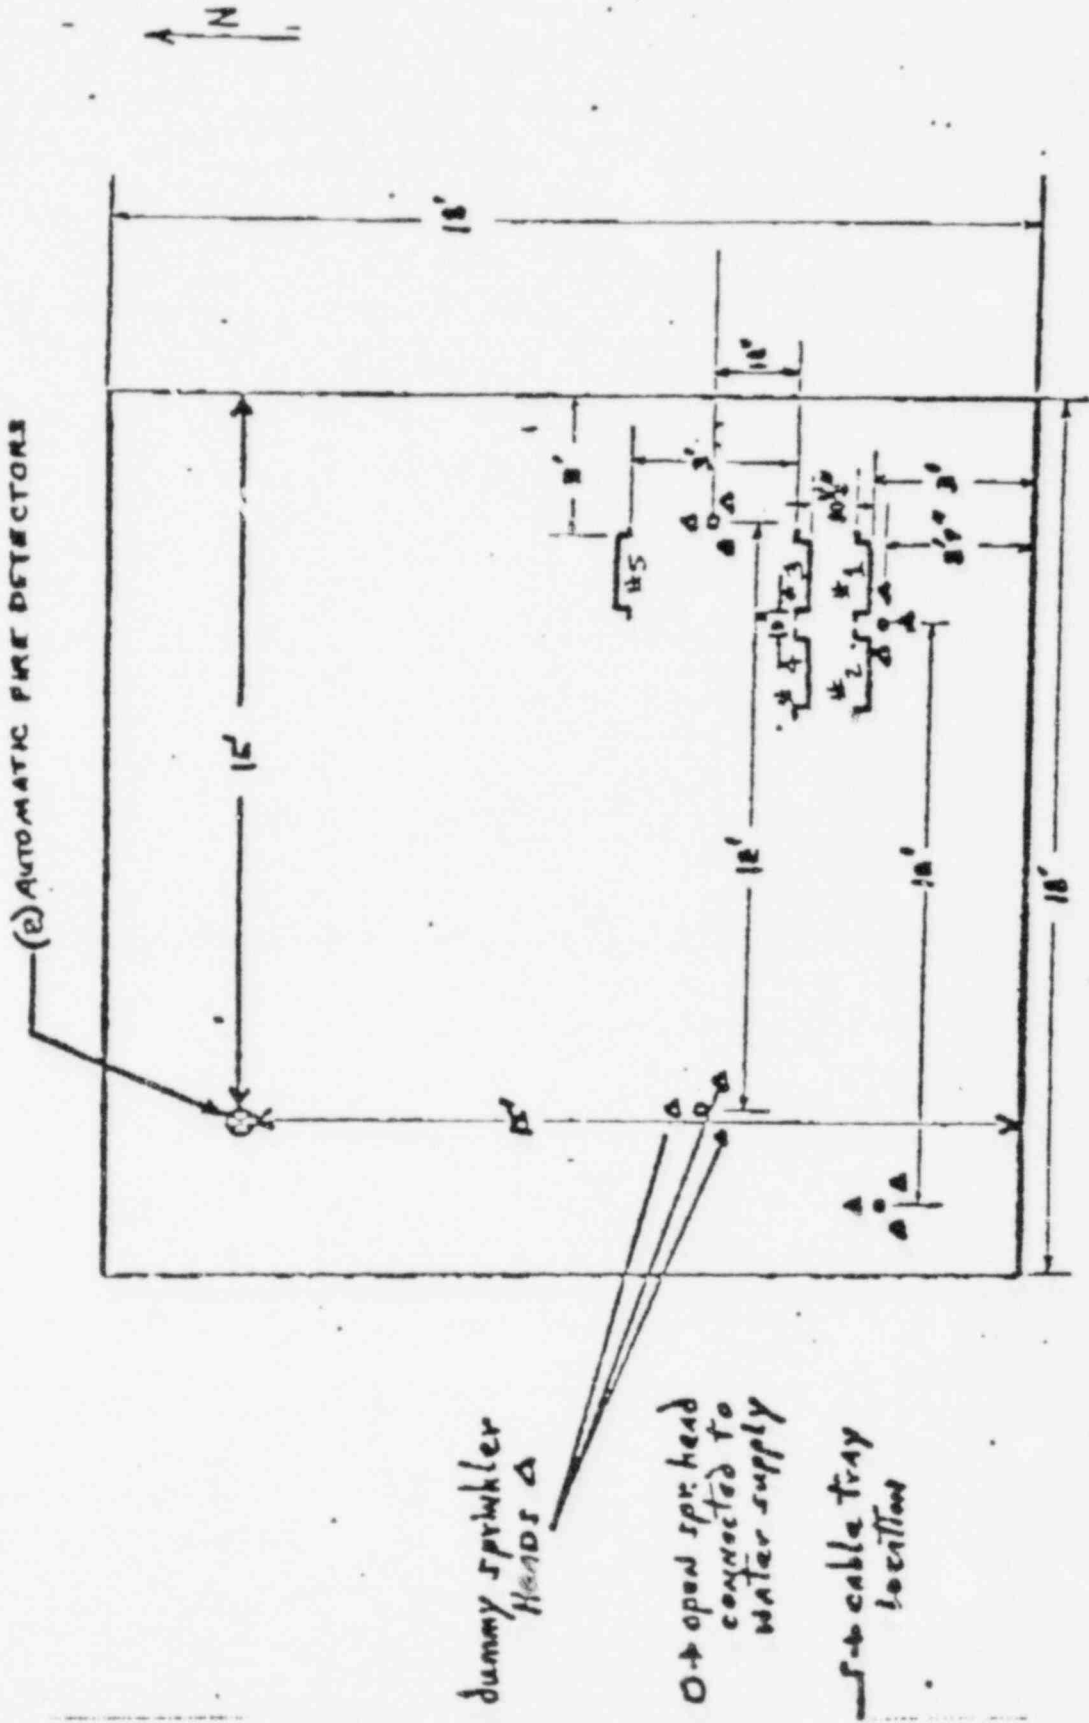
FIGURE 2  
TOP VIEW GENERAL

Vertical Tray Corner Test
