UNITED STATES
NUCLEAR REGULATORY COMMISSION
OFFICE OF INSPECTION AND ENFORCEMENT
WASHINGTON, D. C. 20555

IE Circular 78-18

UL FIRE TEST

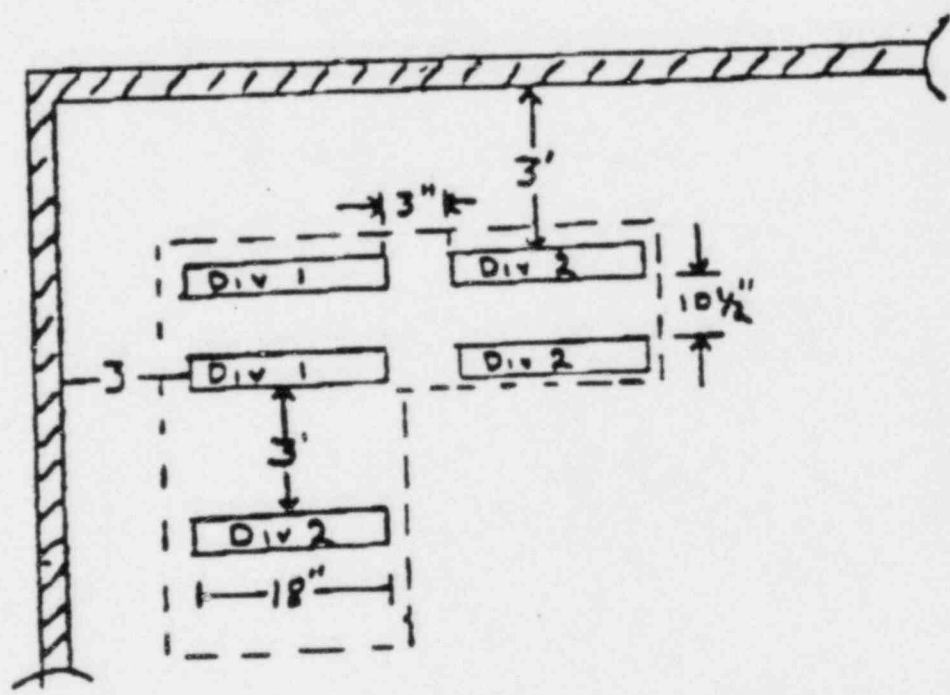
Figure 1

The configuration of the fire test was selected to simulate a section of a plant area with vertical cable trays containing redundant safety divisions arranged such that the redundant divisions could be simultaneously exposed to a potential fire resulting from an inadvertent spill of flammable liquid in the area. The arrangement of the cable trays and the designation of the redundant tray divisions is shown in Figure 1. Figure 2 shows the location of the fire detectors and the three groups of sprinklers. Each of the five cable trays contained cable insulated with polyvinyl chloride and was enclosed in a separated ceramic fiber blanket fire barrier from floor to ceiling in accordance with the manufacturer's recommendations. The sprinkler and detector arrangement was as permitted by NFPA Code. However, no water was actually used at any time during this test due to the failure of some sprinkler heads to actuate, as explained below.

Preliminary information indicates that the flammable liquid or flames penetrated the protective barriers at the bottom of the vertical trays and caused fire damage to the polyvinyl chloride insulation on cables in four of the five trays.

The most probable cause of the fire damage in certain cable trays appears to be related to the absorption or seepage of heptane under the ceramic fiber blanket at the juncture with the floor. Once the heptane entered the interior regions of the cable tray, then ignition apparently occurred via the small opening at the floor or through a vapor/air path within the joints. There is some indication that some cable damage was caused by absorption of heptane on the inside of the barrier (wicking effect) and its ignition which heated a cable tray ladder rung, causing damage to a cable in contact with the rung. The ingress of the heptane into the ceramic fiber needs to be further evaluated since this appears to be the most significant failure mode.

Vertical Tray Corner Test

1. To protect against spills of flammable liquids, barriers or curbs may be needed to prevent entry of the flammable liquid behind fire barriers. A wick effect may also need to be considered in the design of fire barriers.
2. Some small fires may not actuate sprinkler heads. To reduce this possibility in sprinkler systems to be installed, fast response sprinkler heads should be considered (less than approximately 3 minutes in the UL Standard 199 "Automatic Sprinklers for Fire Protection Service").
3. The location of the fire detection devices and the sprinkler heads relative to the fire and components being protected is of great importance. The path of the air movement in the area influences the actuation of such devices and should be considered in the system layout.
