A-40

This is in response to your letter dated May 11, 1981, requesting on behalf of Mr. Thomas Applegate that I recommend suspension of the construction permit for the William H. Zimmer Nuclear Power Station. The request was based on a study by your organization of the NRC's reports of inspections and investigations since early 1979, as well as on allegations made by Mr. Applegate and others.

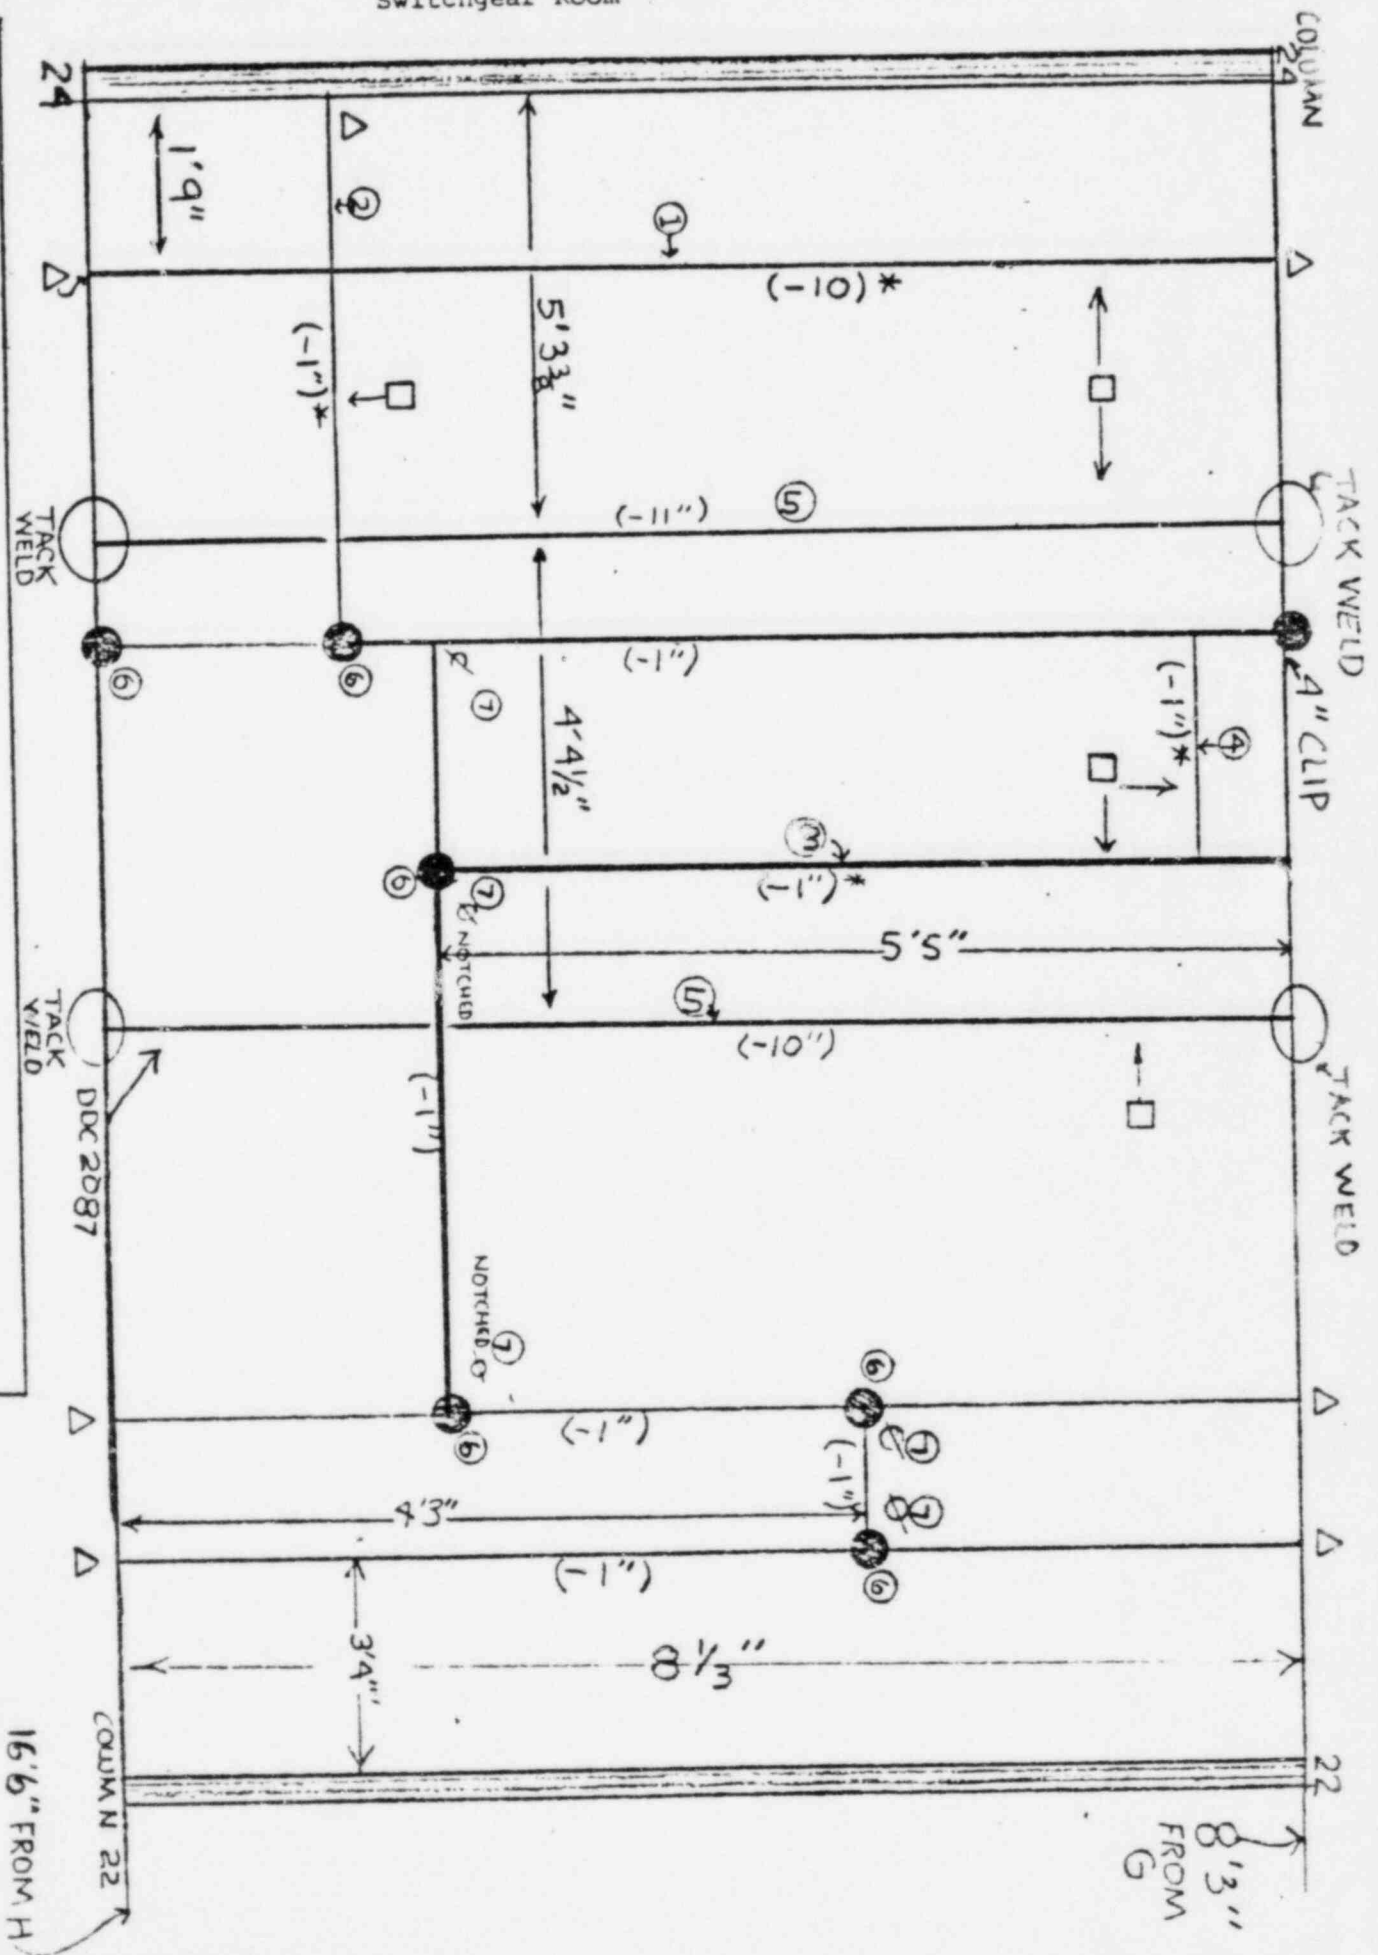
W8 X 17's - Elevation 546 Auxiliary Building
Switchgear Room

These problems and the adequacy of the structural steel are addressed in the licensee's Quality Confirmation Program

- * Not shown on S&L DWG. #S-546, Rev. AB or DDC's listed.
- Re-entrant corners not coped.
- △ Welds or connections covered with fire proofing unable to evaluate.
- No identification on W8X17's or records to support tracibility of material.

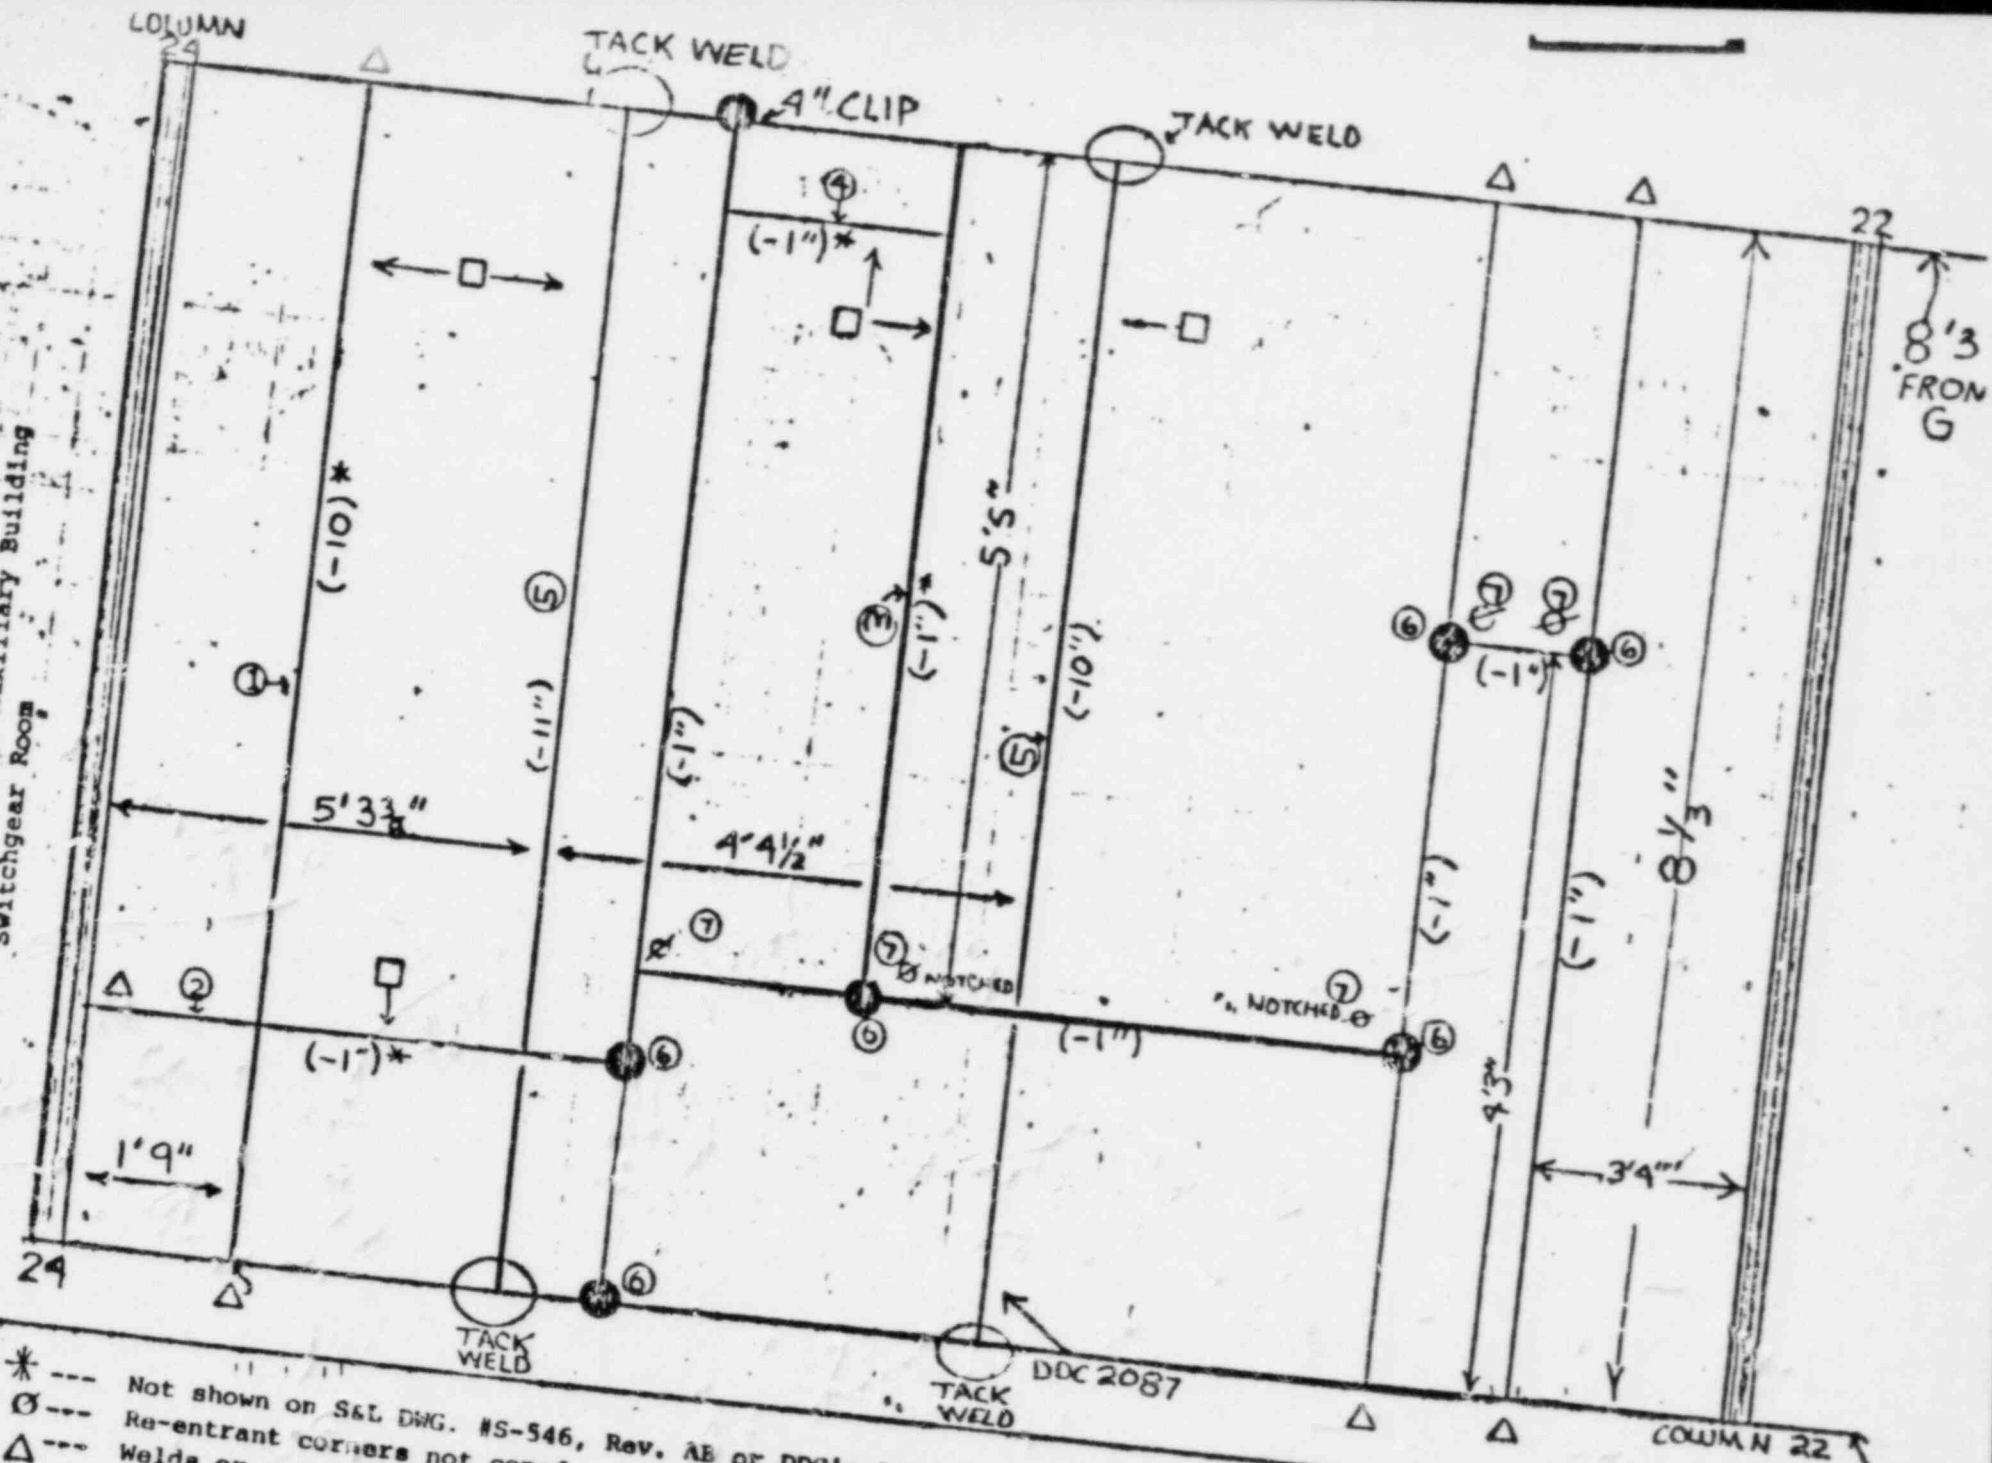
ATTACHMENT A
 WB X 17's - Elevation 546 Auxiliary Building
 Switchgear Room

The beams for which the traceability of the heat numbers was not maintained is contrary to 10 CFR 50 Appendix B, Criterion VIII and the Wm. H. Zimmer QA Manual, Section 8.2 as described in the Appendix A to the report transmittal letter. (358/81-13-04)

- * --- Not shown on S&L DWG. #S-546, Rev. AB or DDC's listed.
- ⊙ --- Re-entrant corners not coped.
- Δ --- Welds or connections covered with fire proofing unable to evaluate.
- --- No identification on WBX17's or records to support.
- --- Defective

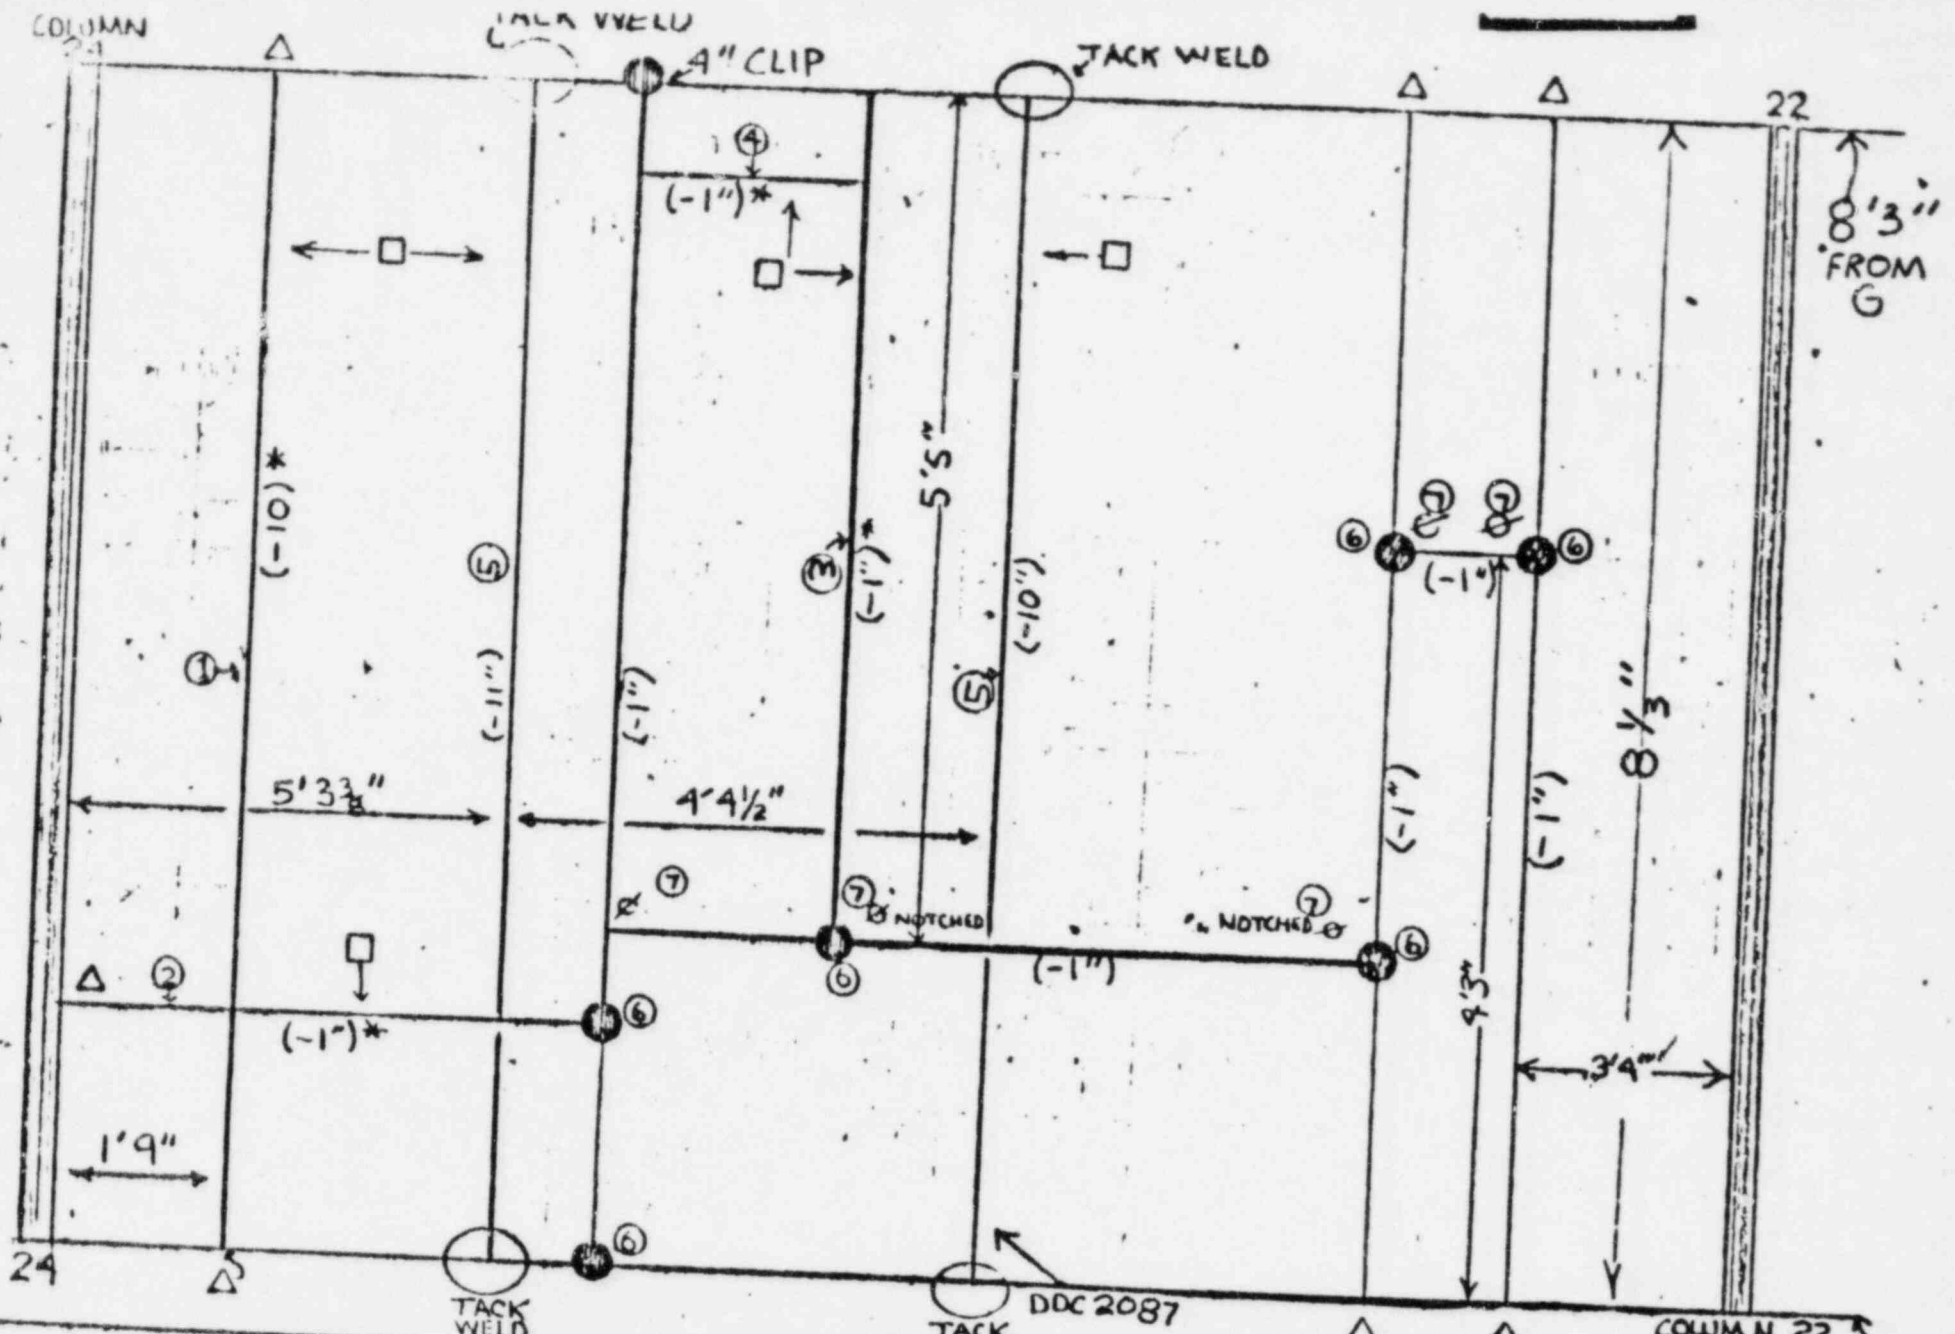
ATTACHMENT A
 WB X 17's - Elevation 546 Auxiliary Building
 Switchgear Room

- * --- Not shown on S&L DWG. #S-546, Rev. AB or DDC's listed.
- ⊙ --- Re-entrant corners not coped.
- △ --- Welds or connections covered with fire proofing unable to evaluate.
- [] --- No identification on WBX17's or records to support tracibility of material
