CHECK VALVE LEAK ROOT CAUSE, ENGINEERING ANALYSIS  
AND REPAIR REPLACEMENT OPTIONS

Check Valve Leak  
Root Cause, Engineering Analysis  
and Repair/Replacement Options

Prepared for  
Palisades Nuclear Station

CMED-058599  
Revision 0  
March 5, 1994

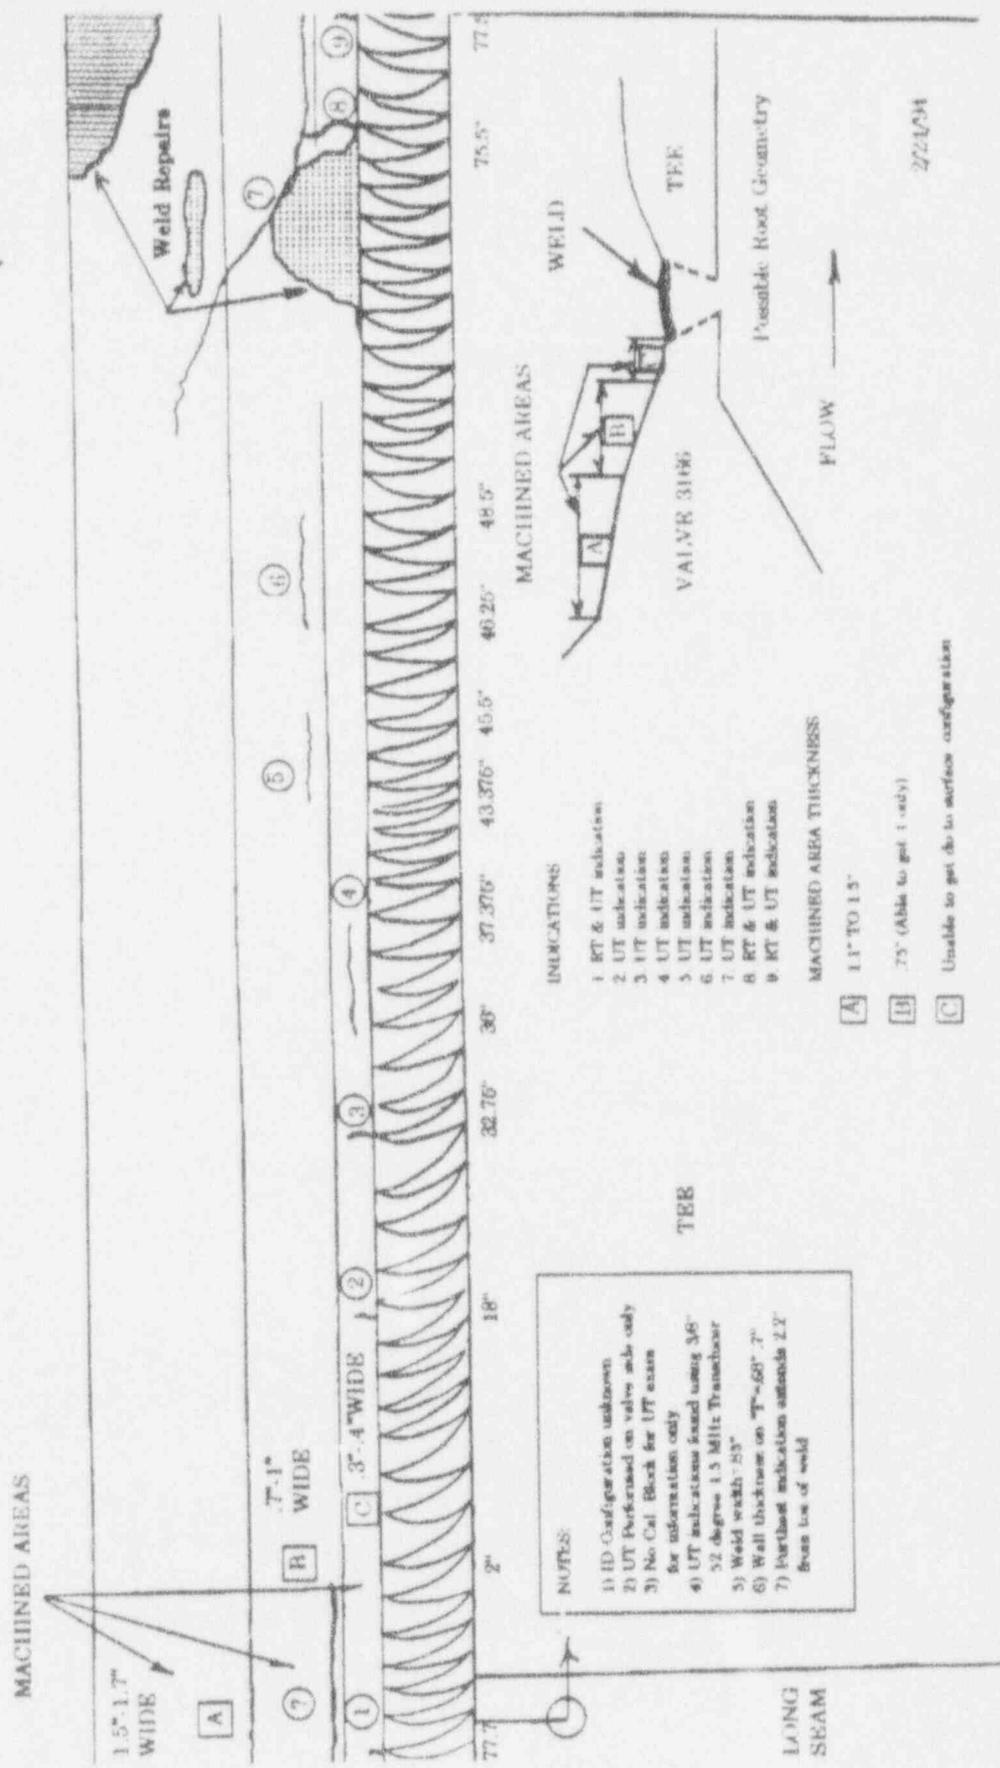
CK-ES310G

The radiograph revealed a linear indication approximately  $3/4$  inch long, oriented transverse from the circumferential weld and lining up (in plan view) with the two indications identified earlier by PT. In addition, two more linear indications were identified approximately  $2\ 1/2$  inches from the previous indication, oriented parallel to one another and also transverse from the circumferential weld. Radiographic examination of the remainder of the weld circumference was performed with no new indications being detected.

An Ultrasonic examination (UT) of the valve casting in the same area revealed an indication oriented circumferentially and corresponding to RT location marker  $61\ 1/4$ , through 0 (circumference approximately 78 inches), to 2 (approximately 19 inches). A second Ultrasonic examination of the remainder of the circumference was performed. This examination on February 23, 1994 identified five additional indications. Due to ultrasonic examination limitations of cast stainless steel and the indication locations in the valve transition, the depth and through wall positions were not determined. The attached Figure 1 shows a sketch locating all indications found. Two of the indications were axial to the toe of the weld. One was at location 18" and one at 32.75" from top dead center. Neither has a length or depth given but appear to be less than  $1/2$ " in axial length. Three of the indications were oriented circumferentially. The first is located at 37" and is approximately  $1\ 3/8$ " long, the second is located at  $44\ 1/2$ " and is approximately  $2\ 1/8$ " long. The third is located at  $47\ 3/8$ " and is approximately  $2\ 1/4$ " long. None of these has a depth or through wall component given nor is the axial distance from the weld given, but they appear to be within 1" from the toe of the weld axially.
