**HENRY J. KAISER
COMPANY**
P.O. BOX 201, MOSSBURN, OHIO 45159

SUBJECT: STATUS OF ZIEGLER INVESTIGATION REPORT, ASSIGNMENT OF
TASKS AND RECOMMENDATIONS

A special counsel office for a federal civil service board in Washington has asked the Nuclear Regulatory Commission to investigate charges of safety defects and criminal violations at the Zimmer Nuclear Power Plant in Moscow, Ohio.

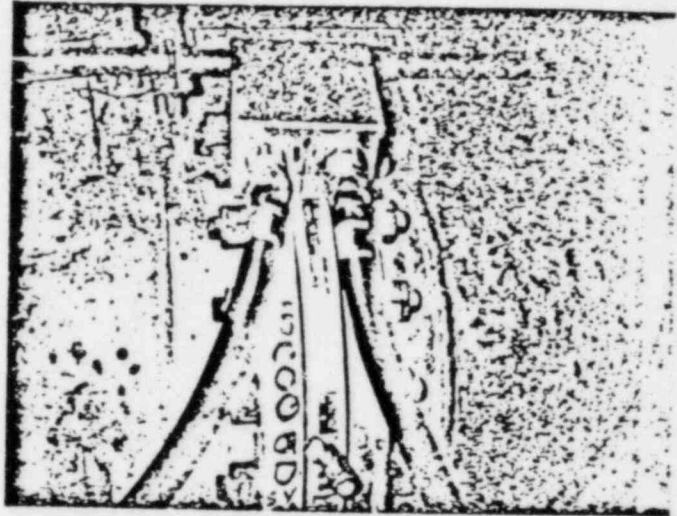
PCO-59
525' 1"

The N.W.C. type of flexible conduit used in the containment area has been splitting. It is not certain to what is causing the flex to split. The splitting seems to be caused from rotting or some reason other than mechanical or carelessness.

9. DESCRIPTION OF NONCONFORMANCE	10. DISPOSITION	11. DISPOSITION INSTRUCTIONS/JUSTIFICATION
<p>LOCATION: CONTAINMENT SYSTEM: CONDUITS (FLEX) - LD, VP, AR, R, RI</p> <p>REQUIREMENTS: QACMI G-4</p> <p>REF: SR 2800</p> <p>DEFICIENCY: THE N.W.C. LIGHTITE TYPE OF FLEXIBLE CONDUIT, USED IN THE CONTAINMENT AREA, HAS BEEN SPLITTING. IT IS NOT CERTAIN TO WHAT IS CAUSING THE FLEX TO SPLIT. THE SPLITTING SEEMS TO BE CAUSED FROM ROTTING OR SOME OTHER REASON THAN MECHANICAL OR CONSTRUCTION CARELESSNESS. SOME EXAMPLES ARE PICTURED ON THE FOLLOWING PAGES.</p>
