UNITED STATES
NUCLEAR REGULATORY COMMISSION
REGION IV
611 RYAN PLAZA DRIVE, SUITE 1000
ARLINGTON, TEXAS 76011

In Reply Refer To:
RIV
Docket No. 50-382/IE Circular 78-18

IE Circular 78-18
Date: November 6, 1978
Page 1 of 3

UNDERWRITERS LABORATORY FIRE TEST

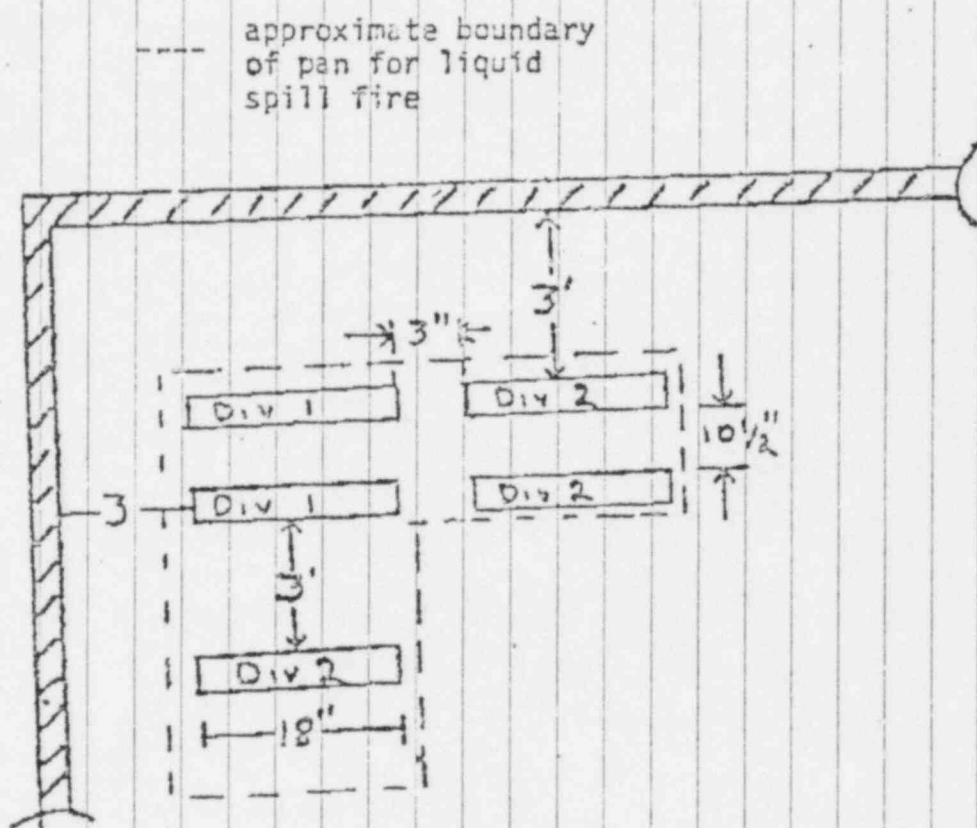
Figure 1

Preliminary information indicates that the flammable liquid or flames penetrated the protective barriers at the bottom of the vertical trays and caused fire damage to the polyvinyl chloride insulation on cables in four of the five trays.

The most probable cause of the fire damage in certain cable trays appears to be related to the absorption or seepage of heptane under the ceramic fiber blanket at the juncture with the floor. Once the heptane entered the interior regions of the cable tray, then ignition apparently occurred via the small opening at the floor or through a vapor/air path within the joints. There is some indication that some cable damage was caused by absorption of heptane on the inside of the barrier (wicking effect) and its ignition which heated a cable tray ladder rung, causing damage to a cable in contact with the rung. The ingress of the heptane into the ceramic fiber needs to be further evaluated since this appears to be the most significant failure mode.

Vertical Tray Corner Test

1. To protect against spills of flammable liquids, barriers or curbs may be needed to prevent entry of the flammable liquid behind fire barriers. A wick effect may also need to be considered in the design of fire barriers.
2. Some small fires may not actuate sprinkler heads. To reduce this possibility in sprinkler systems to be installed, fast response sprinkler heads should be considered (less than approximately 3 minutes in the UL Standard 199 "Automatic Sprinklers for Fire Protection Service").
3. The location of the fire detection devices and the sprinkler heads relative to the fire and components being protected is of great importance. The path of the air movement in the area influences the actuation of such devices and should be considered in the system layout.
