JERSEY CENTRAL POWER & LIGHT COMPANY
OYSTER CREEK NUCLEAR GENERATING STATION

Technical Specification
Change Request No. 68
Docket No. 50-219

REPAIR PROPOSAL NO. 320-78-1

TITLE	PAGE	REVISION NO.	DATE
Repair Proposal No. 320-78-1 OCNGS Core Spray Sparger No. 2	i	1	11/15/78

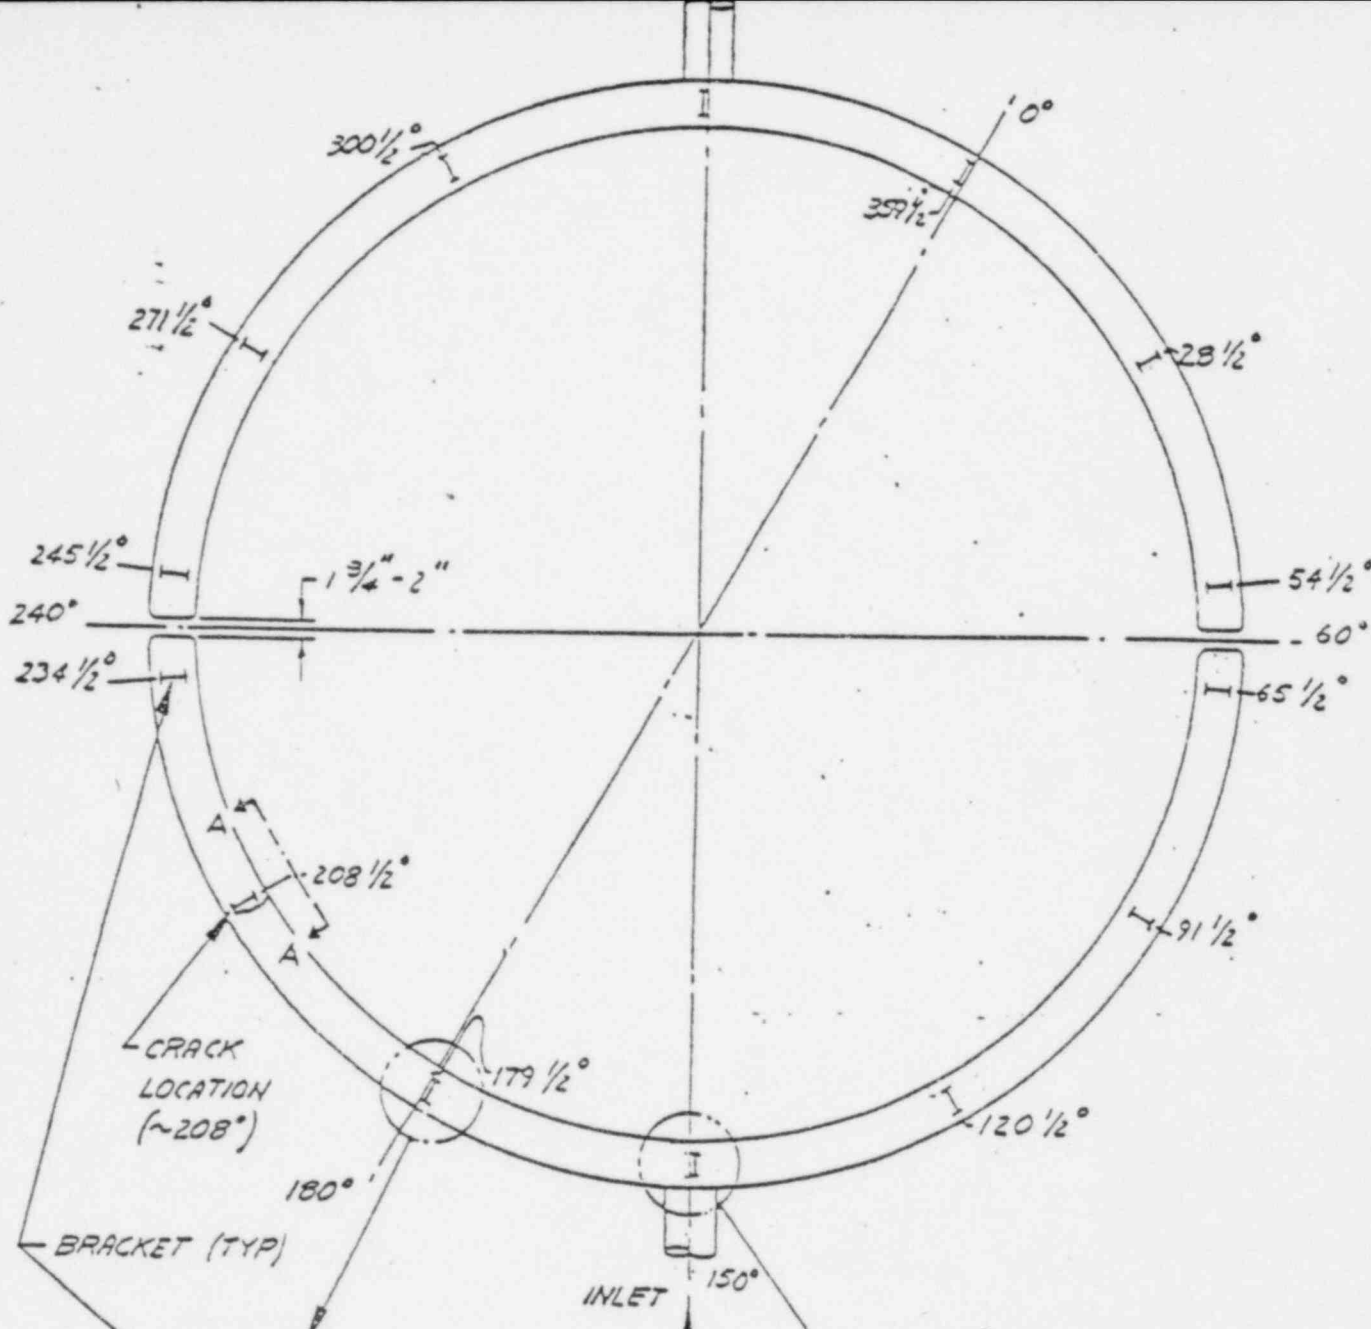
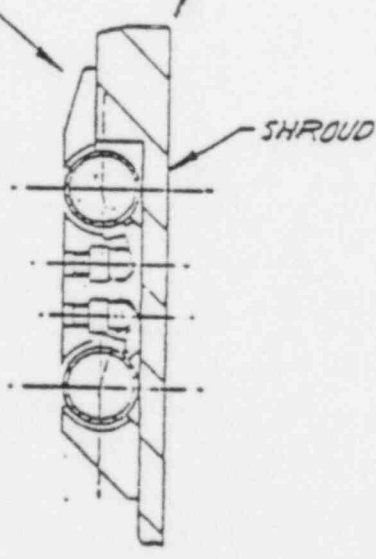
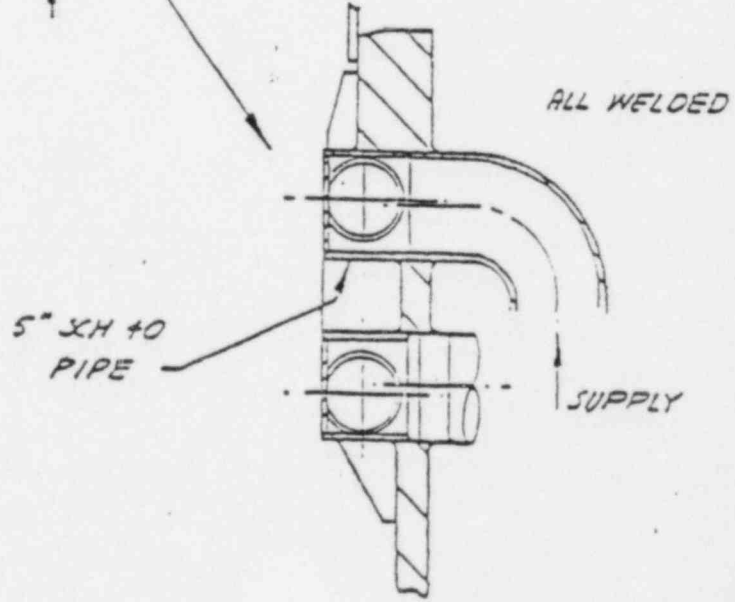
PLAN VIEW & UPPER CORE
 SPRAY SPARGER
 FIGURE 2
 SPECIAL BRACKET AT INLETS

The results of these examinations (performed during mid-October) revealed a single crack-like indication at orientation 208° (see Figure 2) in the upper sparger. A sketch of the indication is shown in Figure 3. As indicated in this figure the crack approaches near the toe of the nearby nozzle fillet weld and extends around the circumference of the sparger at least as far as the top center of the sparger pipe. The crack width appears greatest at a point below the "3 o'clock" position and becomes notably finer (tighter) as it approaches the top and bottom of the pipe.

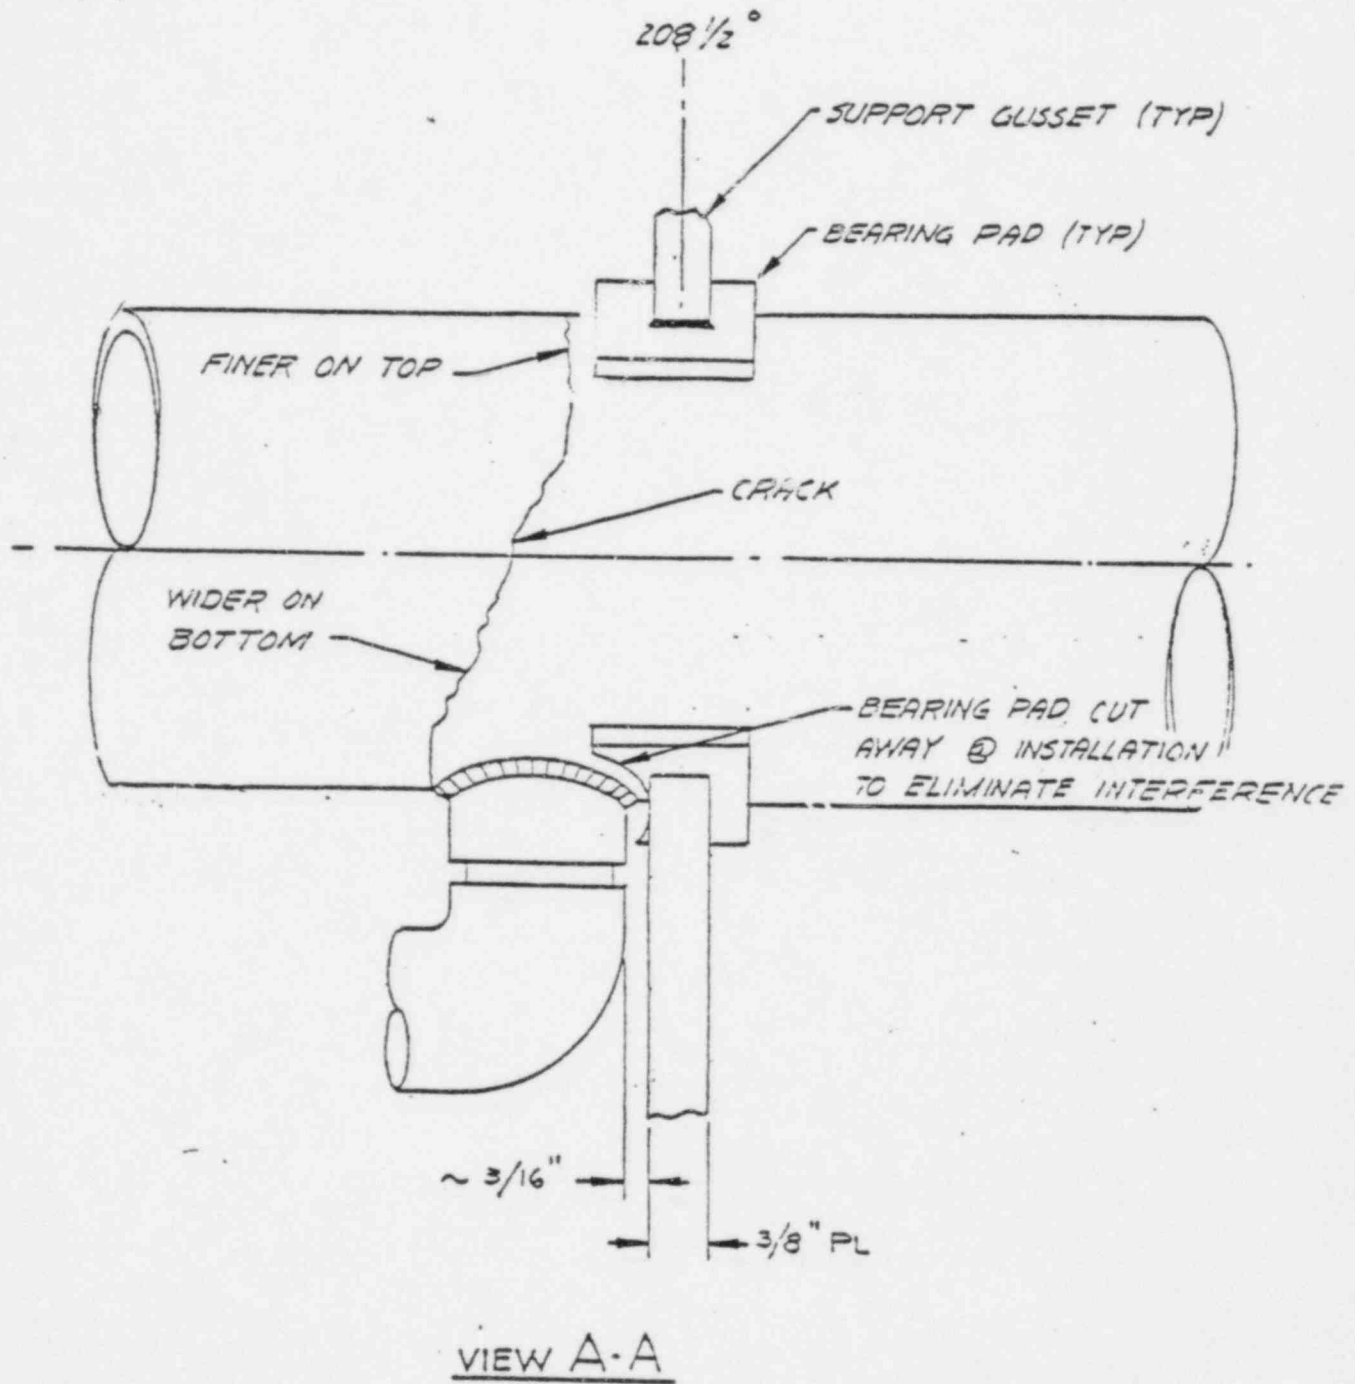
FIGURE 3

The cause of the crack in the upper core spray sparger at orientation 208° has not been positively identified. However, on the basis of the information which is available, the most probable cause of crack initiation and propagation is as follows:

service experience in BWR's have shown that stress corrosion cracks can initiate in the heat affected zones of welds in such pipes. Accordingly, stress corrosion is considered to be the most probable cause of crack initiation in the area of the local cold work or the heat affected zone of the weld.

Sketch of the Crack in the
Upper Core Spray Sparger

The additional structural support is shown on Reference 3.1 and consists of a 19" long clamp assembly which will be attached to the upper core spray sparger over and on either side of the cracked area at 208°. The clamp assembly will be machined, based on as-built dimensions of the sparger, to fit around the two spray nozzle bosses on either side of location 208°. A significant clamping force will be applied at installation by the use of four 3/4" bolts. The clamp assembly will prevent relative movement of the two sections of the sparger even if the crack were to propagate through the sparger cross section and will preclude any significant opening of the observed crack. The clamp assembly also strengthens the core spray sparger in the area of the crack.

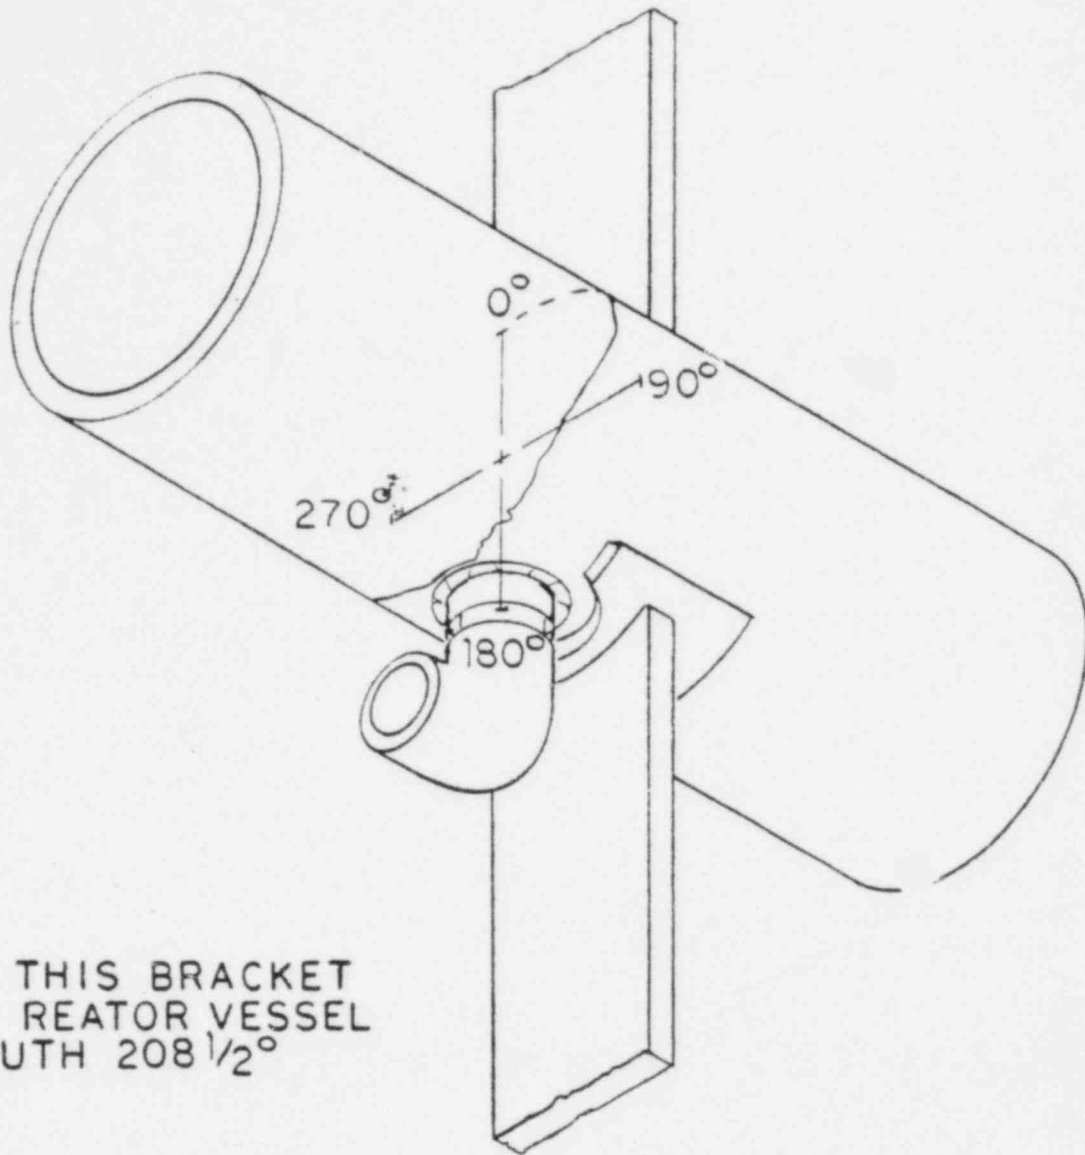
FIGURE 4
SKETCH OF THE CRACK IN THE UPPER CORE SPRAY SPARGER
BOTTOM VIEW

Subsequent inspection efforts during the week of October 30, 1978 enabled the plant staff to view and record a picture of the bottom of the upper sparger at the location of the crack. This inspection revealed that the crack does approach near the nozzle fillet weld, follow the weld contour for a short distance, and then proceeds up the rear wall of the sparger pipe. This crack extension was visible for approximately 45° from bottom dead center of the sparger up the rear (or outside) of the sparger pipe. In this area, the crack appears to be as tight as it is at the bottom of the sparger on the inner radius. See Figure 4 for a sketch of this portion of the crack.

NOTE: THIS BRACKET
IS AT REATOR VESSEL
AZIMUTH $208\frac{1}{2}^{\circ}$

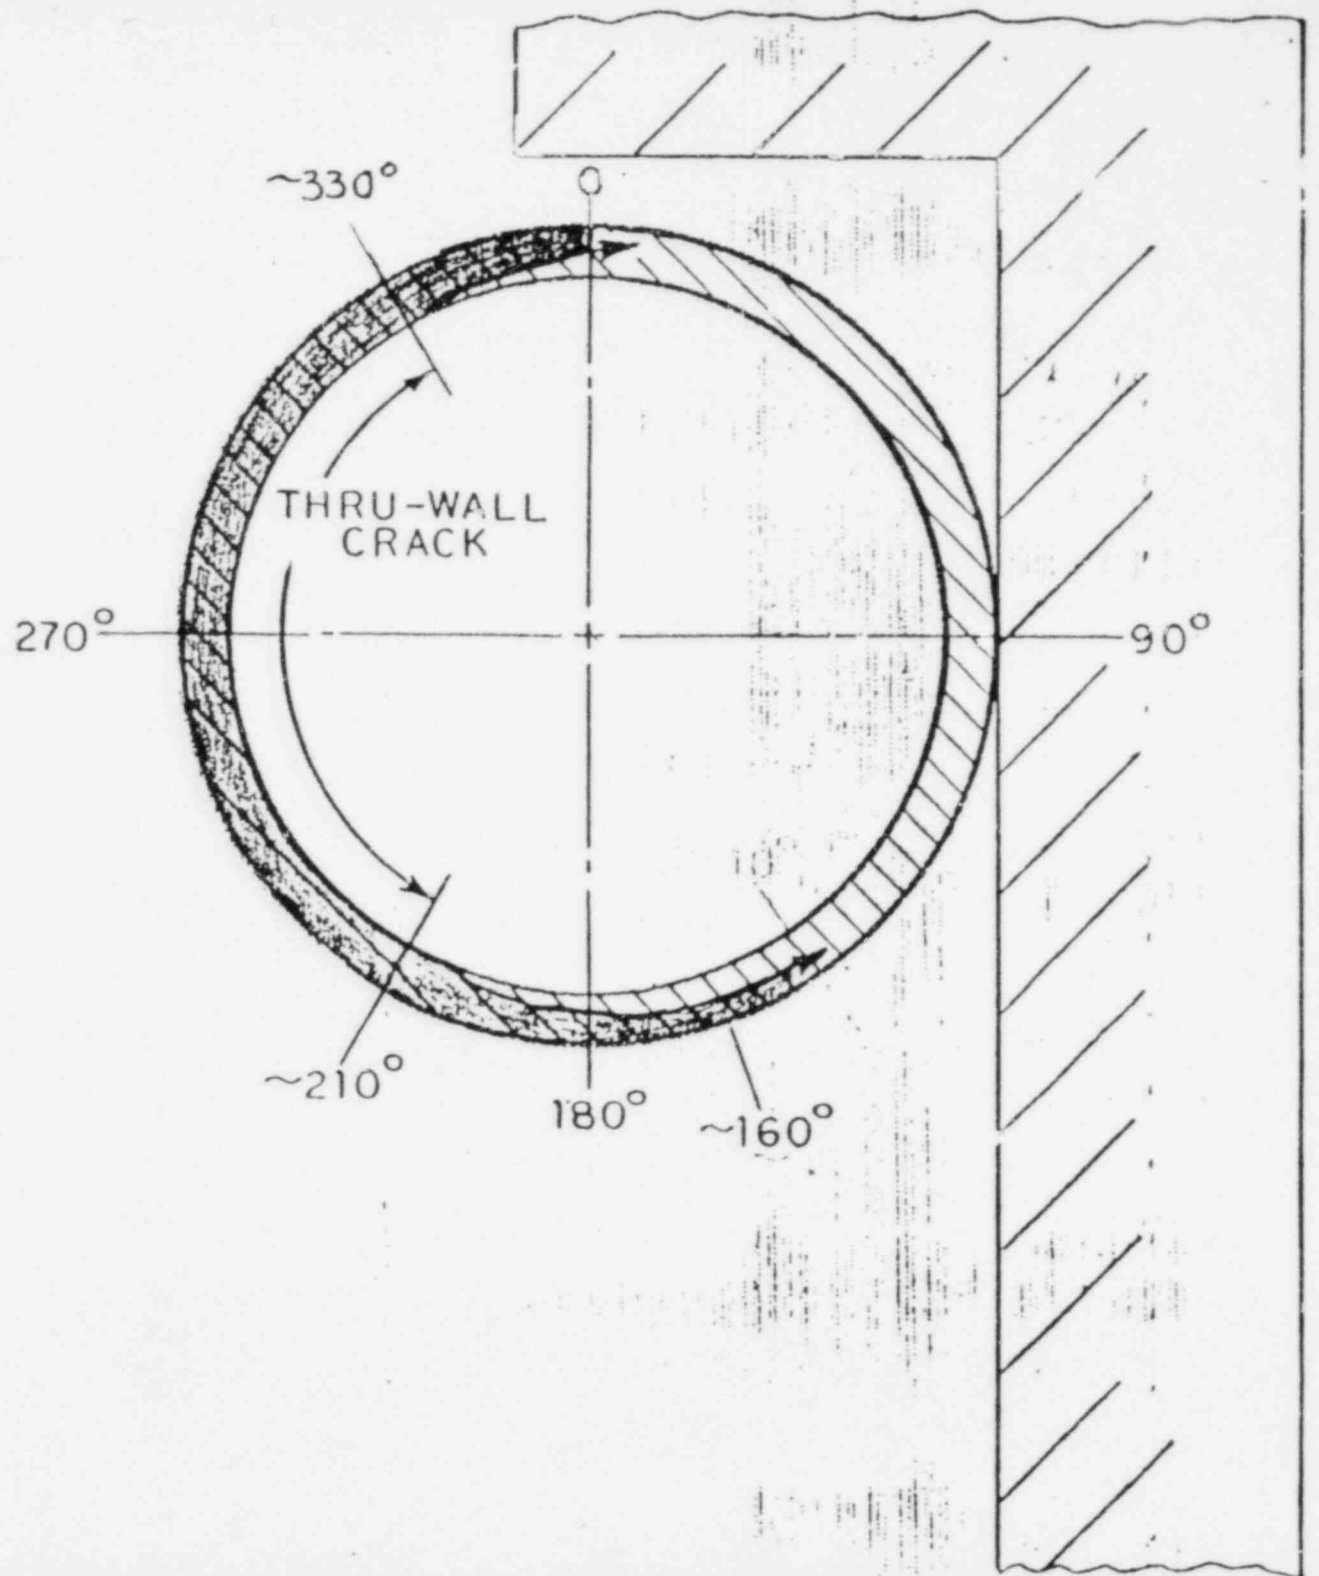
FIGURE 5
CROSS-SECTION CHARACTERIZATION
OF THE CRACK

In order to further characterize the depth and length of the crack at the 208° location in the upper sparger, air was introduced into the sparger through an instrument line which is attached to the core spray piping near the core spray nozzle. The air was gradually fed into the sparger until bubbles were observed from the spray nozzles, indicating that all water was forced out of the sparger. During this process, air bubbles were observed to leak from the crack from near the bottom center of the sparger to a location approximately 45° from the top center of the sparger. No air bubbles were observed from the inaccessible back side of the sparger nearest the shroud inside diameter. This test demonstrated that the crack penetrates the wall of the sparger over an arc length of about 135°. Figure 5 shows a cross-section of the

pipe at the crack location with the best estimate of the crack configuration.

As discussed above, visual examinations and air bubble tests indicate that the crack extends at least from the top centerline around the inboard side for about 220° on the sparger OD and penetrates the wall over an arc length of about 135°. Because the crack length appears to be longer on the OD of the sparger pipe than the ID, it can be inferred that the crack propagated from the OD of the sparger inward. Further, the location of the crack immediately adjacent to a radial support bracket and its location and extent over the inner half of the sparger are consistent with an applied loading which imposes a high bending moment at the crack location. The direction of the moment would be such that the portions of the sparger nearer the reactor centerline are in tension and the portions nearer the shroud in compression.

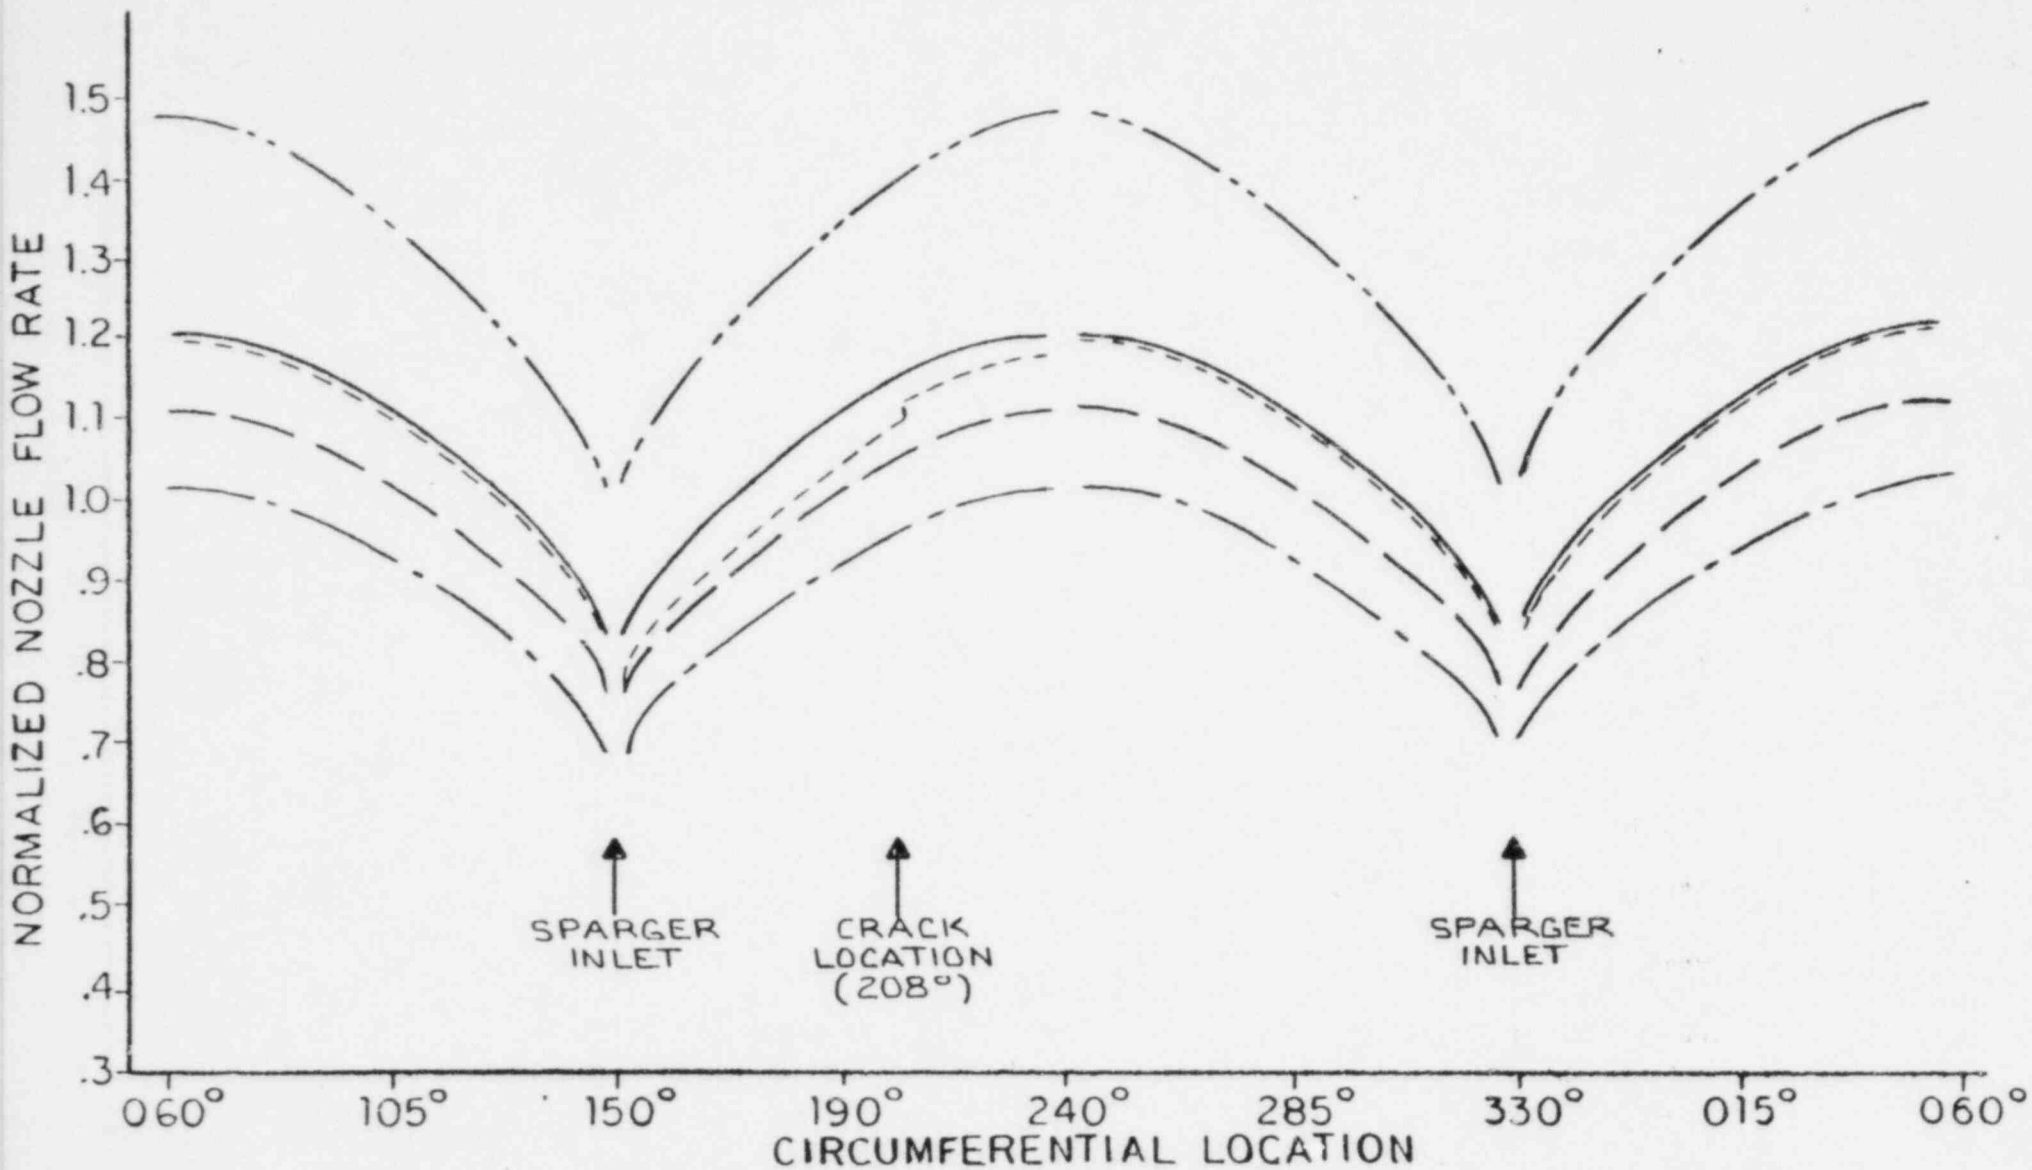
OYSTER CREEK NUCLEAR GENERATING STATION
 NORMALIZED NOZZLE FLOW RATE AS A FUNCTION
 OF CIRCUMFERENTIAL LOCATION
 FIGURE 1

Test measurements and this analysis have shown nozzle flow variations along the sparger of the same order as would exist in the cracked sparger with a system flow of 3640 gpm. Test measurements have also shown the sparger is not sensitive to changes in the system flow and provides acceptable spray distribution with system flows from 3100 to 4500 gpm. Based on this, it is concluded that the nozzle flow variations that could exist with a system flow rate of 3640 or 3700 gpm if the crack increased to a 1/16-inch circumferential gap are within defined acceptable limits and that acceptable core spray distribution would be maintained.
