March 4, 1994  
MP-94-154

Reference: Facility Operating License No. DPR-65  
Docket No. 50-336  
Licensee Event Report 94-002-00

FACILITY NAME (1) Millstone Nuclear Power Station Unit 2	DOCKET NUMBER (2) 05000336	PAGE (3) 1 OF 6
---	-------------------------------	--------------------

TITLE (4)  
Failure to Meet Acceptable Isolation Requirements Between Class 1E Protection Instrument Channels

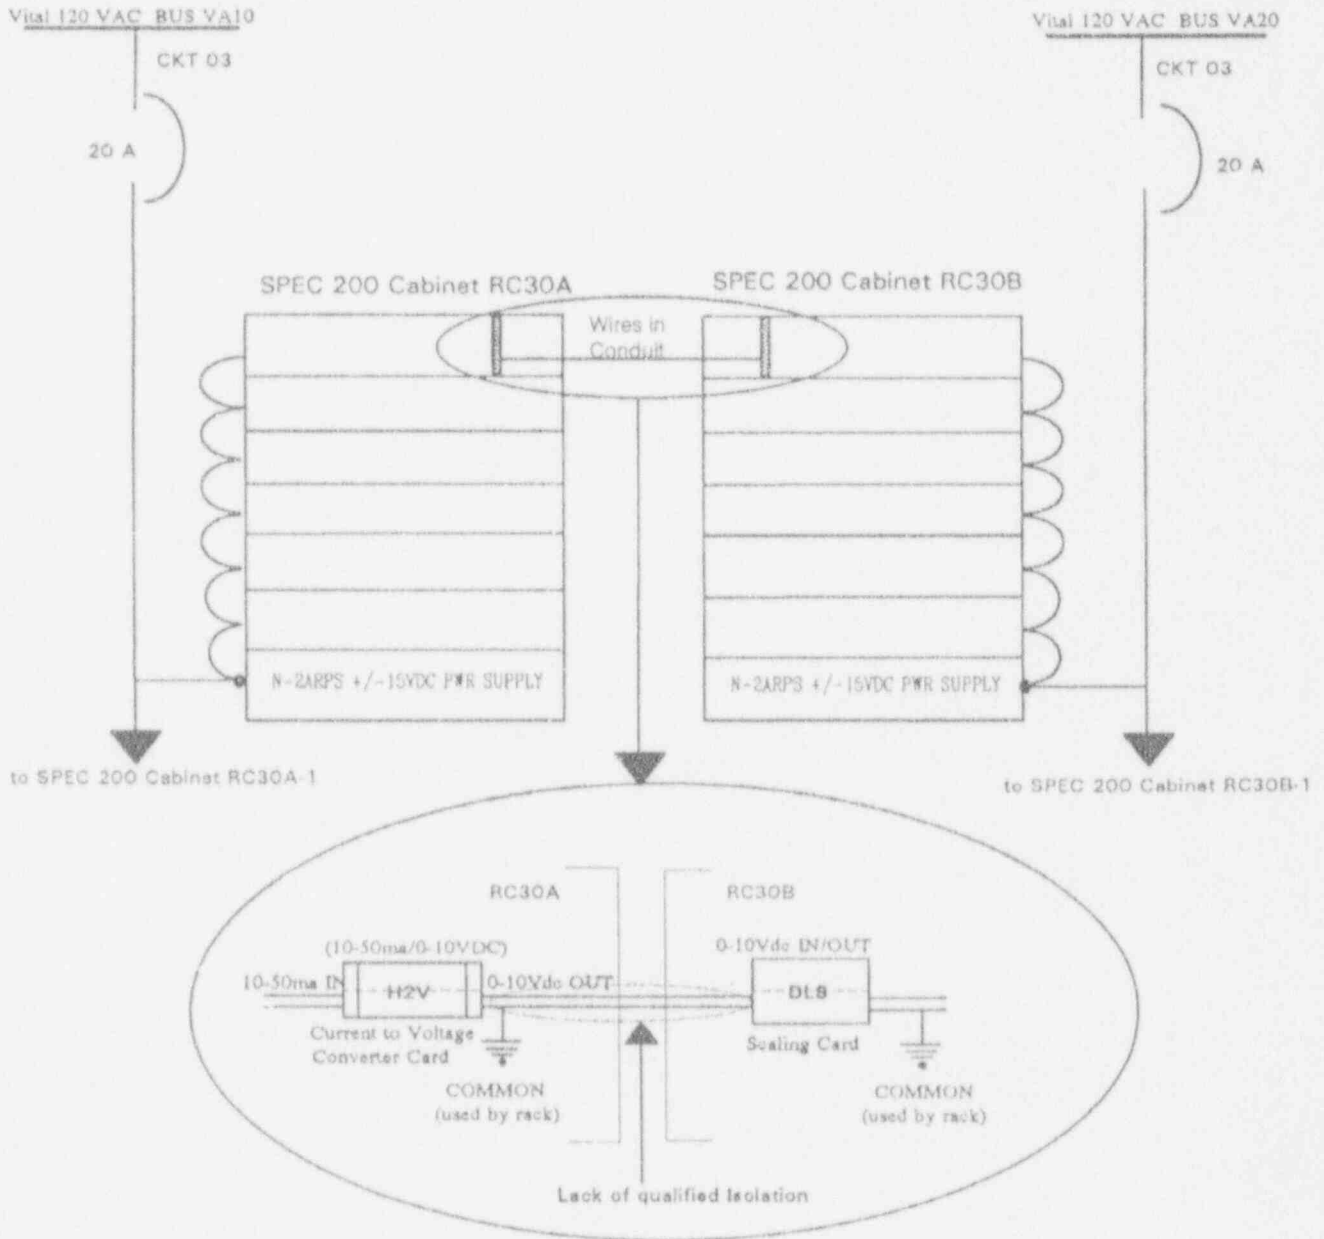
At approximately 1420 hours, on February 4, 1994, while in Mode 1 at 100% power, an engineering review of the pressurizer pressure control loop, P-100X & P-100Y wiring, revealed that safety grade channel isolation requirements of IEEE Std 384-1981, "Standard Criteria for Independence of Class 1E Equipment and Circuits," were not satisfied. On February 15, 1994, the event was determined to be a condition outside the design basis of the plant. The two (2) non-Class 1E (non safety-related) pressure control channels are powered from the Class 1E vital instrument buses via the Foxboro Spec 200 instrument rack power supplies. Due to the lack of a (IEEE Std. 384) qualified isolator between the two pressure control channels and the lack of an in depth analysis to demonstrate that the existing configuration provided acceptable electrical isolation, it was postulated that a fault could potentially propagate between the 2 channels of safety-related instruments and compromise their independence from a single failure.

The wiring permits the pressurizer (0-10Vdc) low voltage control signal to pass from cabinet RC30A to RC30B via an isolated current to voltage (H2V) converter card. The common leg of both cabinets became connected due to the wiring configuration of the H2V card (refer to the attached figure). If a catastrophic fault in the form of a voltage surge from the 120VAC feed or +15/-15 Vdc power supply, or a ground fault were to occur, the fault could affect both cabinets. Each cabinet power supply also feeds an independent channel of safety-related (Class 1E) reactor protective system (RPS)/Engineered Safety Features Actuation System (ESFAS) instrument loop. Therefore, the wiring deficiency could affect the safety-related instrument loops if the fault were to cause failures of the +15/-15 Vdc power supply units in each cabinet. Cabinet RC30A is powered from safety train (Facility Z1) 120 Volt Vital Instrument AC (VIAC) bus VA10. Cabinet RC30B is powered from safety train (Facility Z2) 120 Volt VIAC bus VA20.

Because the design of the P-100X & P-100Y channels resulted in the tying together of two channels of safety-related circuits, the condition resulted in the potential reduction of protective channel independence, if a fault were to occur. This configuration was contrary to the Millstone Unit 2 FSAR stipulation that reactor protective system channels meet the isolation requirements of IEEE Std. 279-1971. The instruments affected are listed on Attachment 1.

As corrective action, a design change is planned to be completed in the near future to provide isolation for the two pressurizer pressure channels and thus RC30A & B in order to maintain a design basis consistent with the FSAR description.
