St. John's Mercy Medical Center

Re: Reply to a Notice of Violation

License No. 24-00794-03
Docket No. 030-02283

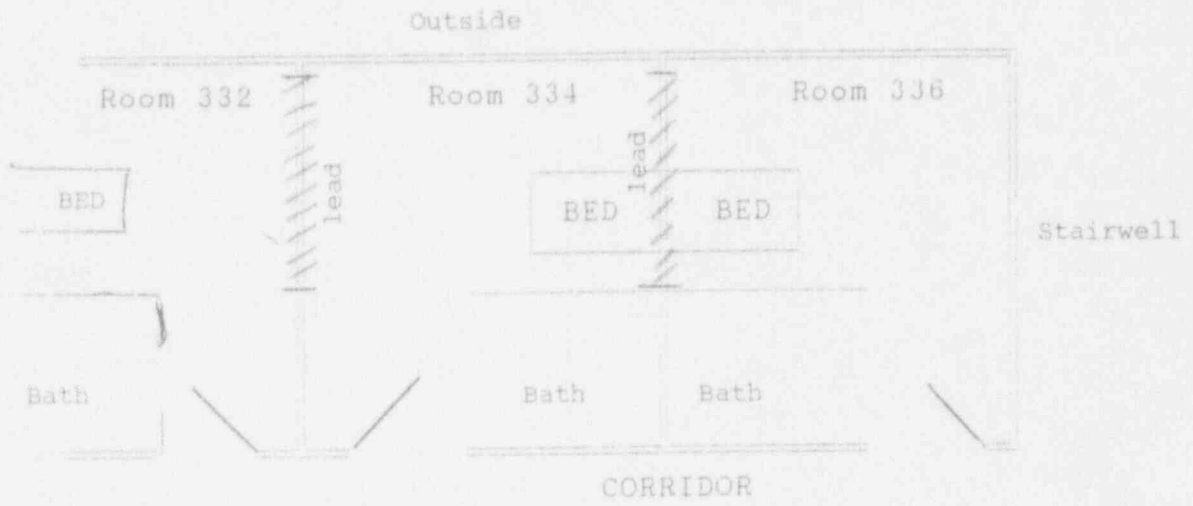
Map of 3B Oncology
Radiotherapy Rooms

The shielding requirements were originally calculated for Cs-137 as these rooms are also used for brachytherapy implant patients. Thicker shielding is required for Cs-137 than for I-131. In December 1992, additional shielding was placed in the walls of the two therapy rooms, 334 and 336, to extend the coverage beyond the area of the bed to include the entire living space. Prior to this time, maximum radiation exposure rates were found in the foyer at 1.5 mrem/hr. With the increased lead coverage, rates are generally in the 100 urem/hr range just inside the door. This rate is the maximum that will be found in the room, because the entire living area is shielded with 1 inch lead. Typical readings in the bed area are 20-60 urem/hr.

Testing was conducted in August 1991 and again in December 1993, after additional shielding, which demonstrated both the improvement in reduced rates in adjacent rooms and the adequacy of shielding to maintain rates at such a level as to ensure compliance with new 10 CFR Part 20 regulations. A pure source (not including patient absorption) of 150 mCi of I-131 located in the bed of room 334 has been demonstrated to yield 0.142 mrem/hr at the foot of the bed in room 332 and 0.533 mrem/hr at the bed in room 336. (There is greater distance to the bed in room 332 than room 336, see enclosed map.)
