REPORTABLE OCCURRENCE 78-33

FORT ST. VRAIN NUCLEAR GENERATING STATION
PUBLIC SERVICE COMPANY OF COLORADO
P. O. BOX 361
PLATTEVILLE, COLORADO 80651

REPORT NO. 50-267/78-33/03-L-0

IDENTIFICATION OF
OCCURRENCE:

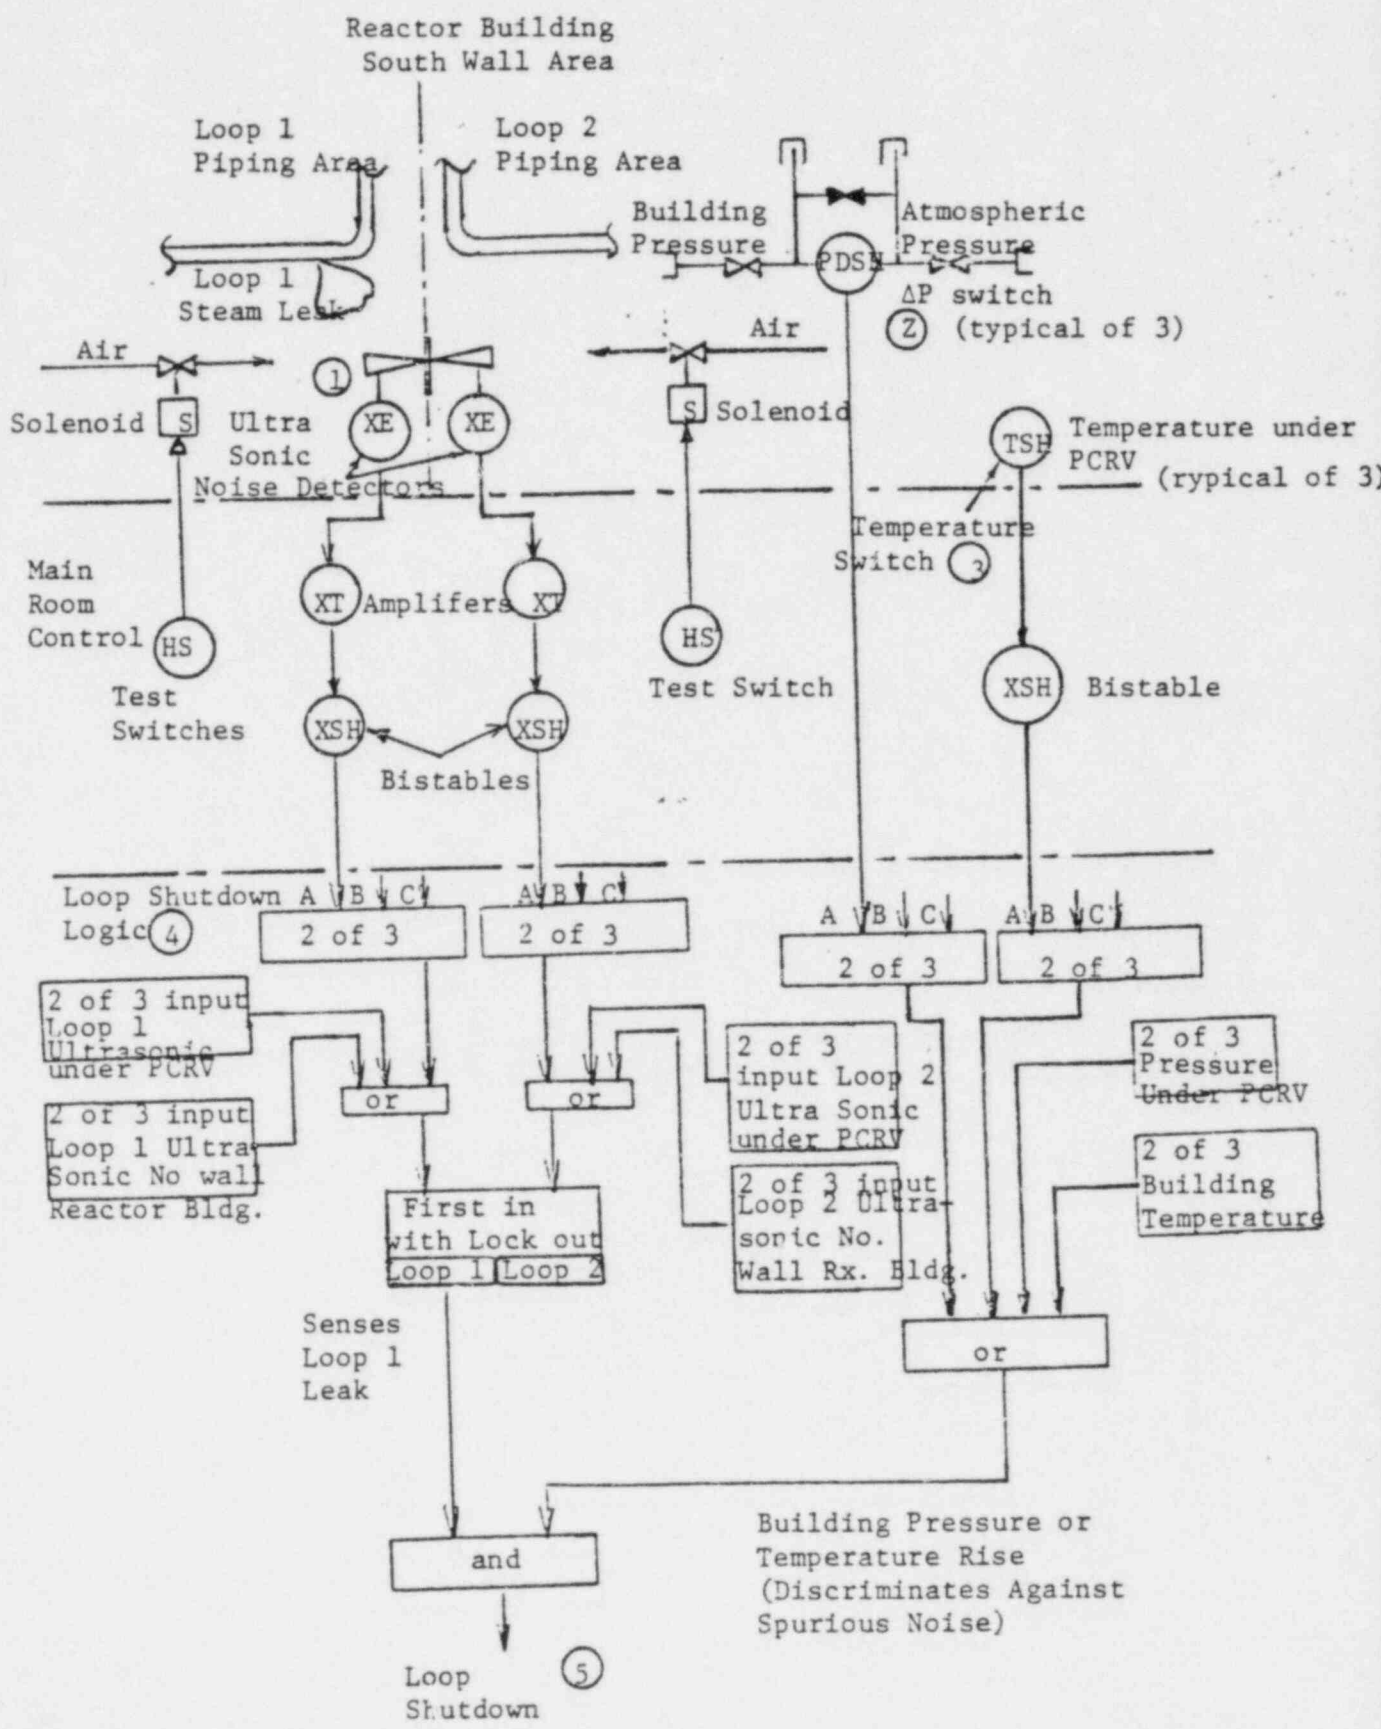
See Figure 1 (typical for redundant channels). A combination of ultrasonic noise, detected by noise detectors, (1), in conjunction with a pressure rise, detected by pressure differential switches, (2), or a temperature rise, detected by temperature switches, (3), indicates a pipe rupture. If a pipe rupture occurs, the loop shutdown logic, (4), initiates a loop shutdown, (5), through a series of solid state electronics and relays.
