NUREG-0040
Vol. 17, No. 4

Licensee Contractor and Vendor Inspection Status Report

Quarterly Report
October-December 1993

U.S. Nuclear Regulatory Commission

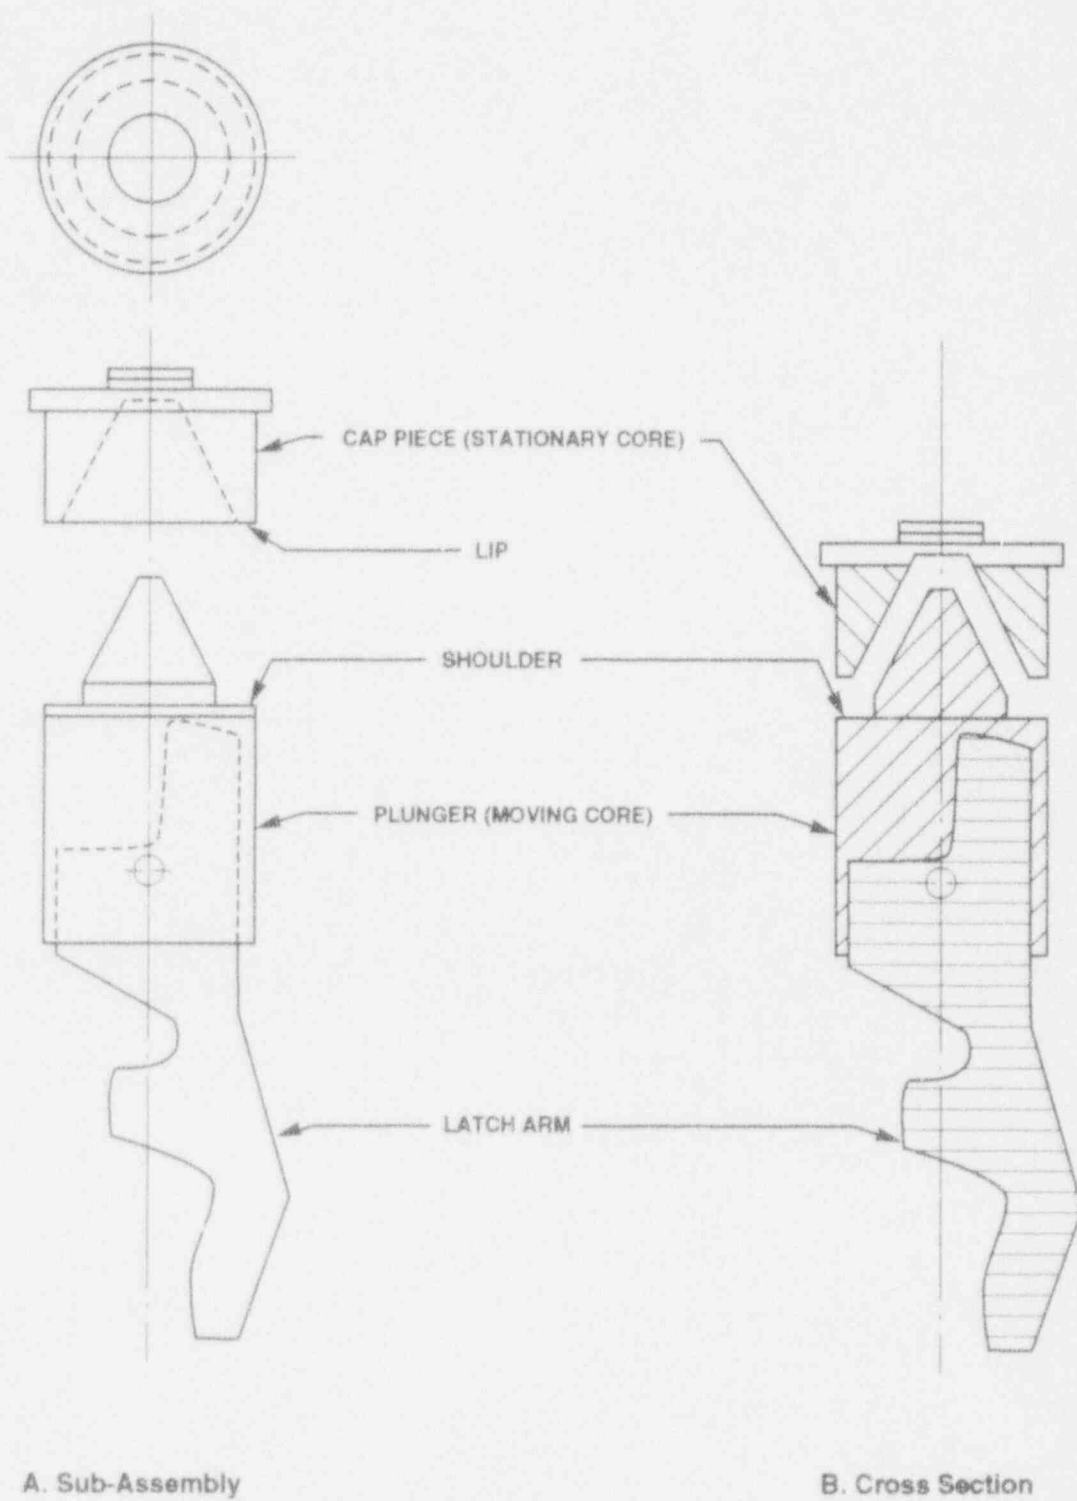
Figure 1. X-relay Magnetic Core

- Mechanical binding due to dirt accumulation between the moving core and the brass sleeve.
- Mechanical binding due to different coefficients of thermal expansion caused by heat dissipated by the energized coil.
- Dimensional variations of the X-relay frame.

On September 9, 1993, at W, in the presence of the NRC, a Haddam Neck engineer was able to cause the two parts to adhere to each other and prevent the moving core to fall freely by gravity by applying pressure to the plunger and the top cap piece of the armature while twisting them together. W and the licensee believe that residual magnetism or mechanical adherence are two of the probable causes for the parts sticking together.
