LABORELEC RODESTRAAT 125 B-1630 LINKEBEEK	Tel 02/38.20.211 Telex 22297 Fax 02/38.20.241
---	---

HEADING	STEAM GENERATOR PWSCC IN SERVICE LEAKAGE EXPERIENCE IN BELGIUM	21 pages
SUMMARY	<p>Belgium has a large experience of operating steam generators with PWSCC through-wall axial defects in the tube roll transitions.</p> <p>The service behaviour has nevertheless been very good, with a rather low primary to secondary leakage.</p> <p>This report documents the available data and investigates the reasons for the observed leakrate variability and discrepancy with respect to theoretical models and laboratory experiments.</p>	
ANNEXES

REFERENCES LABORELEC	
Document	M00-90-022/R-PH/SD
Task/Beneficiary	M00/00339/ELNUC

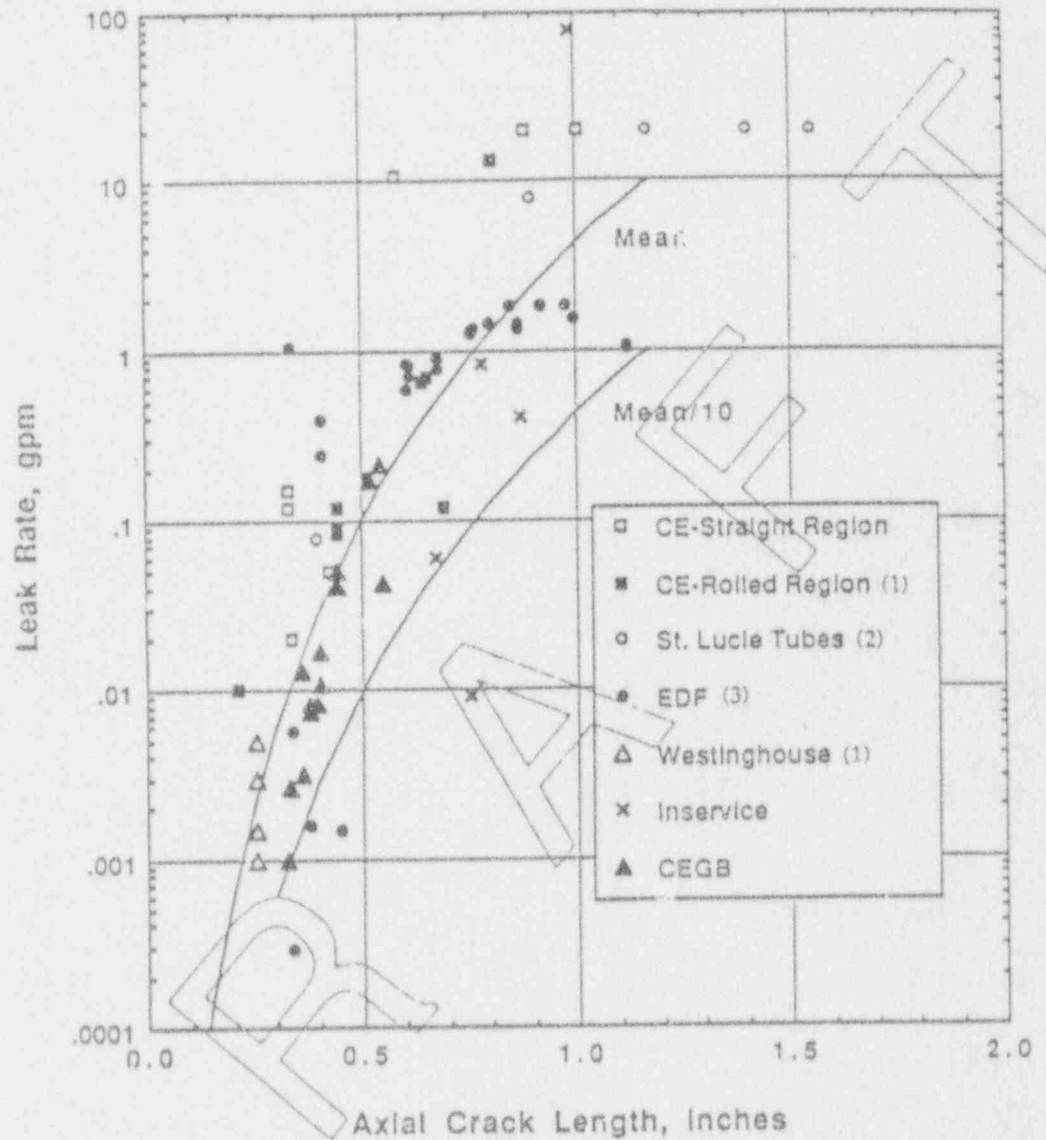
Figure 2-6. Leak Rate Versus Nominal Axial Crack Length for Corrosion Cracked Steam Generator Tubes, 600° F (data from Appendix E)

In order to correlate the measured leakrate (the abovementioned 140 l/h extrapolation) to the known crack characteristics of the individual leakers, use was made of the "mean divided by 10" leak curve from figure 2.6 of the EPRI guidelines for Alternate Tube Plugging Criteria [ref. 2] ; this figure is appended to table 1.

The results are shown in table 1. There is a reasonable agreement of the total in service leakrate (140 l/h) with the predicted leakage from the actual leakers (340 l/h). However the predicted leakrate associated with all known cracked tubes would have been larger by one order of magnitude (1600 l/h).

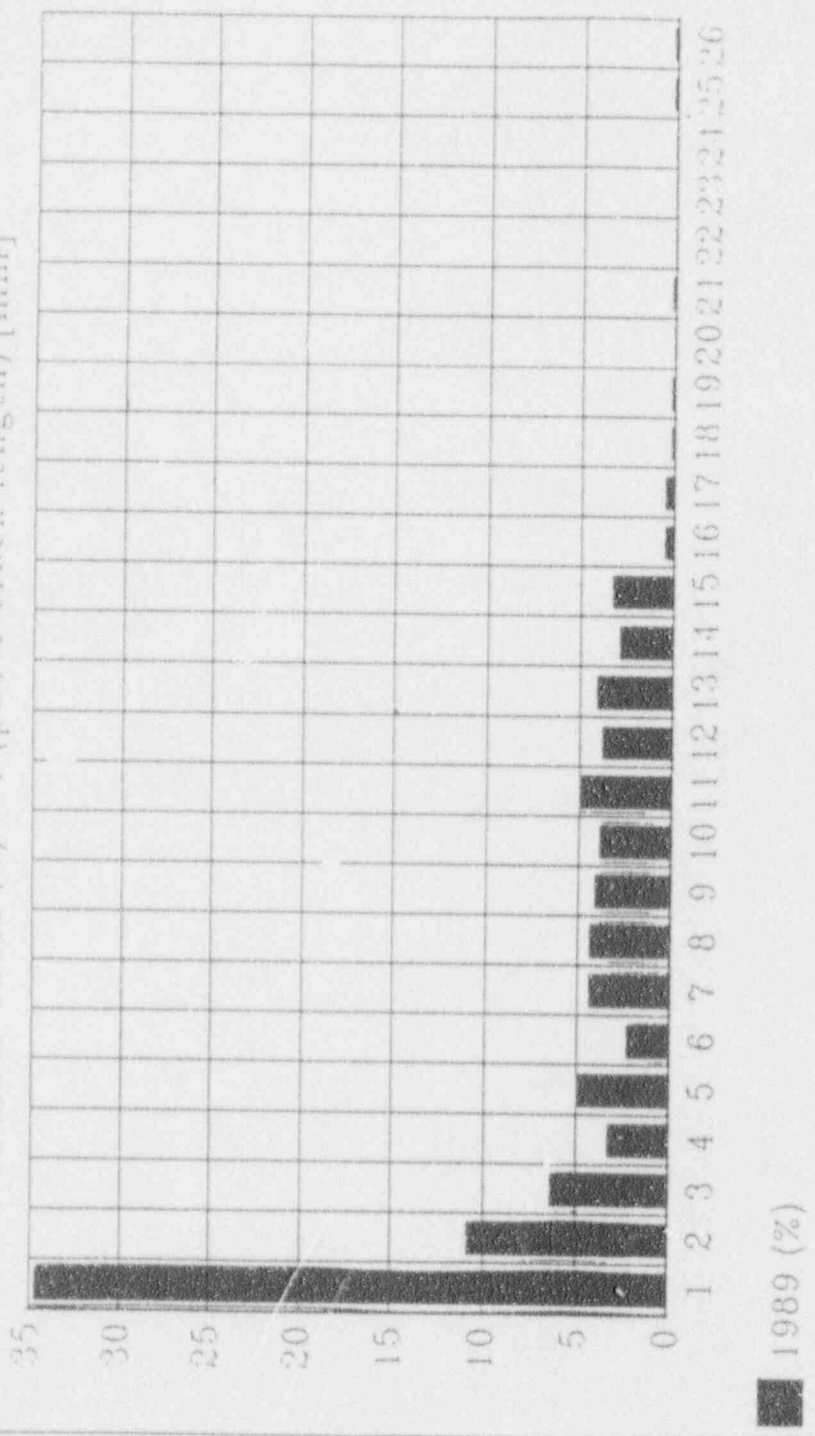
FIGURE 1 : Distribution curve of maximum crack length in roll transitions

The crack length distribution is illustrated by figure 1 ; it should be noted that about 20 % of the cracks are relatively long (> 10 mm).

Almost all cracks indicate a depth of (close to) 100 %. This does not imply that all are physically through-wall ; however previous experience from pulled tubes shows that most of them are effectively through-wall.

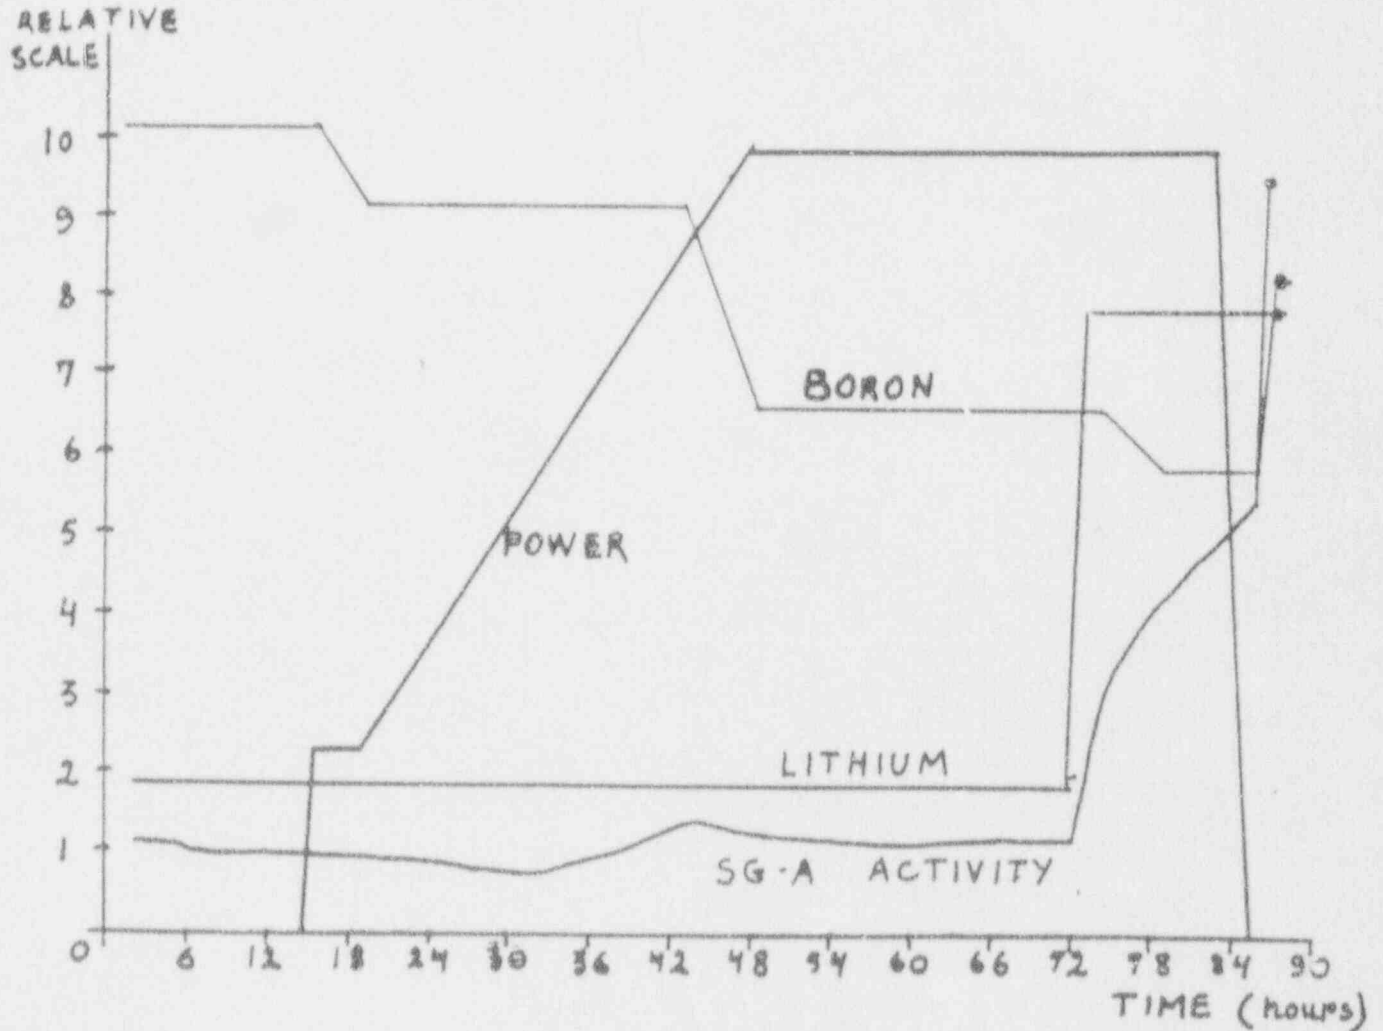
FIGURE 2

After a long unscheduled outage from November 1989 to February 1990 (replacement of cracked turbine blades), the plant could not restart because of a large leakage from SG-A, increasing rapidly from 8 to 70 l/h (0.035 to 0.3 gpm) at the time the plant was shutdown (after only 2 days of full power operation).

The time history of the event is described by figure 2, where the initial B and Li levels are respectively 1000 and 0.2 ppm.

The large leak experienced at plant restart is attributed to crack leak area cleaning as a side effect of the COMBAT decontamination process ; this effect has been clearly enhanced by the injection of Li (which was realized in a "one shot" operation, instead of the usually more progressive adjustment).

LEAKRATE INCREASED FROM
8 TO 70 l/h (.035 → .30 gpm)
MIGHT HAVE DOUBLED AFTER
SHUTDOWN INITIATION

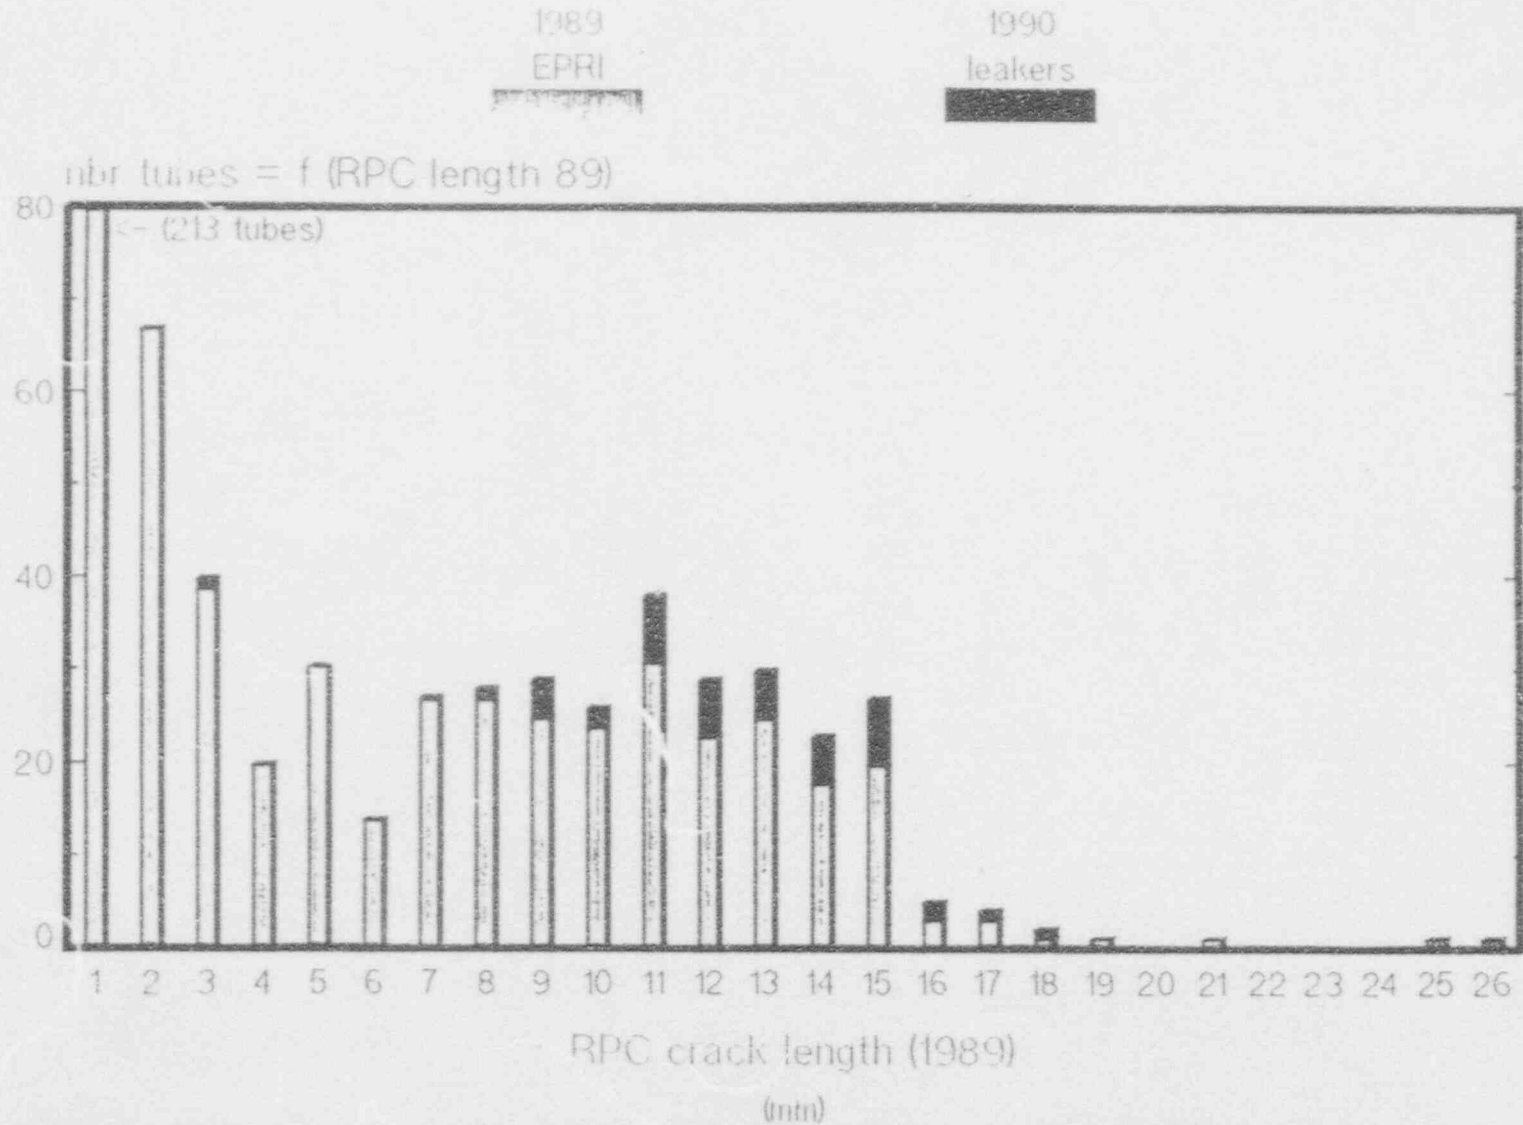
FIGURE 3

Among the 143 leakers, 47 were inspected by ECT/RPC during the regular June 1989 outage and it was thus possible to relate them to the measured maximum crack length in roll transition.

The results are illustrated by figure 3 (from ref. 5) and indicate that, while a larger percentage of the longer cracks did leak, this percentage did not exceed 25 % for crack lengths in excess of 10 mm and did not include all of the cracks in excess of 15 mm ; in fact the longest cracks (25 and 26 mm) were not detected as leakers. This is also illustrated by figure 4 (from ref. 6).

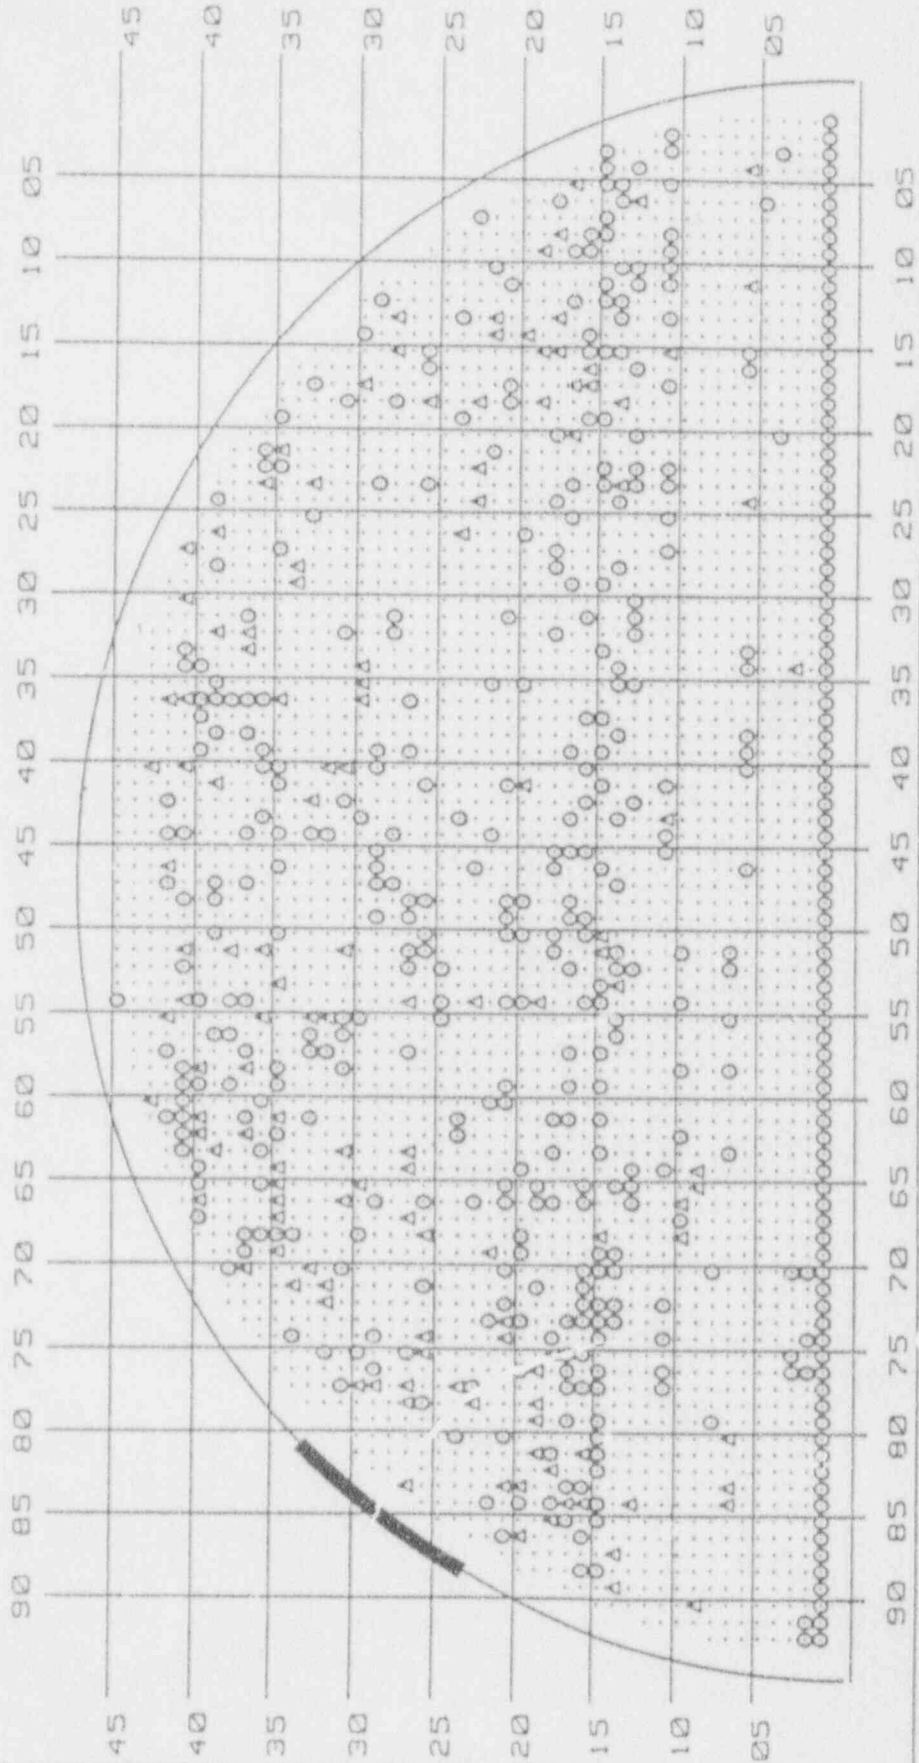
FIGURE 5

- the behaviour of the actual leakers does not support this assumption,
 - . the denting at the top of the tubesheet acting as a leaktight barrier ; this is apparent from the tubesheet map where the 135 inspected leakers are mostly outside the sludge/dent area (see figure 5),

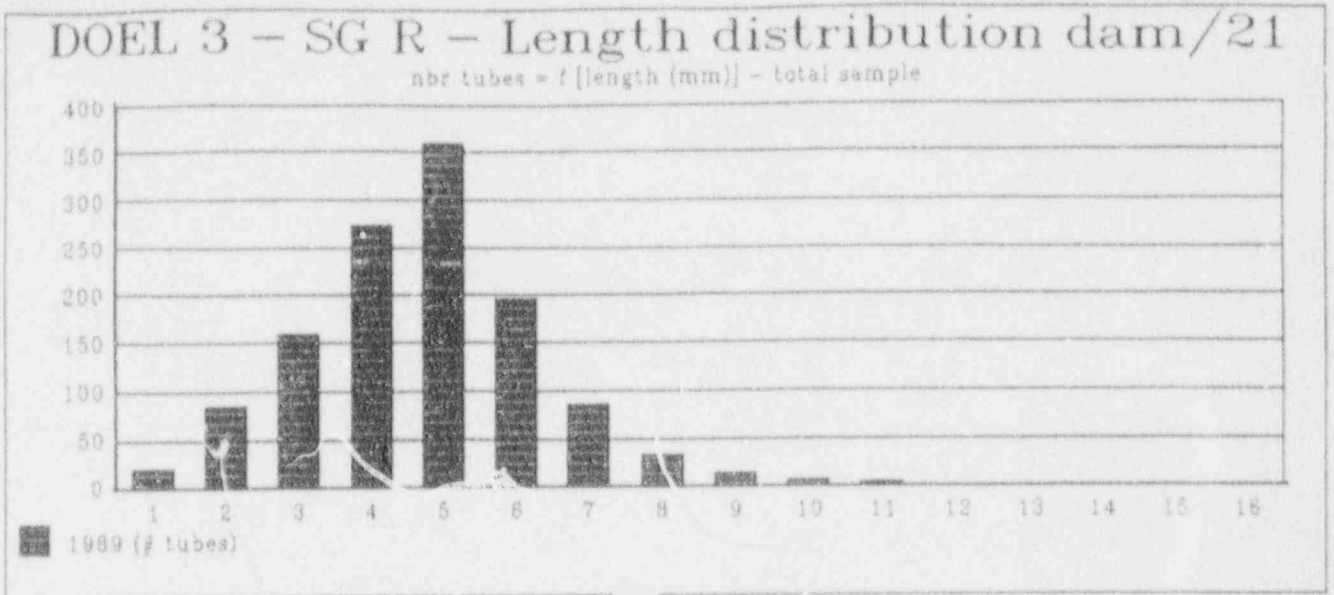
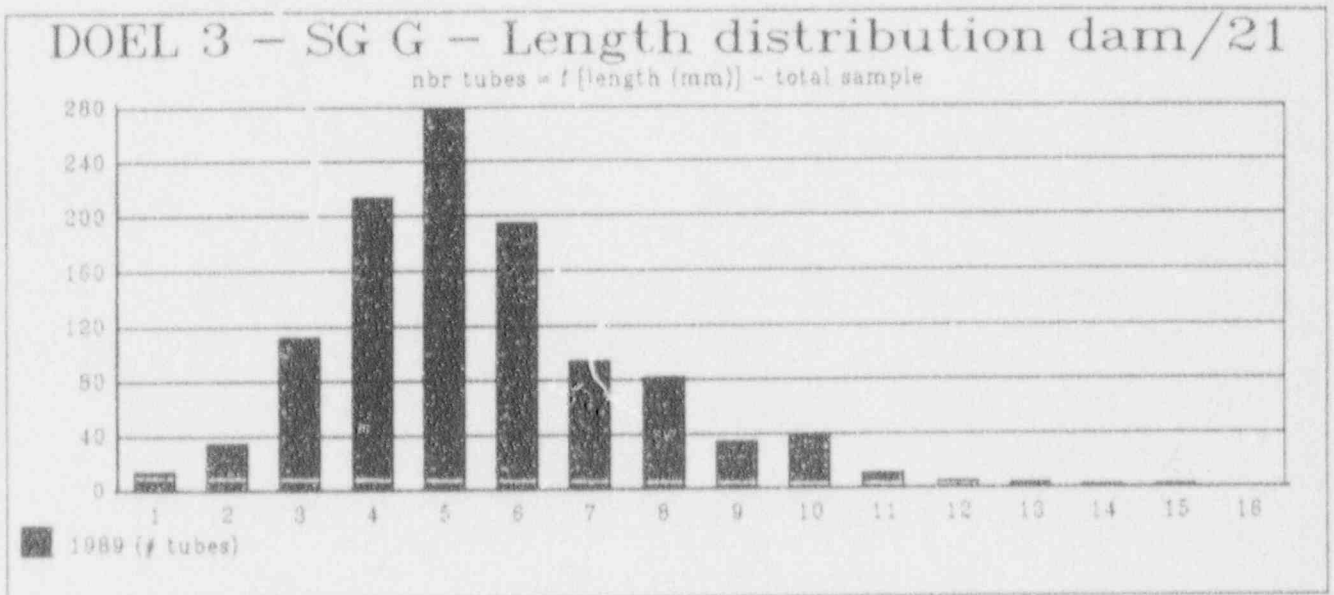
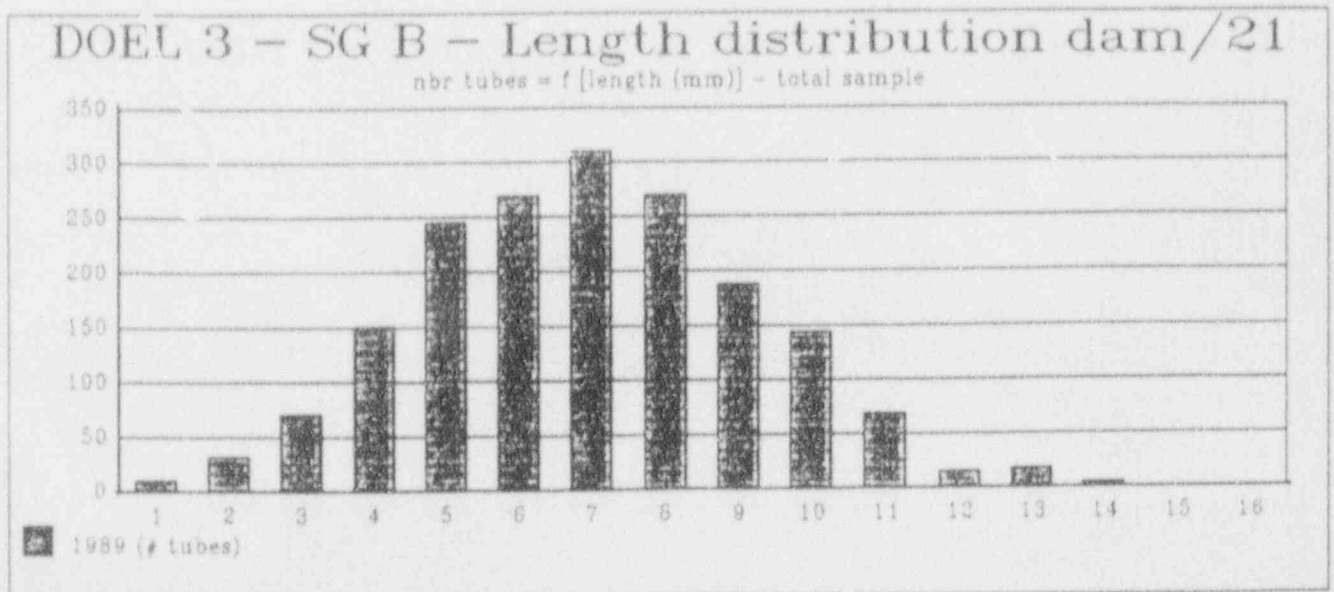
FIGURE 6

The results from the 1989 inspection are illustrated by figure 6 and summarized in the following table (only PWSCC cracks in roll transition)

SG #	R	G	B
Number of cracked tubes	40 %	35 %	57 %
Crack length [average	5 mm	5,5 mm	7 mm
]max.	11 mm	15 mm	15 mm
Crack number [average	4	4,5	5
(in same RT)]max.	11	11	12

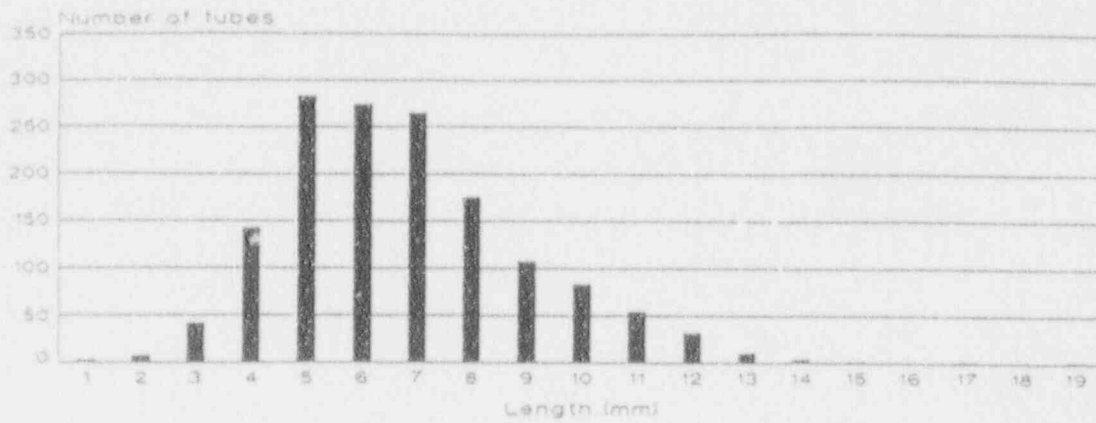
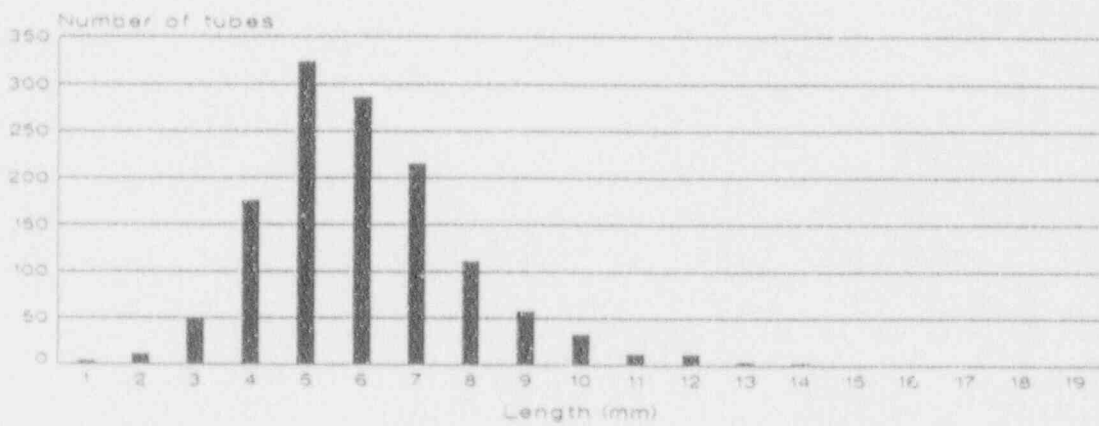
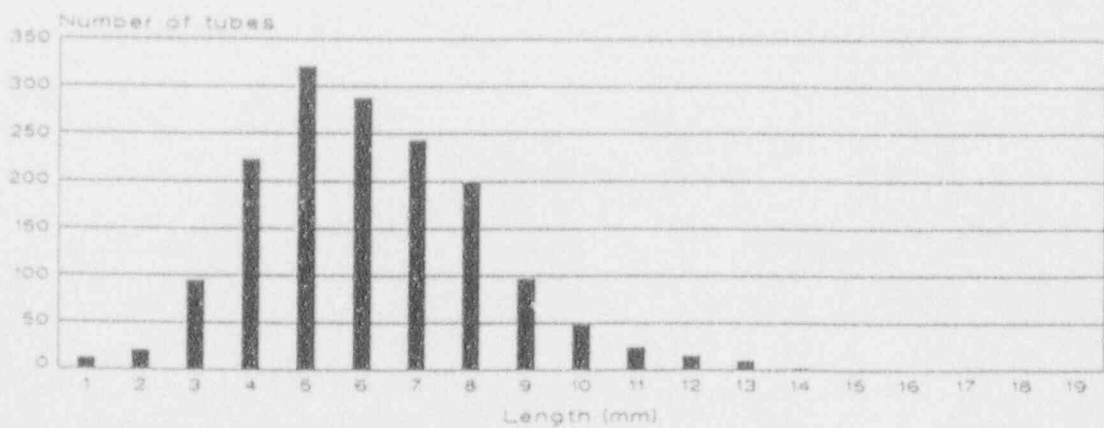
FIGURE 7

The results from the June 1990 inspection are illustrated by figure 7 and summarized in the following table (only PWSCC cracks in roll transition)

SG #	1	2	3
Number of cracked tubes	45 %	39 %	48 %
Crack length [average	7 mm	6 mm	6 mm
[max.	14 mm	14 mm	14 mm
Crack number [average	3	3	3
(in same RT) [max.	11	10	12

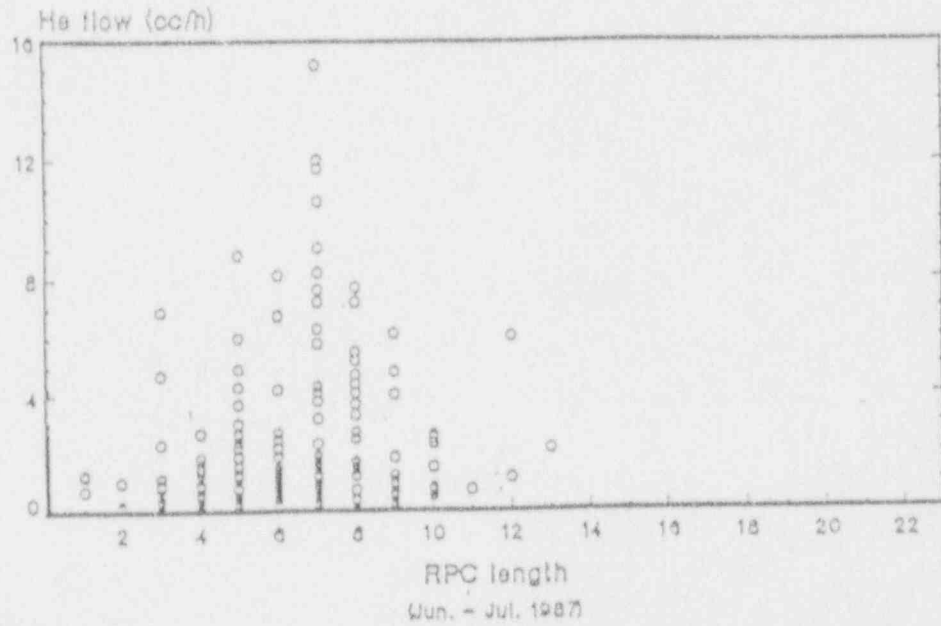
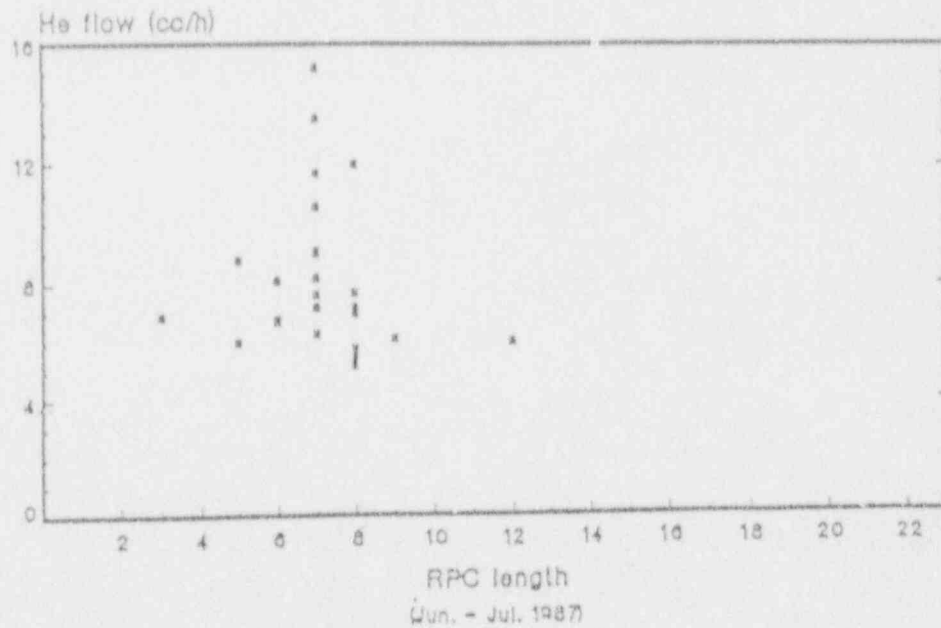
FIGURE 8

The helium test detected 335 leaking tubes (none of them large enough to correlate with the observed in service leakrate). A plot of the He leakrates versus the crack lengths (measured by ECT/RPC) is illustrated by figure 8, which mimics the distribution curve of crack lengths, thus suggesting a strong correlation between leakrate and crack length. Moreover only one of the 27 "larger" He leakers (> 5 cc/hr) did coincide with one of the 49 "longest" cracks (> 10 mm).
