SACRAMENTO MUNICIPAL UTILITY DISTRICT □ 6201 S Street, Box 15830, Sacramento, California 95813; (916) 452-3211

DOCKET NO. 50-312
LICENSE NO. DPR-54
SPECIAL REPORT NO. 82-05

In accordance with Rancho Seco Nuclear Generating Station Technical Specifications Section 6.9.5.B.1 and 10 CFR 50 Appendix K, the Sacramento Municipal Utility District hereby submits a report of the Reactor Building Inspections performed during July of 1982. A summary of discrepancies is listed below. Work Requests have been issued to correct these items.

Inspection on July 14, 1982

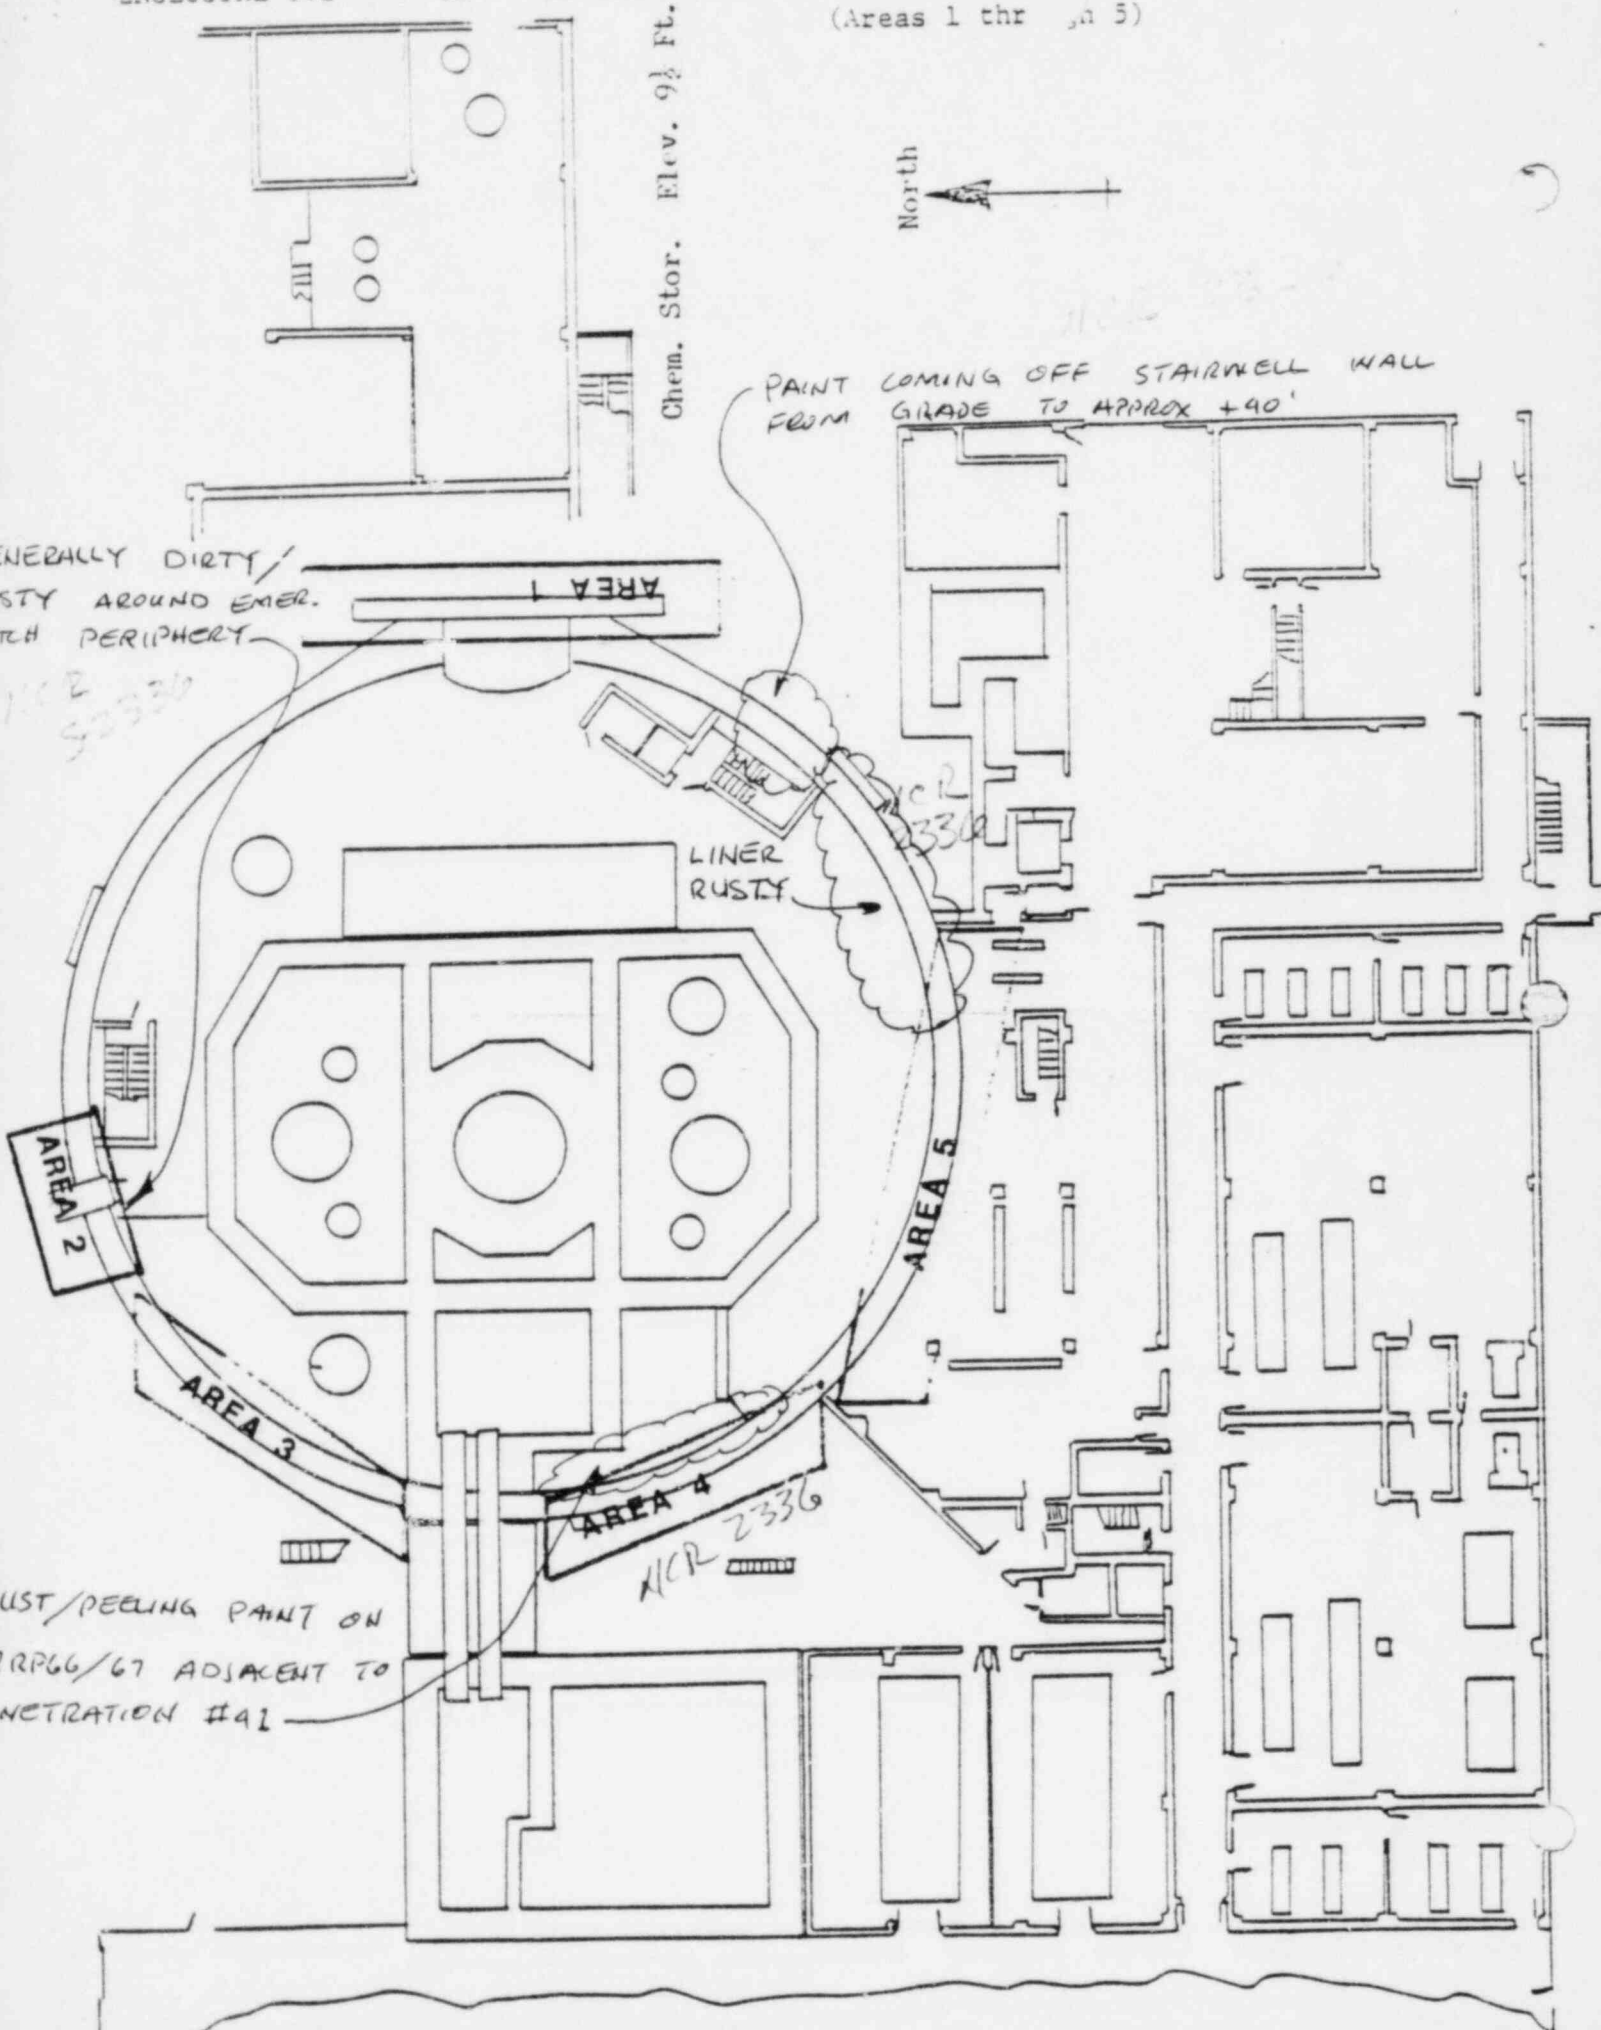
PAINT COMING OFF STAIRWELL WALL FROM GRADE TO APPROX +90'

GENERALLY DIRTY / RUSTY AROUND EMER. EXIT PERIPHERY

LINER RUSTY

RUST/PEELING PAINT ON TRPG6/67 ADJACENT TO PENETRATION #41

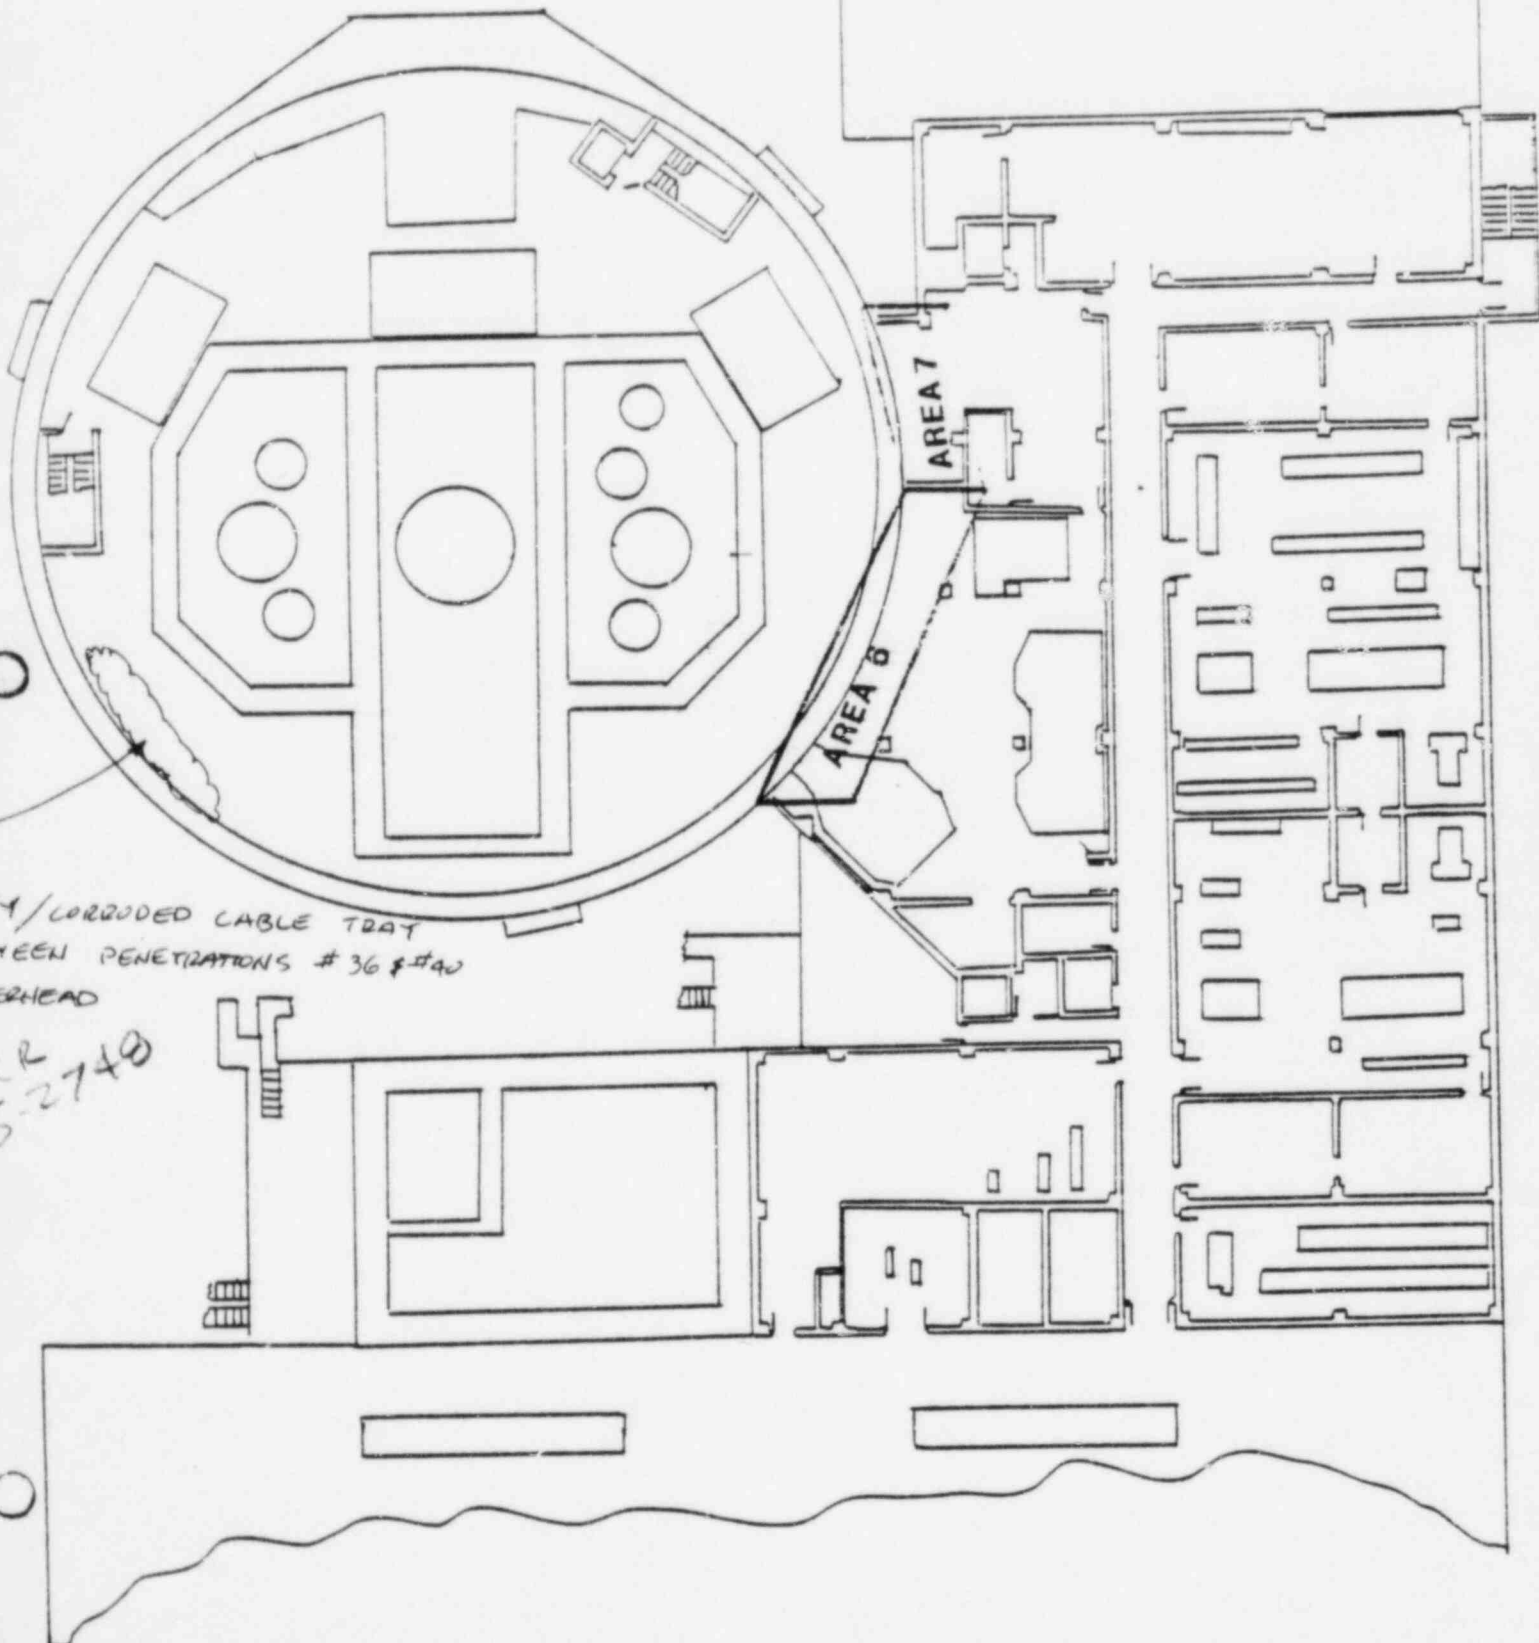
SPECIFIC AREAS OF EXTERIOR SURFACES TO BE INSPECTED
(Areas 6 and 7)

Observations and Results OK (SEE ENC. 6.1 pg. 2)

Observations and Results OK (SEE ENC. 6.1 pg 2)

UNSTY/LOADED CABLE TRAY
BETWEEN PENETRATIONS #36 & #40
OVERHEAD

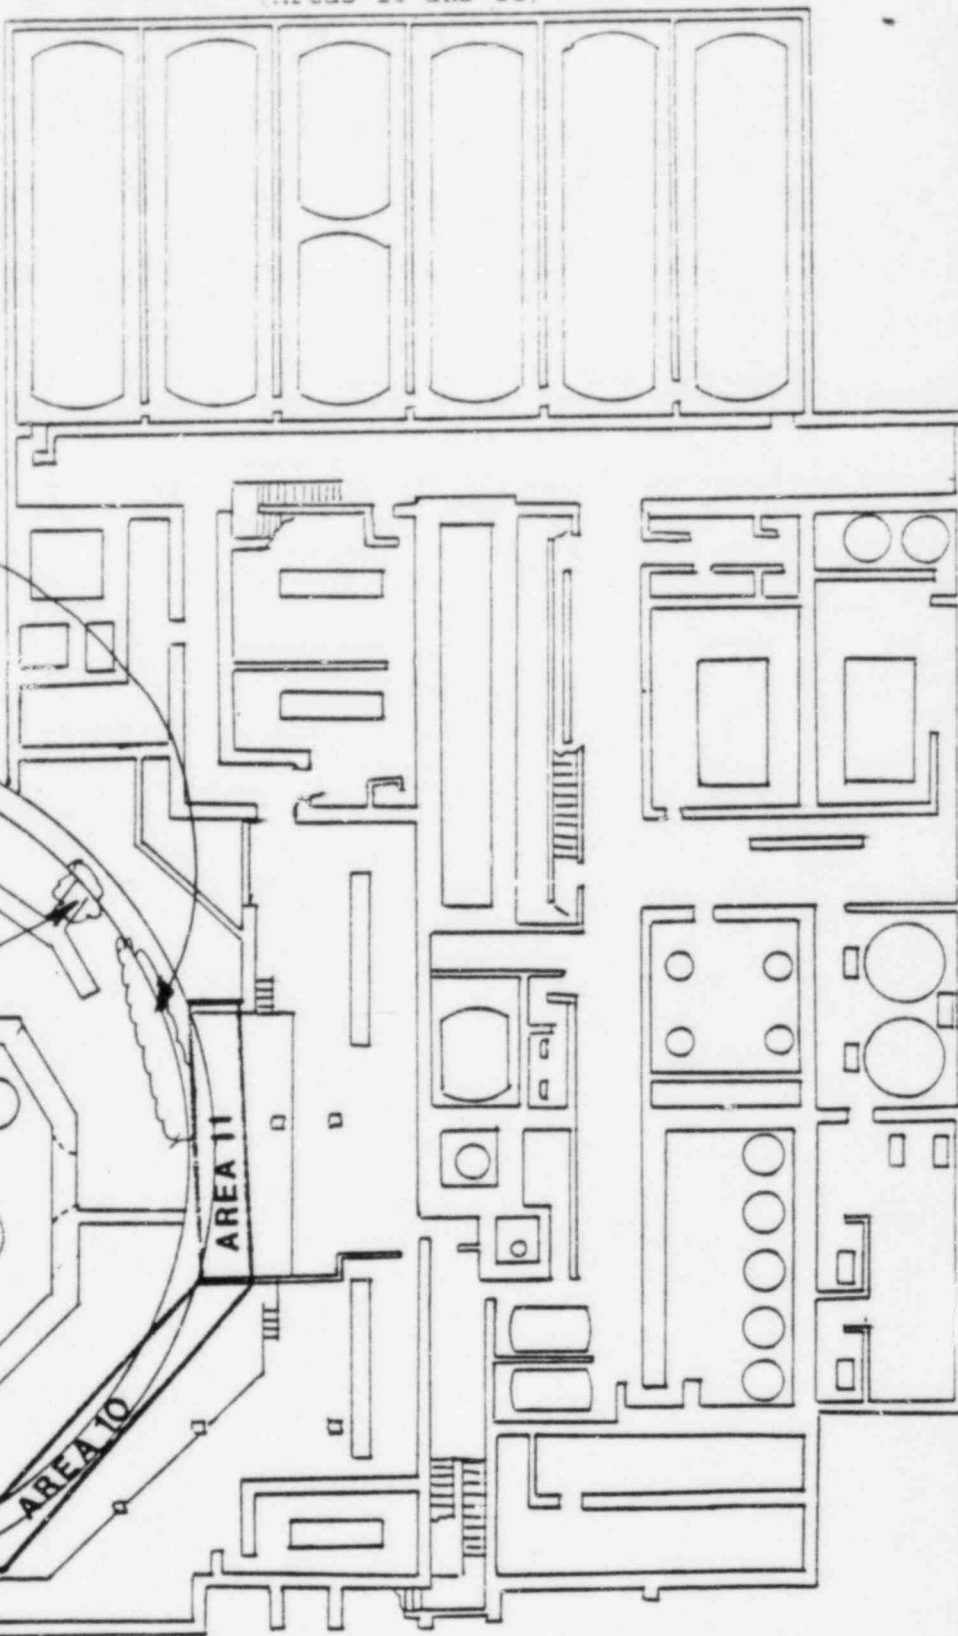
SPECIFIC AREAS OF EXTERIOR SURFACES TO BE INSPECTED
(Areas 10 and 11)

Observations and Results OK GREASE RUNNING DOWN WALL FROM CEILING ABOVE PENETRATION # 62. PER AIR 5-1661 SEE PAGE NORMAL PIC 7-20-82

Observations and Results OK (SEE ENC. 6.1, pg 4)

RUSTY/CORRODED FLANGES &
PEELING PAINT ON MUCH NSW
PIPING.

NCR
S-2326
BADLY RUSTED
BEHIND BULKHEAD

ECN 3298
3299
