50-151

214 Nuclear Engineering Laboratory
103 South Goodwin Avenue
Urbana, IL 61801-2984

March 9, 1994

Final Report on Delay Tank Leak
at the
UIUC Nuclear Reactor Laboratory

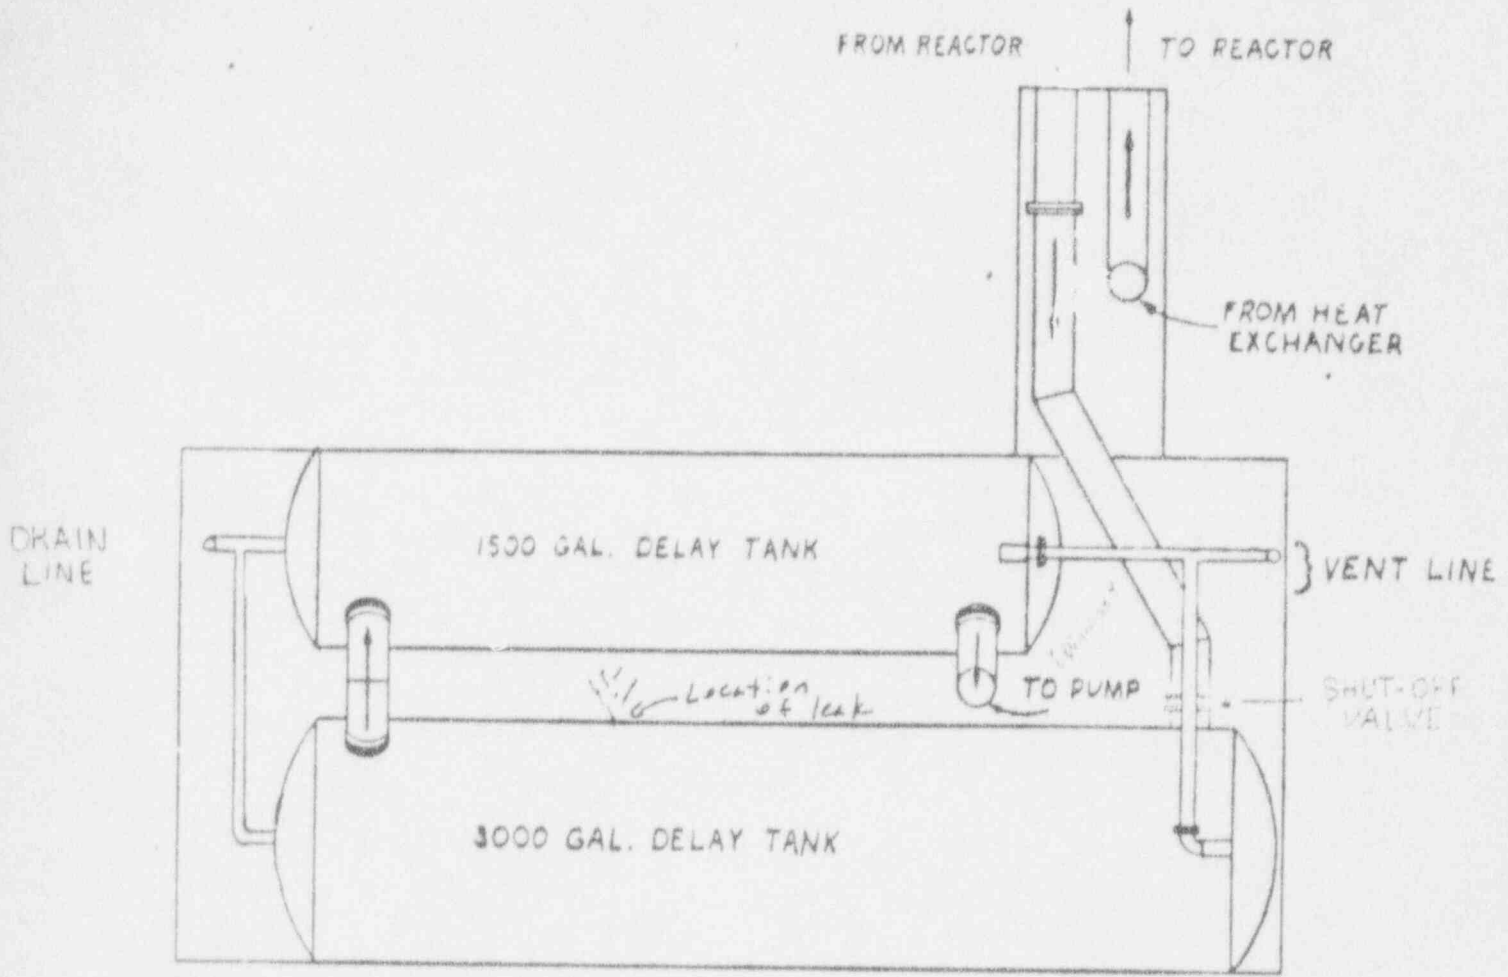
FIG. IV-6 PRIMARY FLOW COMPONENTS IN THE VAULT

The stress caused by this situation apparently caused a fracture in one of the circumferential weld seams in the large delay tank [see Fig. IV - 6]. The 3 gpm makeup valve operated sporadically during Tuesday afternoon, but that was attributed to the fact that the controller got wet when the tank overflowed. The next day the reactor and primary system were operated and it was noticed that the 3 gpm makeup valve was operating fairly frequently and the operator decided to shutdown the reactor. It was found that there was a vault sump alarm and the vault was opened. Approximately 1400 gallons of water were found in the vault and the leak was immediately evident as it was relatively close to the manway. A physical inspection was

performed on both delay tanks and no other leaks were found. The leak is approximately 4 inches in length along a circumferential weld on the 3000 gallon tank slightly above the tank centerline.

- A welder, qualified in aluminum welding, and employed by the University of Illinois repaired the weld in the delay tank on Monday morning, January 10, 1994. *[It was later determined that the welder was not 'certified' for welding on an ASME qualified tank. This situation developed due to miscommunication on the part of the Reactor Supervisor and the Operations and Maintenance Division of the University of Illinois. The Reactor Supervisor did not specify correctly to O & M what was required.]* It was noted that the crack was very evidently due to the stress placed on the weld and not due to corrosive forces. It was also noted that the area of the original weld where the crack occurred had been ground down. This presents the possibility that a stress zone may have been introduced at that time that failed during the transient. The vast majority of the weldment on the tanks still retained the weld cap material, i.e., no grinding had taken place.

- DNV Industries, Inc. of Des Plaines, IL was engaged to perform an NDE inspection of the weld repair and all other accessible weldment. DNV is certified to inspect aluminum tank welds. Dye penetrant and ultrasonic testing of the weld repair and all other accessible weld material on the delay tanks and the sections of the primary piping were tested. No further cracking was evident on any of the weld seams.

- The University of Illinois welder was later certified on aluminum welding to the satisfaction of the Superintendent, Division of Boiler and Pressure Vessel Safety, Office of the State Fire Marshal. However, when the tank was filled with water weepage was found at both the top and the bottom of the repair weld where the new weld material fused with the original weld material. The tank was drained again and a certified welder from Independent Mechanical Industries, Inc. was brought in to repair these weepage points successfully.
