Subject: Licensee Event Report 94-001 for the Fort Calhoun Station

FACILITY NAME (1) Fort Calhoun Station Unit No. 1	DOCKET NUMBER (2) 05000285	PAGE (3) 1 OF 12
--	-------------------------------	---------------------

TITLE (4)
Safeguards Actuation and Subsequent Reactor Trip Due to Relay Failure

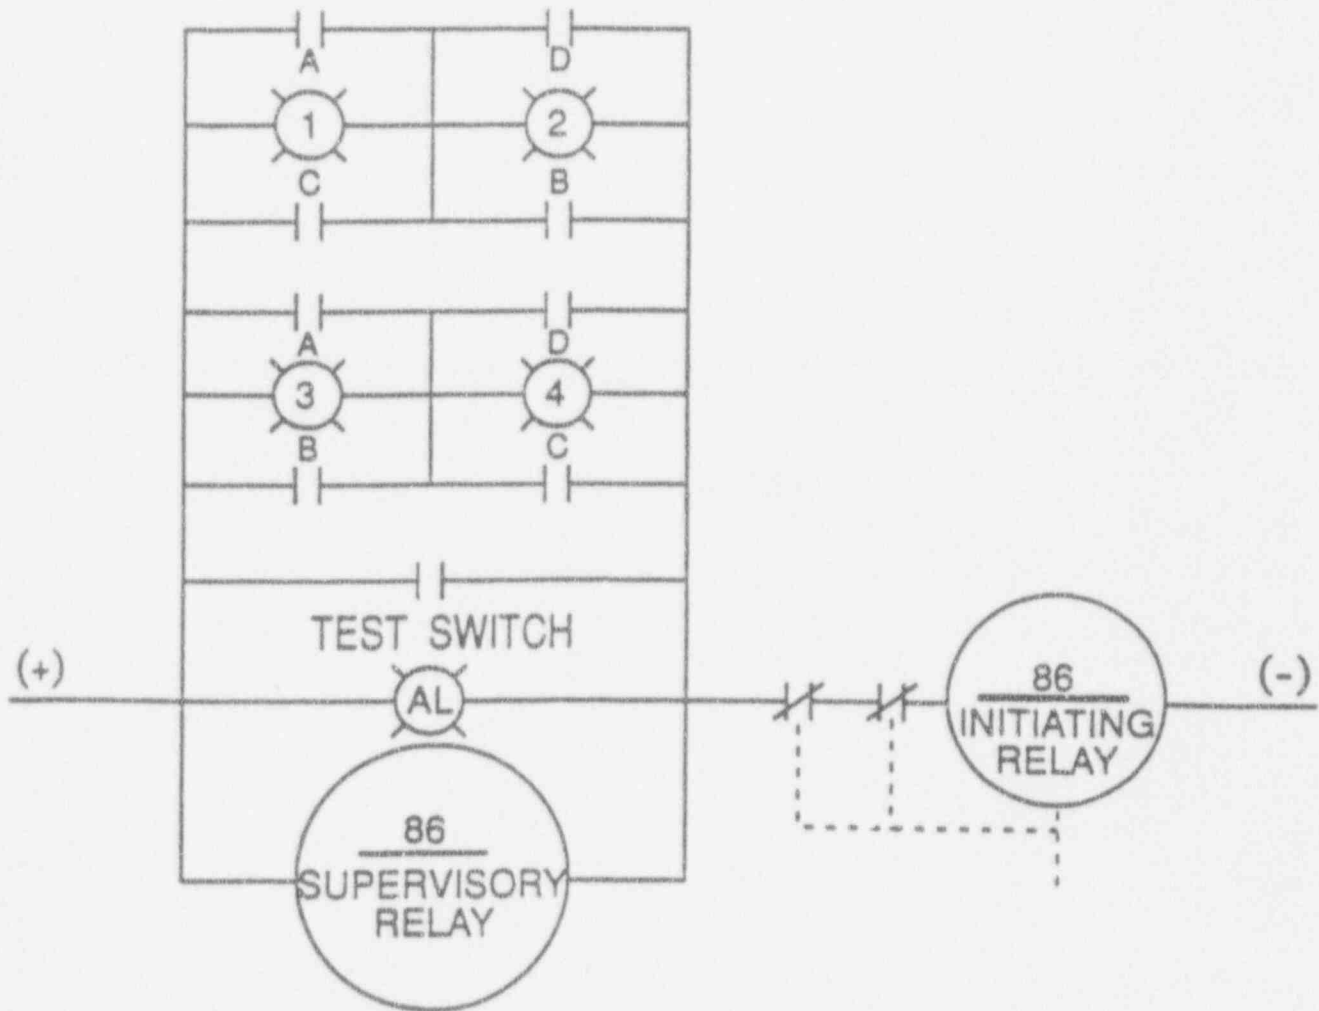
Figure 1
Supervisory Circuit Example

Means are provided to supervise the operability of the safeguards initiation/actuation circuits (see Figure 1). A supervisory relay is provided to monitor each initiation/actuation signal lockout relay circuit. The supervisory relay will become de-energized and actuate a trouble annunciator in the event of an open circuit, a loss of power, or completion of initiation logic without a corresponding lockout relay trip.

The February 11, 1994 event was caused by the failure of relay 86B/CPHSS. This relay is a normally-energized supervisory relay for lockout relay 86B/CPHS. The supervisory relay experienced a short circuit across its coil which resulted in the invalid actuation of 86B/CPHS (see Figure 1). The actuation of 86B/CPHS initiated safeguards actuations and resulted in a turbine/reactor trip.

1. The supervisory relay that failed (86B/CPHSS) was replaced and the replacement relay was tested on February 12, 1994. The failed relay will be sent off-site for investigation of the failure mechanism. This investigation will be completed by August 31, 1994.

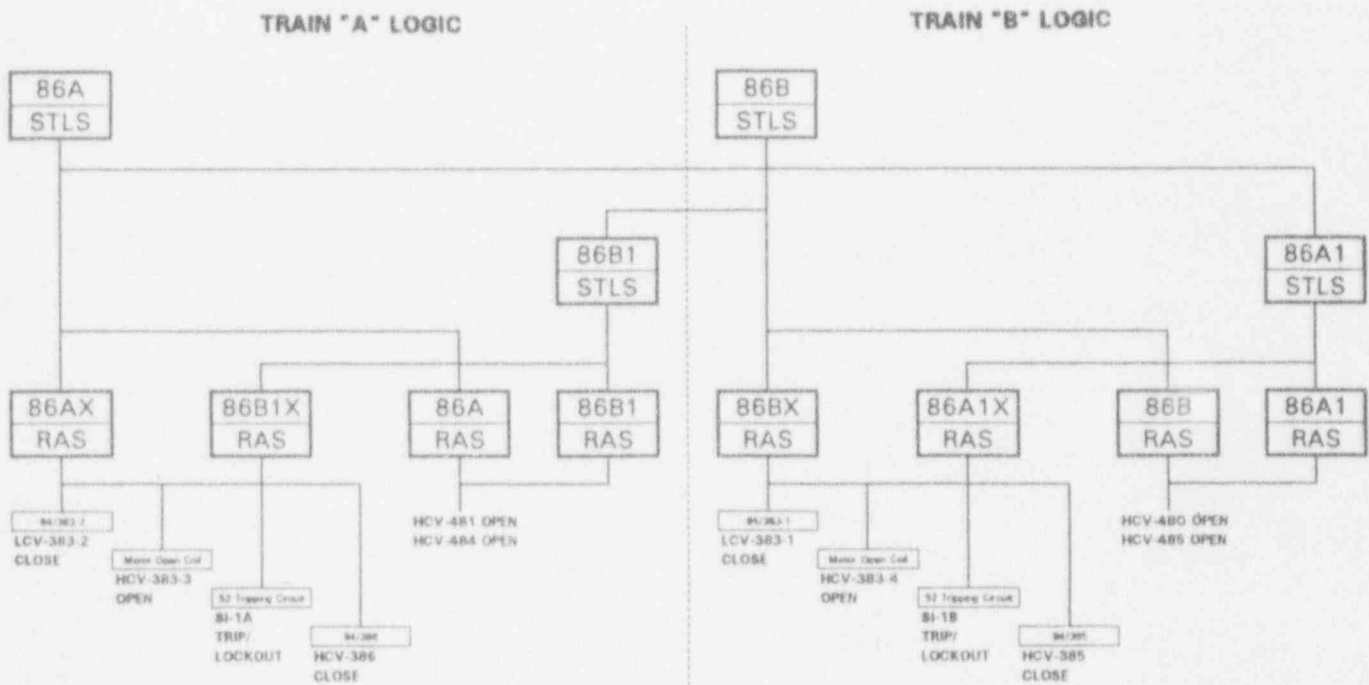
Figure 2
STLS/RAS Logic

Initial investigation identified a concern involving a postulated premature actuation of either of two STLS lockout relays (i.e., 86A/STLS or 86B/STLS), due to a coil-shorting failure of a supervisory relay (see Figure 2). If such a failure were to occur coincident with certain accidents (i.e., a LOCA, a SGTR, or a MSLB), a premature Recirculation Actuation Signal (RAS) could be generated. Such a premature RAS could result in loss of water to the HPSI, LPSI and, if in service, the Containment Spray pumps, due to the realignment of the suction header from the SIRWT to the containment sump.

The design of the STLS/RAS lockout relay supervisory circuits was part of the original plant design, and as such, was developed over twenty years ago. An investigation determined that the potential for a coil-shortening failure of a supervisory relay was considered at the time of the original design, but was apparently not found to be a credible failure mode. As a result, it has been concluded that the root cause of this problem was failure to anticipate a potential failure mode in the original design of Engineered Safeguards initiation/actuation circuitry.

- b. Temporary modifications were implemented on February 18, 1994 and February 19, 1994 to eliminate the identified concerns, by disconnecting the eight supervisory relays.

- c. The temporary modifications will be removed and a permanent resolution of the design basis concerns implemented, by the end of the 1995 Refueling Outage.
