CALVERT CLIFFS NUCLEAR POWER PLANT  
1650 CALVERT CLIFFS PARKWAY • LUSBY, MARYLAND 20657-4702

SUBJECT: Calvert Cliffs Nuclear Power Plant  
Unit Nos. 1 and 2; Docket Nos. 50-317 and 50-318;  
License Nos. DPR 53 and DPR 69  
Licensee Event Report 94-001, Revision 1  
Reactor Trip Due to Opening of 13.8 Kilovolt Feeder Breaker

TITLE (4)  
Reactor Trip Due to Opening of 13.8 Kilovolt Feeder Breaker

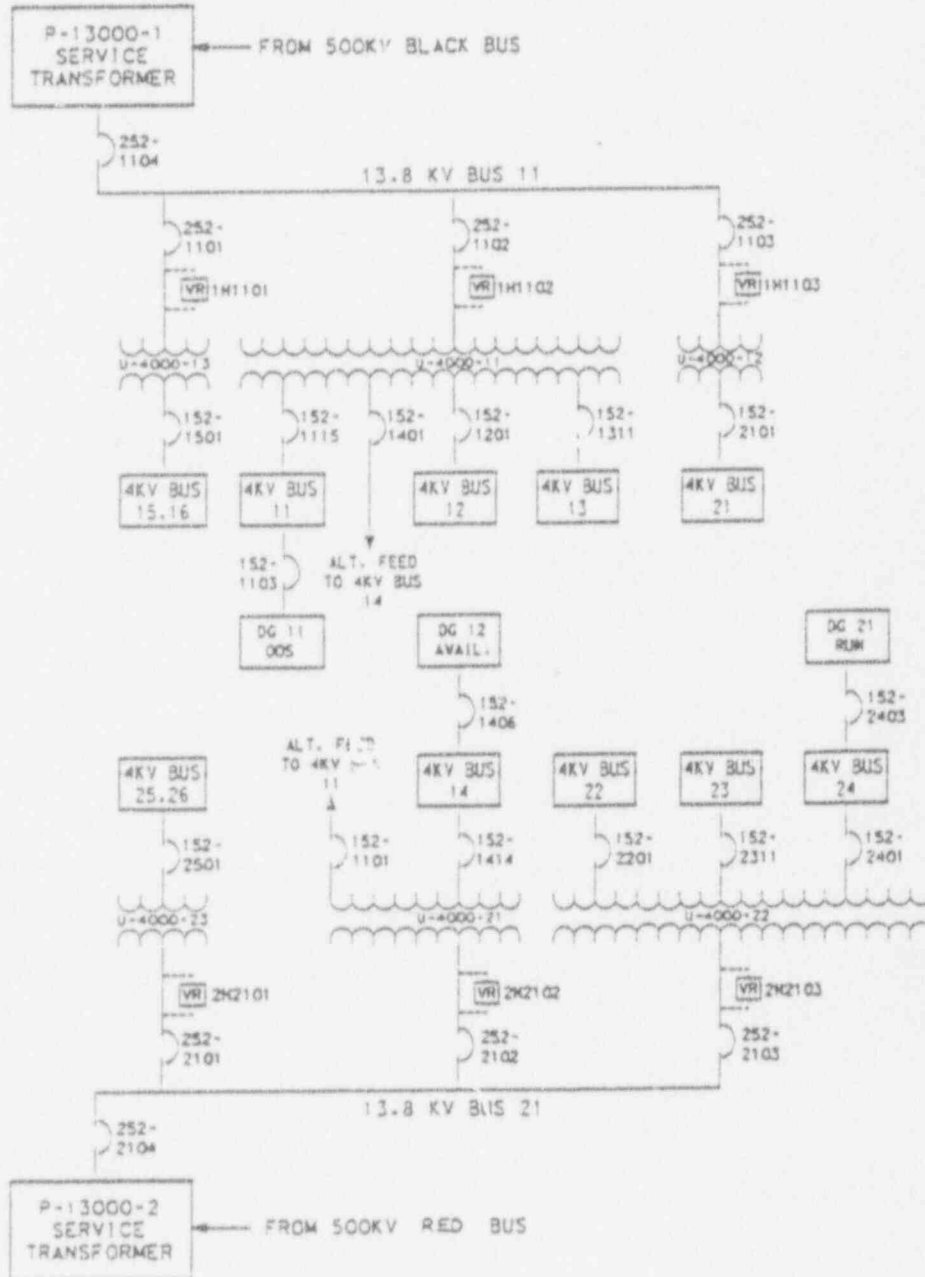
FIGURE 1

Figure 1 provides a schematic of the power supply scheme discussed in this Licensee Event Report (LER).
